Funicular Railway Inspection report - 2018

Job name: **FunInsp 2018**
Job number: **18011**
Client: **Cairngorm Mountain Ltd**
Engineer: [REDACTED]
Date: **July 2018**

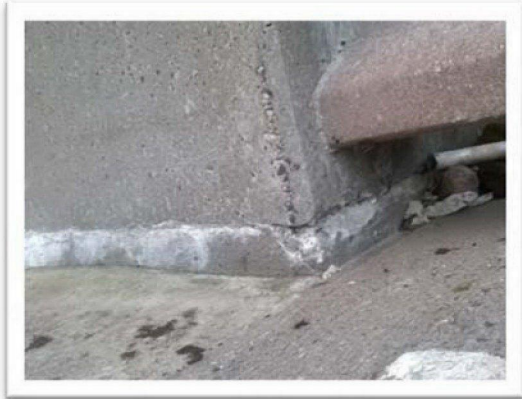
Ref clause 4.1.3

4.1.3 Horizontal shear cracking was observed between the upstand block and the main bulk of the foundation at: Ref photo [1]

Pier 48
Pier 78, this was repaired in 2017

Photo [1] Construction joint / shear fracturing where thrust block upstand meets main foundation.

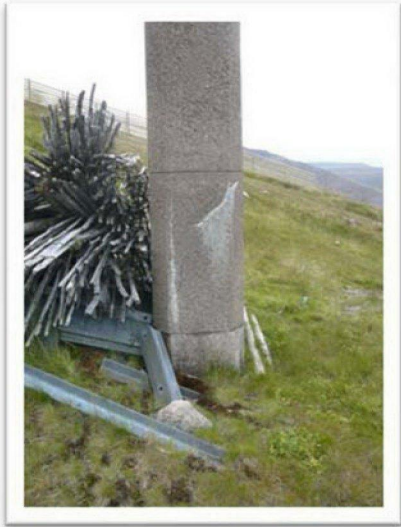
Ref clause 4.2.2

4.2.2 Description: Fractures of the main piers were observed at a number of locations. The available drawing show that the piers were pre-cast shells that were infilled with insitu reinforced concrete. It is therefore concluded that cracks to the shells are of no grave consequence, although they should be reviewed at each annual inspection. Ref photos [3], [4].

Photo [3] Main pier 91 showing cracks in shell.

Recommendation: There is no cause for concern at this time.

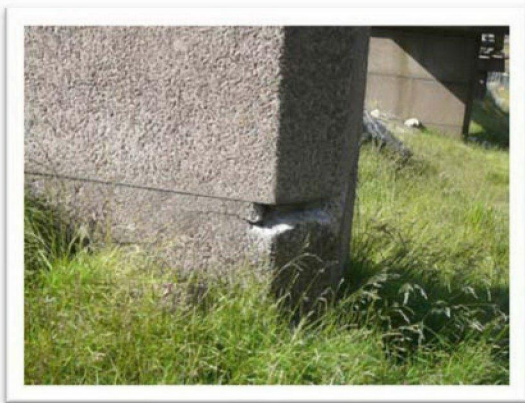
Ref clause 4.2.2

Photo [4] Significant chip out of pier shell.

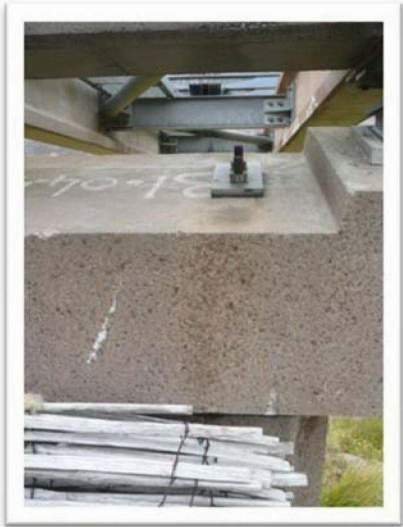
Ref clause 4.3.3

4.3.3 Description: Crack through pier cross head, running up one face and through the PT bolts holes on the top and down the other side, this is apparent on the line of both PT bolts. This appears to be a development on the previous year, when the cracks were only recorded on the line of one bolt. Ref photos [5].

Photo [5] Pier 93. Crack rising up through pier crosshead and passing through bolt group. This was the only cross head where this was observed.

Recommendation: This would not be a concern in its self as the cracks are of a minor nature, but the appearance of a developing situation is of concern. Crack monitoring studs have been installed and will be monitored until a feel for the situation is achieved.

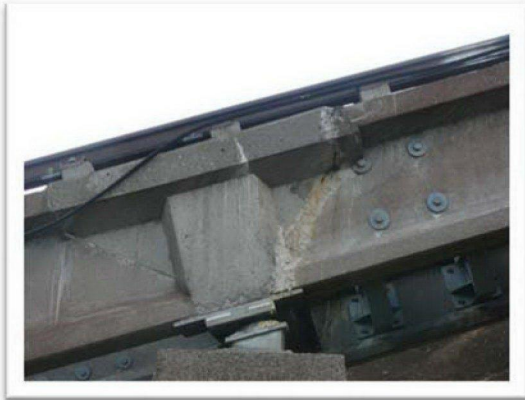
Ref clause 4.5.1

4.5.1 Description: The construction drawings made available for the insitu area are stamped “preliminary” leaving doubt over the construction details. The drawings show a system for mechanical coupling of the reinforcing bars to provide continuity at some locations. One of these couplers is specified as an Ancon PB32, which involves an onsite grouting operation, this would be susceptible to poor quality control. For operational reasons close quarters examination of this joint as a train passes was limited to one location, pier 56, during the 2016 inspection. Here the crack was clearly seen opening then closing again, by an estimated 1mm, as the train passed. The concern here is that the coupler may have failed leading to a redistribution of stress to the midspan of the beams. Correspondence with A F Crudens, Consultant Civil and Structural Engineers for the scheme, confirm that the beams were designed to have sufficient strength as a simply supported beam, but that continuity reinforcement was added to restrict deflections. If this coupler has failed then greater than desirable deflections would be expected at mid span leading to compromised durability of the structure. This appears to be happening. Ref photo [7], [8], [9].

Photo [7] Pier 56, an overview showing previous repairs carried out.

Recommendation: Reform the insitu joint at beams 9 and 56. This is currently being worked on under *ADAC-structures* project number 18007.

Elsewhere inject the joint with resins to prevent water ingress and consequent rusting of embedded reinforcement.

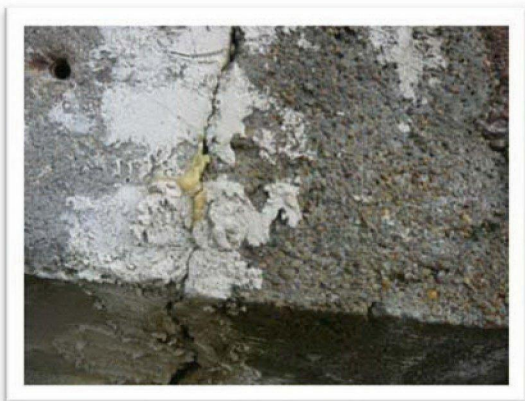
Photo [8] Pier 56 crack near top of flange unloaded.

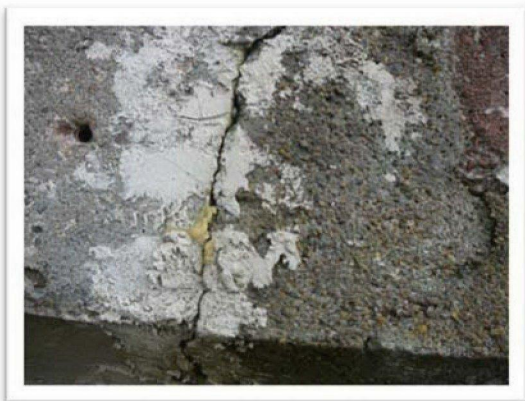
Photo [9] Pier 56 crack near top of flange as train passes. Estimate increase in crack width = 1.0mm.

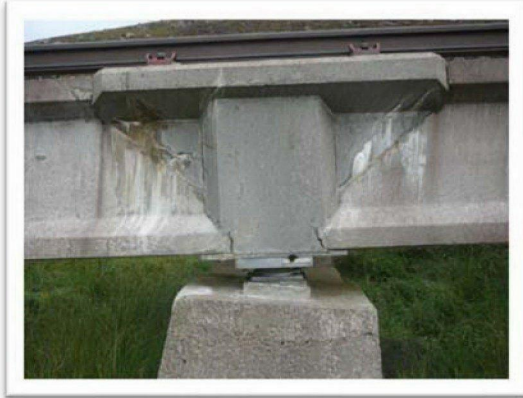
4.5.3 Description: Cracking within the insitu fill, between the precast beam ends. This generally appeared as vertical cracks, often with considerable calcite bleed, sometimes white, elsewhere stained brown. Ref photo [10], [11].

Photo [10] Pier 9, one of the poorer insitu infills. Showing joints opening between Insitu and precast plus cracking within the mass of the Insitu, both inclined and near vertical.

Recommendation: Monitor for developing problems.

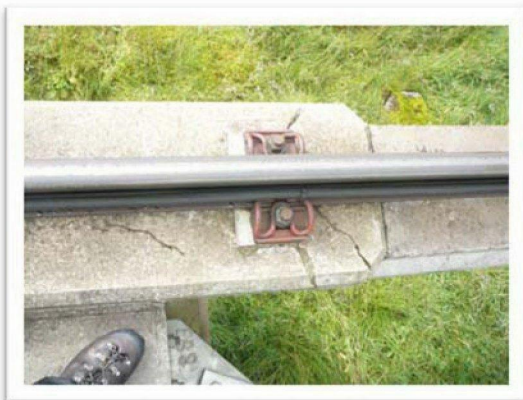
4.5.2 Description: Significant shear cracking on top of insitu concrete. This appears to indicate the failure of lapped reinforcement. This is most likely either due to inadequate lap or poor quality concrete. Ref photo [11].

Photo [11] Pier 9 from above.

Recommendation: Break out the top half of this insitu and ensure reinforcement arrangement meets requirements for continuity and reform in good quality concrete, see 4.5.1 above.

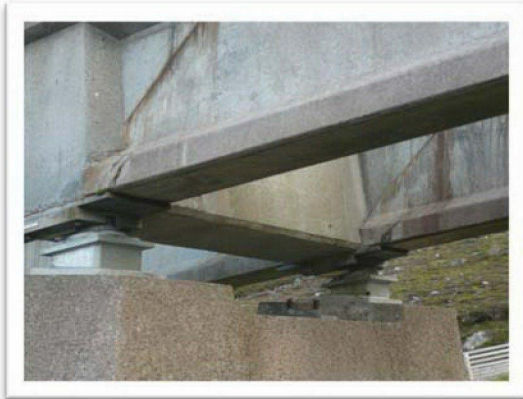
Ref clause 4.5.4

4.5.4 Description: Fracturing of the flange ends of the precast beams, usually the bottom flange. At the time of writing some work had started to address this. The crack lines were drilled and resin injected to seal them. In most cases the described block of concrete fell away at the interface with the reinforcement – these then became local mortar repairs. It appears that this block of effectively unreinforced concrete is fracturing off at the bearings possibly due to some minor eccentricities of the bearing. In some instances the failure is seen in the top flange Ref photos [12], [13], [14].

Photo [12] Diagonal cracks through the lower flange of the precast beam bearings.

Recommendation: Where applicable, resin inject cracks to seal against water ingress and to reduce the risk of corrosion problems. Where the block of concrete falls away as described above then the repair is to be done in mortars with stainless steel reinforcing dowels.

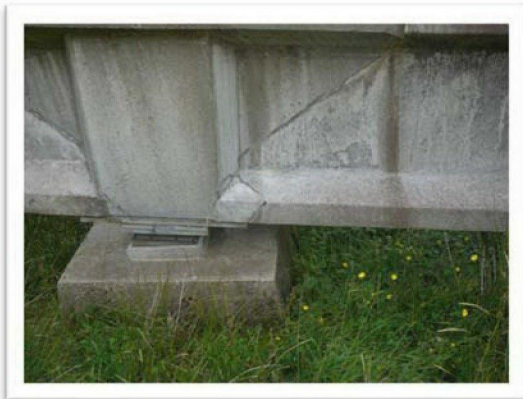
Photo [13] Showing bottom corner fracturing away.

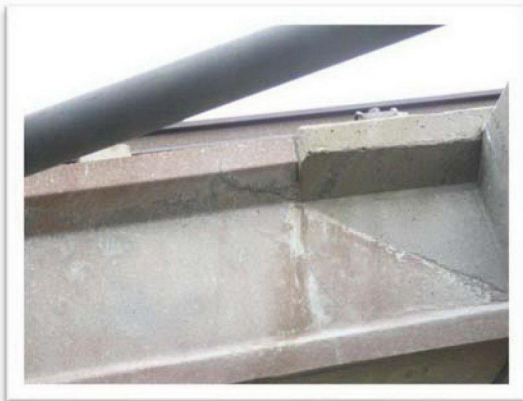
Photo [14] Flange fracture also seen at top of beams. This was less often.

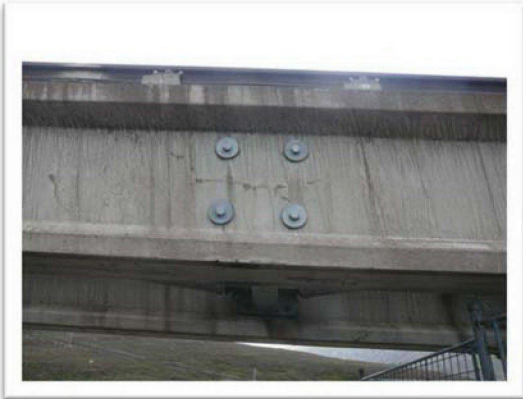
Ref clause 4.6.5

- 4.6.5 Description: A repeating pattern of micro cracking was observed between the bolts through the web of the precast concrete beams at the cross bracing connections.

Photo [15] Typical crack patterns around bolt groups.

Recommendation: None of these observations were of a scale or nature to give rise to concern.

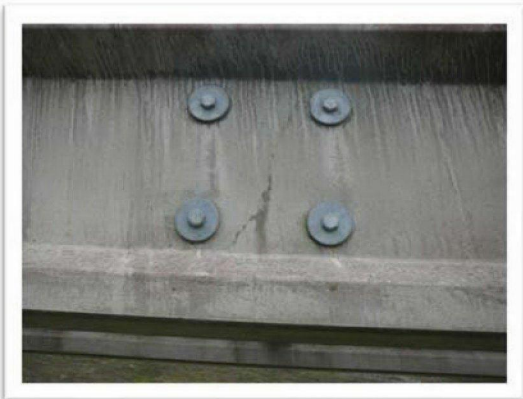
Photo [16], ditto

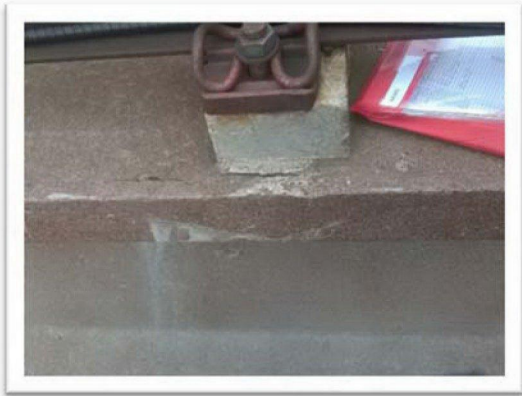
Ref clause 4.6.6

- 4.6.6 Description: A number of beams showed longitudinal cracking in the top flange. It is thought that these are cold joints – a disappointing feature in a factory made item. Ref photo [17]

Photo [17] Longitudinal cracking of the top flange of the PCC beams, here short.

Recommendation: At this stage beams 43 and 93 are not a concern.

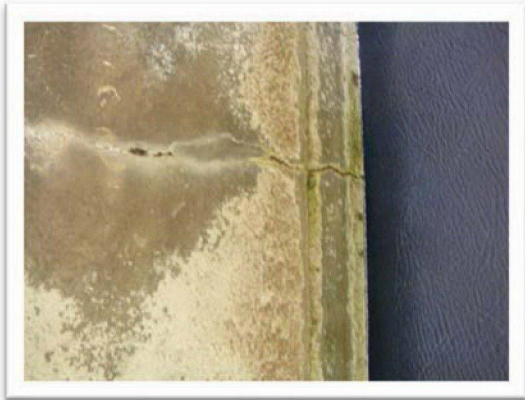
Ref clause 4.6.7

4.6.2 General comment: Cracking >0.2mm width is present in a large number of the lower flanges of the precast beams. However, the majority of cracks do not exhibit rust staining and do not appear to be ‘live’ i.e. they do not appear to open and close under different load conditions.

BS 8110-2 section 3 clause 3.2.4.2 states that to prevent corrosion in aggressive environments the crack width should not exceed 0.3mm. There are many instances where this limit is exceeded and it is no surprise that rust staining is being seen.

Photo [19] View of crack on typical mid-span underside of beam.

Recommendation: A detailed assessment of what has caused this cracking has not been carried out, but it seems likely that there is more than one cause. It is recommended that a capillary and

crack sealing product be applied to one or two particularly bad beams as a trial and monitored for performance, if it proves satisfactory then it be rolled out to all problem areas.

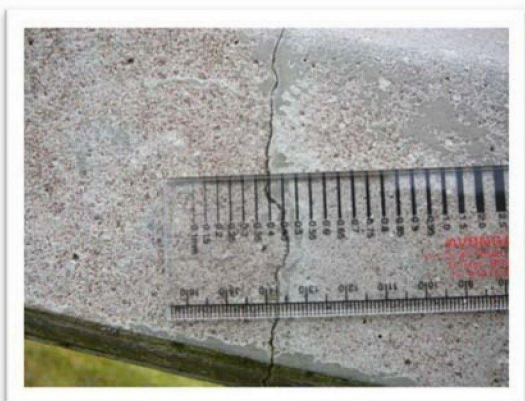
Photo [20] The above photographed crack as it appears on the side of the beam.

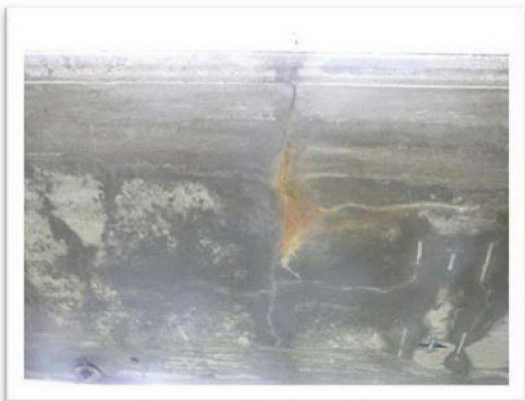
The possibility of ongoing corrosion of the reinforcing steel should be considered, together with the long-term consequences of this, should it be left uncorrected. It is recommended that measures should be taken to seal any cracks where rust-staining is apparent, so as to eliminate oxygen and water ingress.

Photo [21] Crack at mid span of beam exhibiting rust staining.

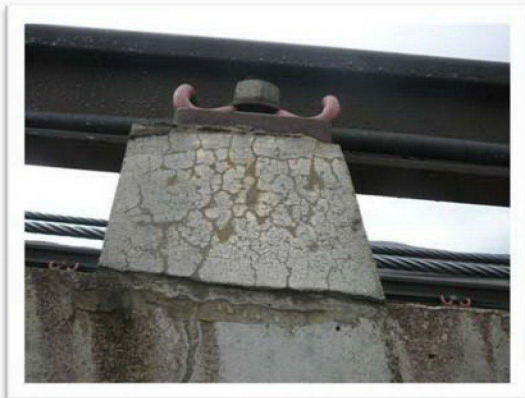
Ref clause 4.7.1

Photo [22] Typical grout plinth, exhibiting crazing, but stable

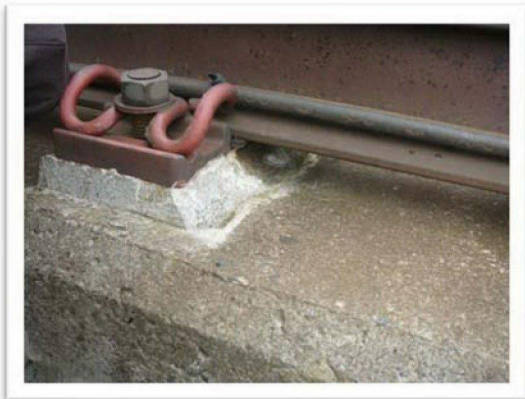
Photo [23] Typical case of a flake off one face of plinth. This regarded as stable.

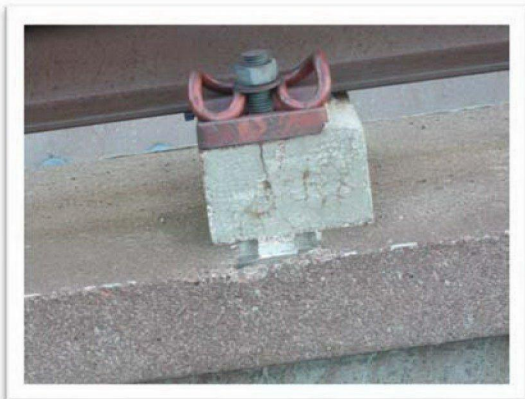
Photo [24] Grout plinth showing fracture. Regarded as stable at this time.
