DECEMBER 2018  
HIGHLANDS AND ISLANDS ENTERPRISE

# CAIRNGORM FUNICULAR RAILWAY

## VIADUCT APPRAISAL REPORT

Rp01

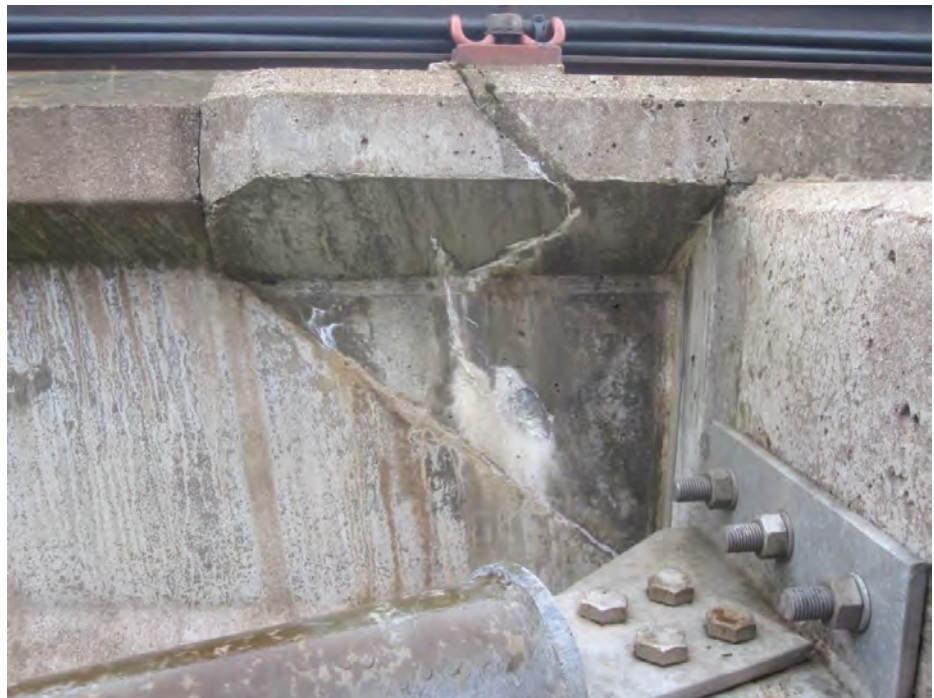
- 1 Cracks have been observed in the main concrete beams at numerous locations. There are cracks in the bottom flanges of most precast beams up to 0.5mm wide believed to be flexural cracking. There is widespread micro-cracking in the precast web beams around the bolted bracing connections. However, the largest cracks are in the insitu concrete close to the interface between precast and insitu concrete, which in some cases cracks extend through the bottom flange of the precast beam. In many cases attempts have been made to seal cracks, for example by resin injection. At two locations - piers 22 and 56 - the cracks have been seen to widen by approximately 0.7mm under the action of live loads and close up again after the load has passed. [Refer ADAC condition reports Nov 2015, Dec 2016, July 2017, July 2018]

Figure 2-6 Cracking at a pier 9 (refer defect 1)

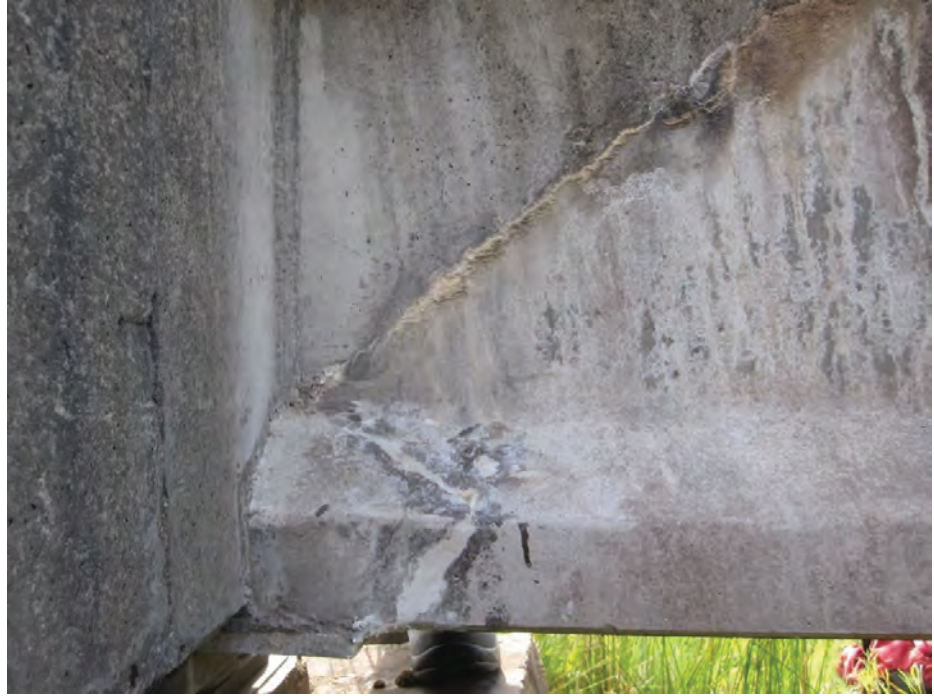
Figure 2-7 Crack repair at pier 9 (refer defect 1)

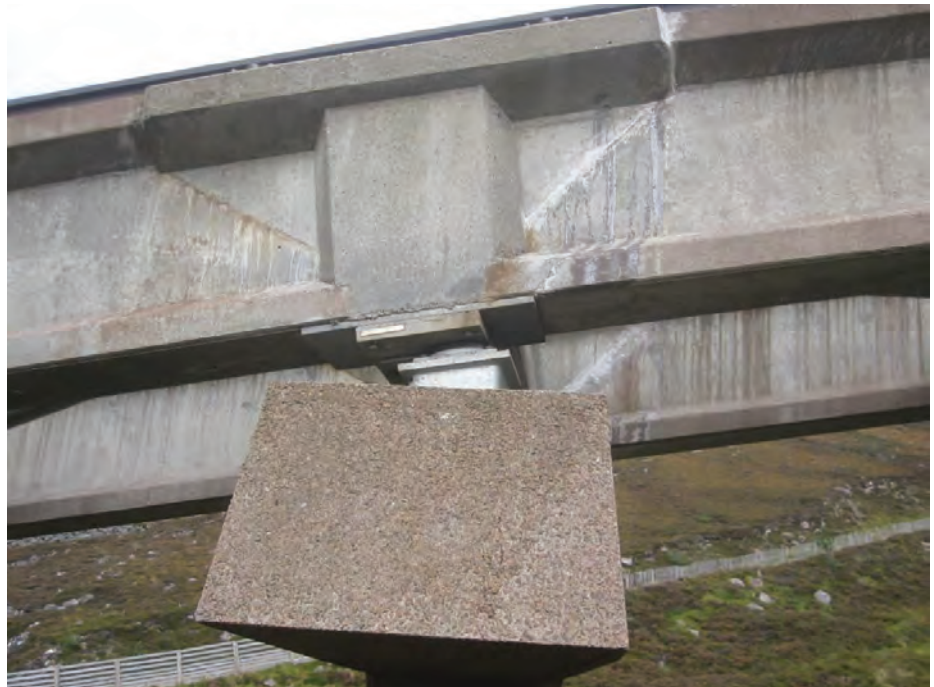
- 3 There is evidence of leakage at cracks, especially at the scarfed joints. Many have considerable calcite bleed and rust staining is noted at some of the cracks [Refer ADAC condition reports Nov 2015, Dec 2016, July 2017, July 2018]

- 4 The grout under bearings is disintegrating at several locations. [Refer ADAC condition reports Nov 2015, Dec 2016, July 2017]
- 5 Many sliding bearings appear to be misaligned longitudinally. The bearings at several piers, especially in areas 3 and 4 were seen to be near the end of the sliding tracks suggesting that under extreme temperatures the bearings might slide beyond their stainless steel tracks. [Refer ADAC bearing report Aug 2018]

Figure 2-8 Typical crack leakage and bearing misalignment (refer defects 3 and 5)

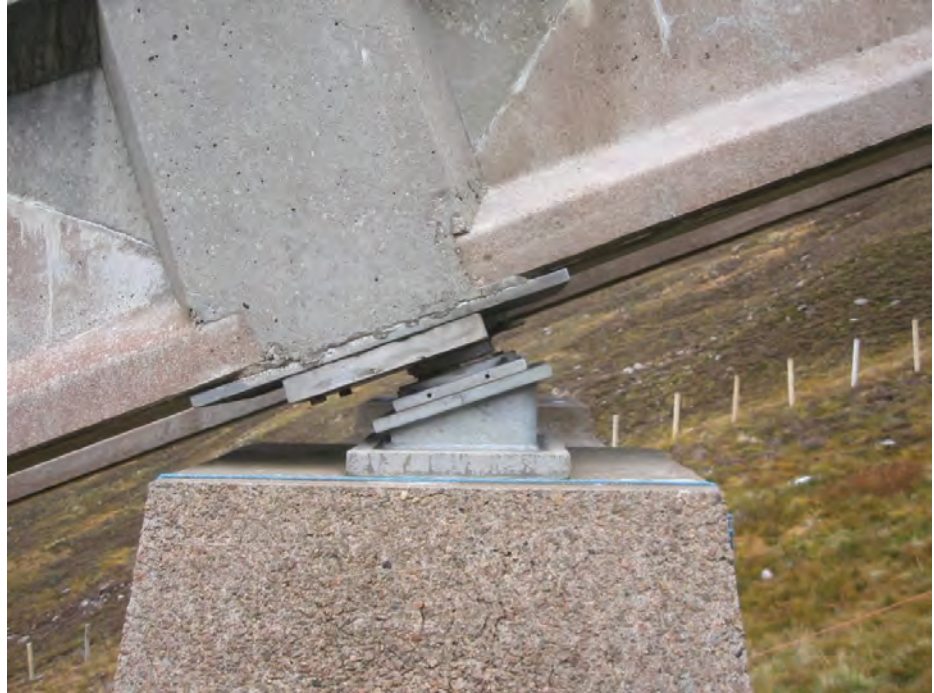
Figure 2-9 Bearing misalignment (refer defect 5)

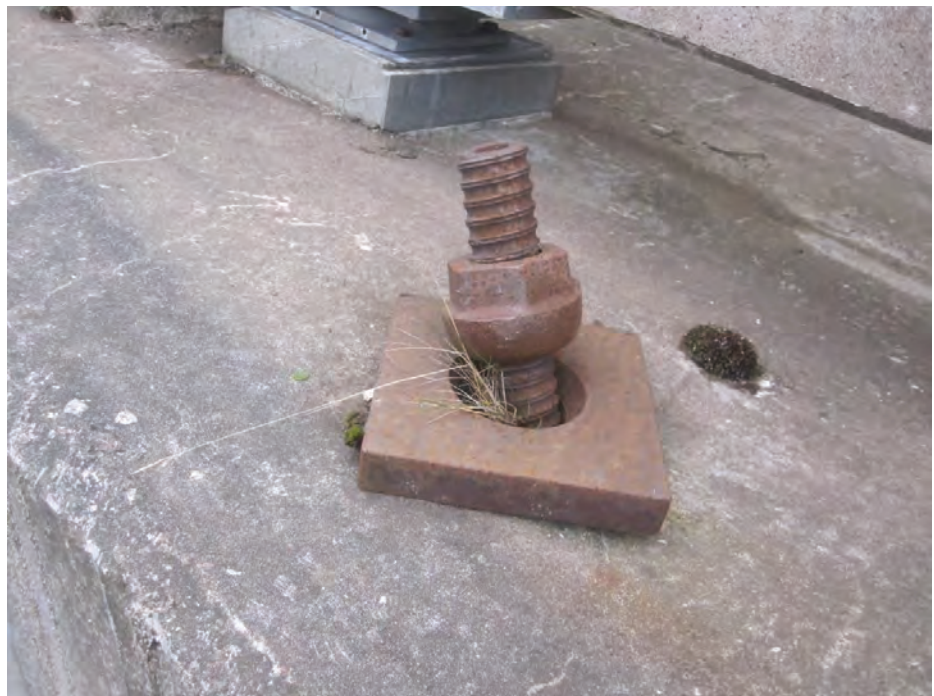
- 6 One pier - pier 91 - appears to be leaning away from vertical by approximately 1°. [New observation by COWI/ADAC, Nov 2018]
- 7 Some rock bolts at anchor blocks can be loosened by hand. [New observation by COWI/ADAC, Aug 2018]

Figure 2-10 Loosened rock bolt in anchor block (refer defect 7)

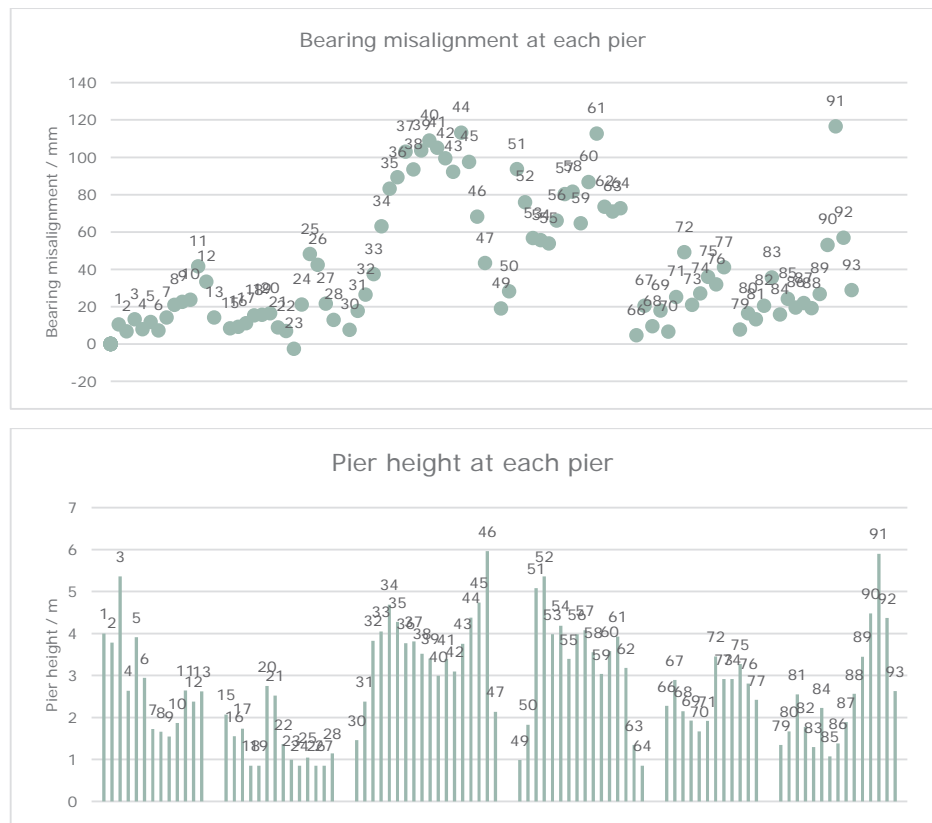
Results from site surveys and measurements suggest bearings absolute and relative positions vary widely along the viaduct's length. A representation of distance from theoretical centre of relative positions at piers is shown in figure 6-4.

Figure 6-4 Longitudinal displacement of bearings along viaduct length at a reference temperature of 0°C and pier heights for comparison.

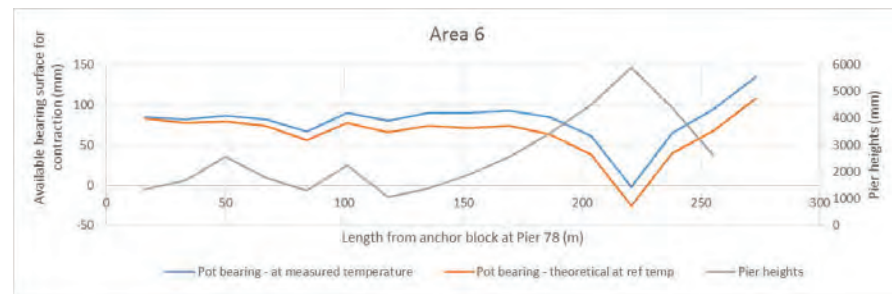
Review of ADAC's bearing report, Aug 2018, and bearing monitoring confirms that some bearings exhibit partial loss of contact at temperatures as high as +5°C. At lower temperatures many bearing locations experience some degree of contact surface overhang which typical increases with correlation to pier height. Figure 6-5 shows the correlation between measured and theoretical bearing positions relative to pier height. Monitoring has confirmed that although broadly in line with expected, measured results are consistently less than theoretical predictions.

Figure 6-5 Longitudinal displacement of bearings, measured (at ambient temperatures of 8.9 to 20.8°C) and theoretical (at reference temperature 0°C).

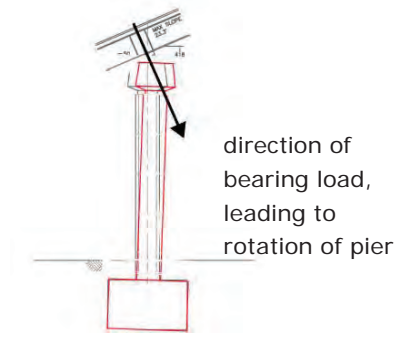
Although investigations have not definitively identified the reason for bearing misalignments there is a correlation between the most overloaded pier foundations and the observed misalignments of bearings in areas 3 and 4 and pier 91. Based on current knowledge it is thought the most likely reason for the bearing misalignment is that some pier foundations have failed and rotated in towards the slope due to the inclination of the bearings as shown in Figure 7-1. All the bearing misalignments are in the uphill direction, which supports this theory.

Figure 7-1 *Rotation of pier leading to bearing misalignment*

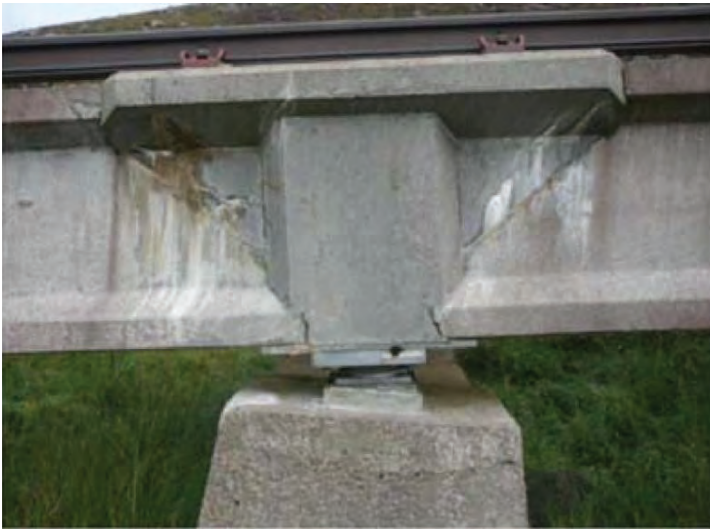
Showing: Cracking of a precast  
beam bottom flange where it  
meets the bearing plate.

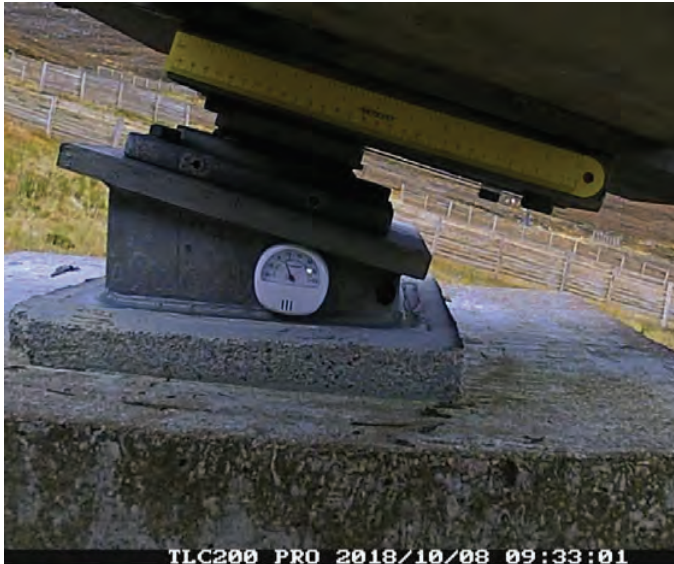
These results would suggest that the bearing exceeds the available sliding surface at a temperature of approximately 5degC.

Figure 3 - Pier 44, extremity of movement

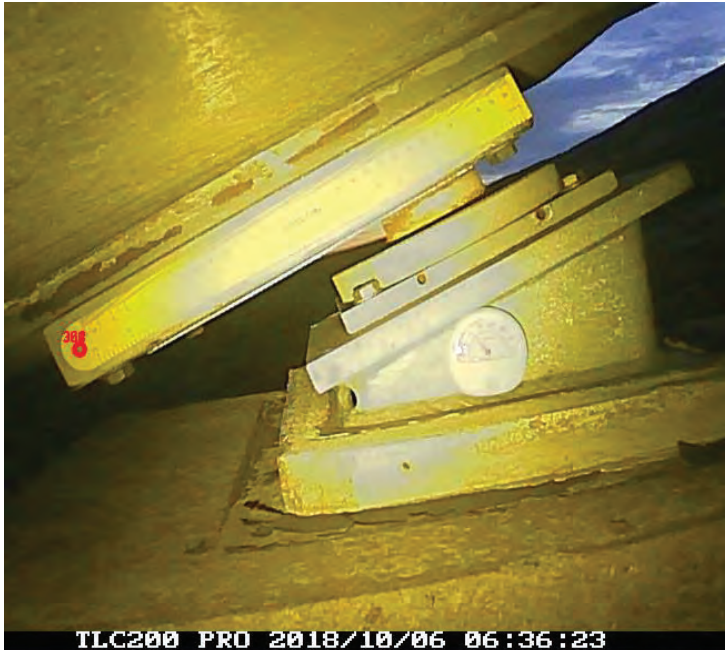
Based on the movement range seen, the bearing exceeded the available sliding surface by around 12mm at the extremity of its movement range, which occurred at 0degC air temperature. This result agrees with measurements taken on site by ADAC structures/COWI though is less than theoretical. It is however noted that the limited monitoring period for this bearing did not include days where the temperature was colder (below 0degC). As such the bearing is likely to have exceeded its sliding surface by more than this value.

Figure 9 - Pier 91, extremity of movement

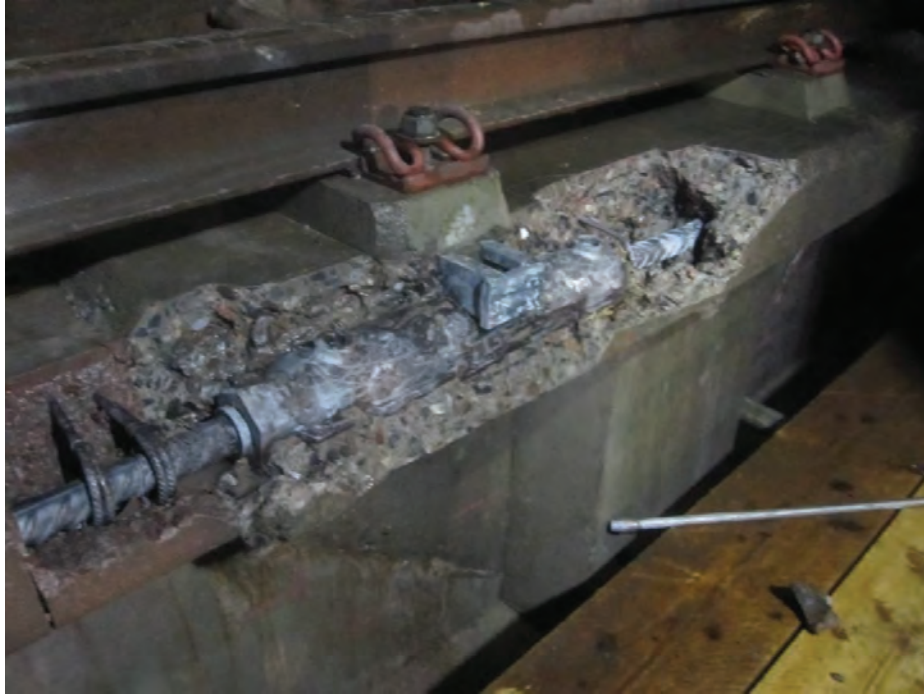
Figure 5 Exposed grouted coupler at pier 22

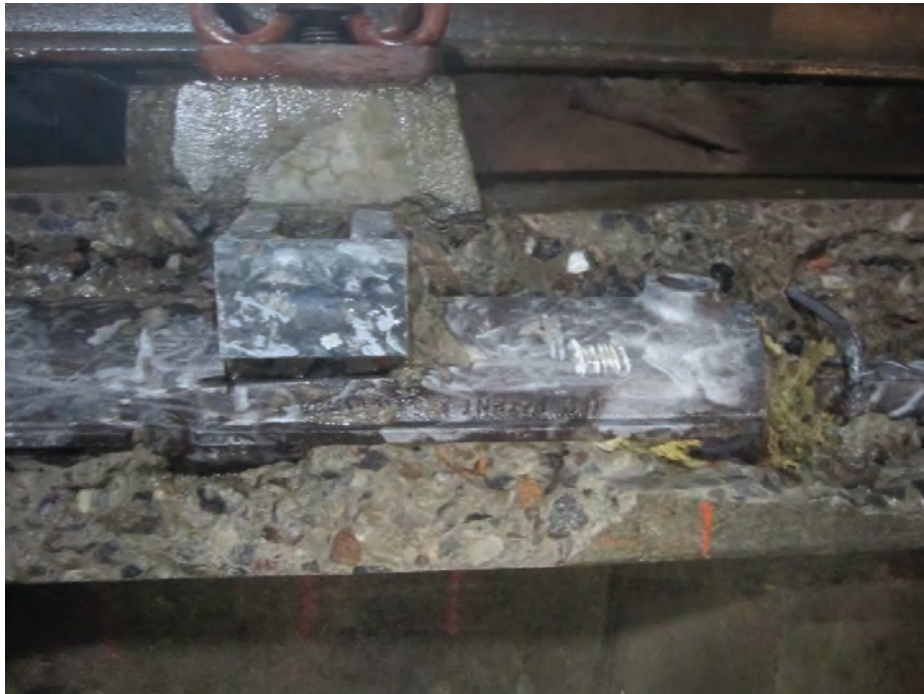
Figure 6 Close-up view of grouted coupler cut-out around HALFEN channel at pier 22

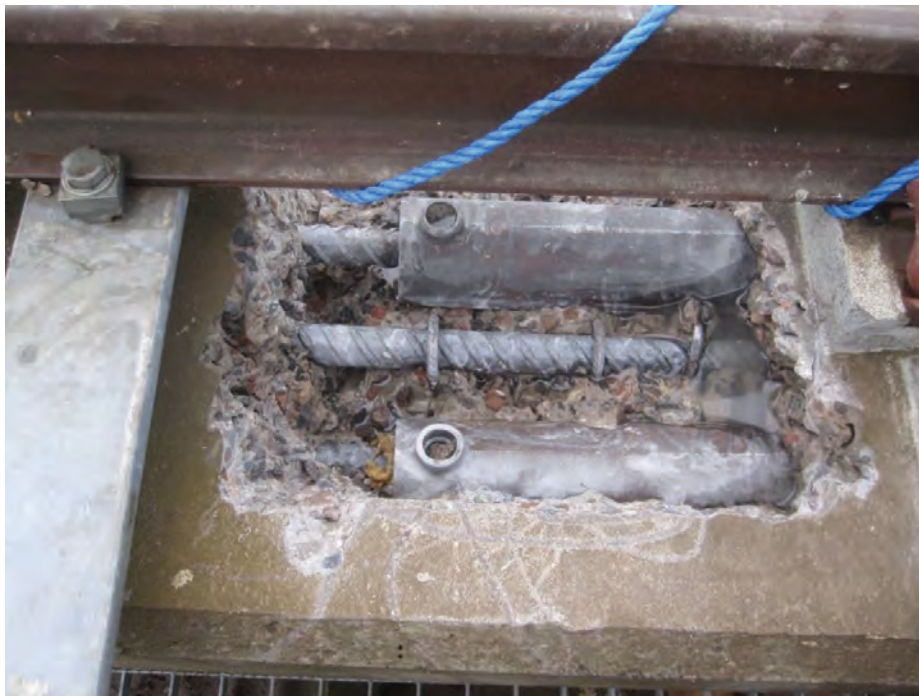
Figure 7 Breakout at pier 56 showing staggered coupler arrangement

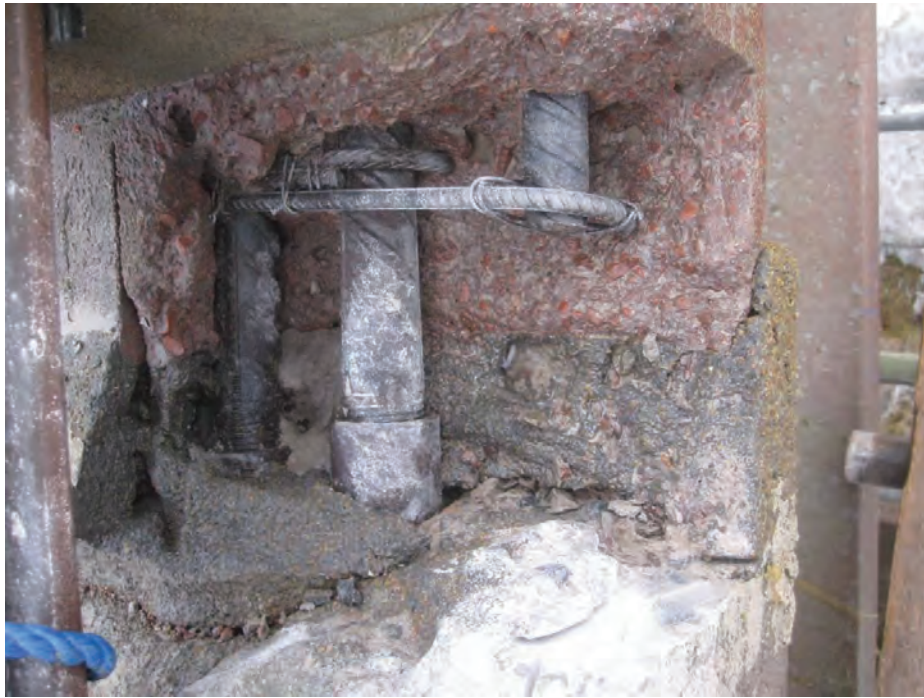
Figure 8 Breakout at pier 56 showing termination of T25 bar before the in-situ concrete interface

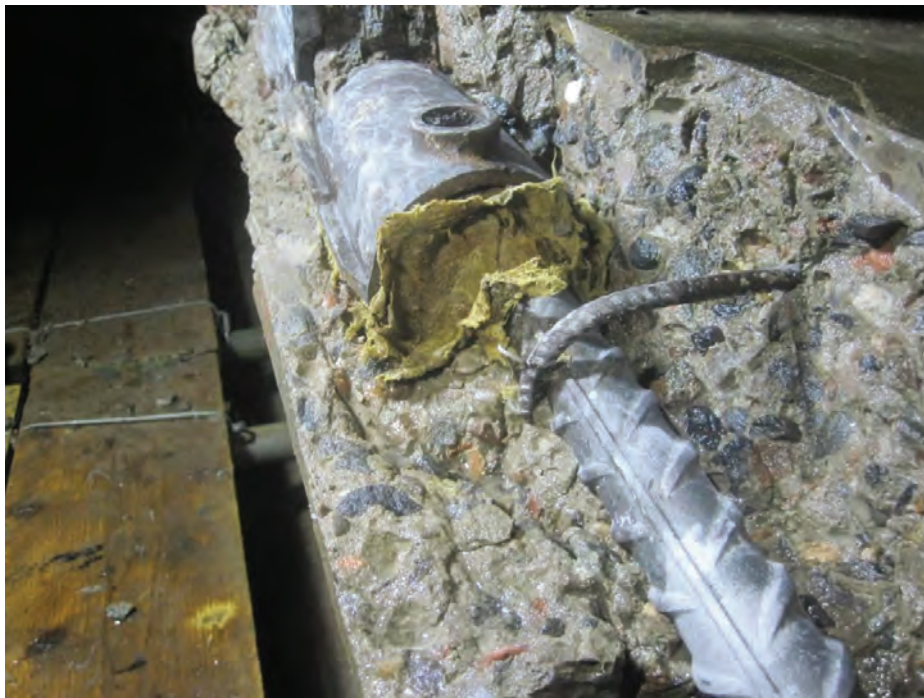
Figure 9 DENSO tape at grouted coupler end
