DECEMBER 2018  
HIGHLANDS AND ISLANDS ENTERPRISE

# CAIRNGORM FUNICULAR RAILWAY

## VIADUCT APPRAISAL REPORT

Rp01

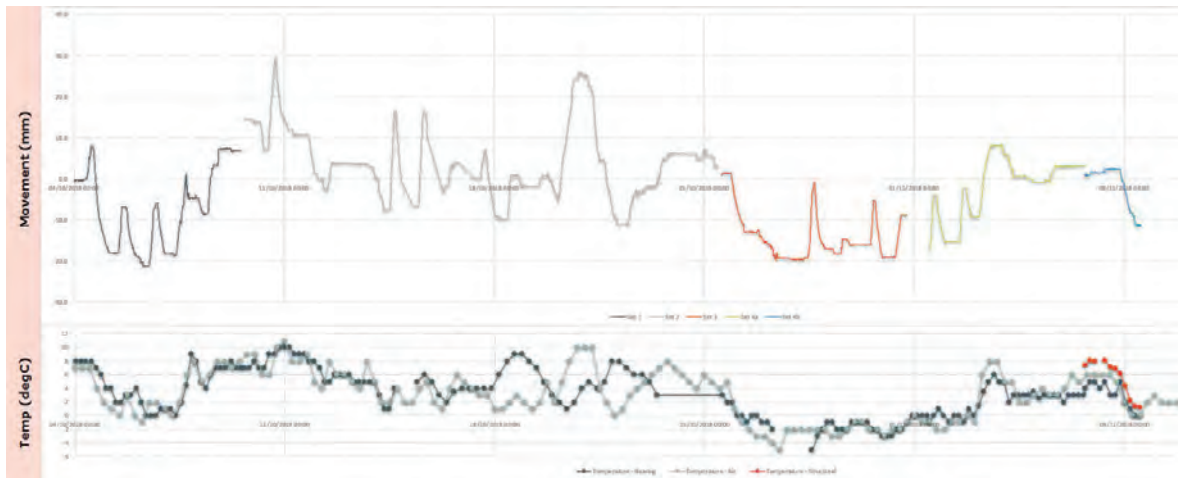
Figure 1 - P44

This pier is 260m from the point of fixity and would experience a theoretical movement of up to 3.1mm per degree. These results are considered similar and within the accuracy of this method.

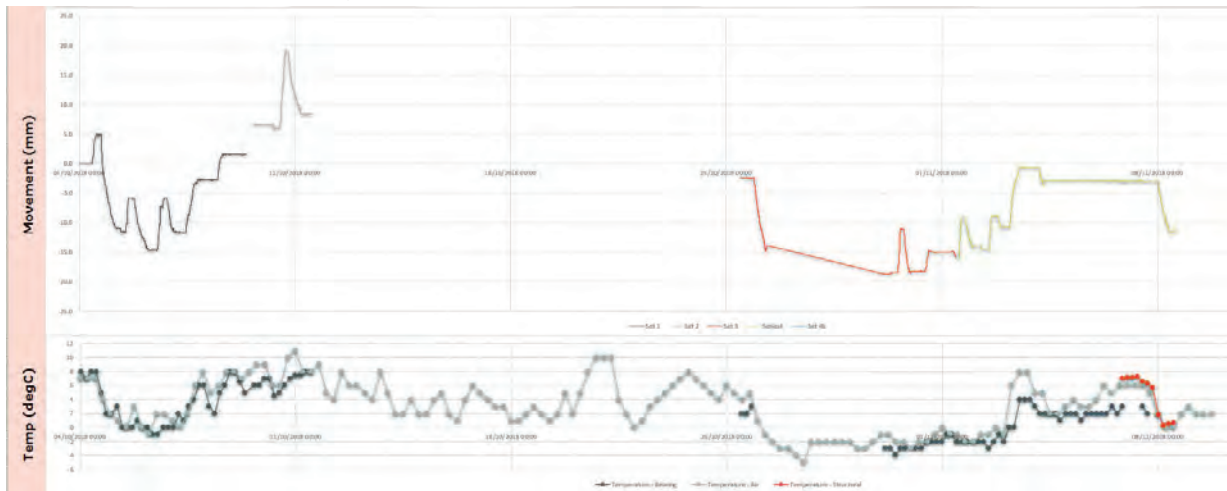
Figure 4 - Movement Range - P61

An approximate movement range of -20mm (contraction) and +20mm (expansion) was seen from the zero point (taken as the start of movement).

This pier is 214m from the point of fixity and would experience a theoretical movement of up to 2.6mm per degree. These results are considered similar and within the accuracy of this method.

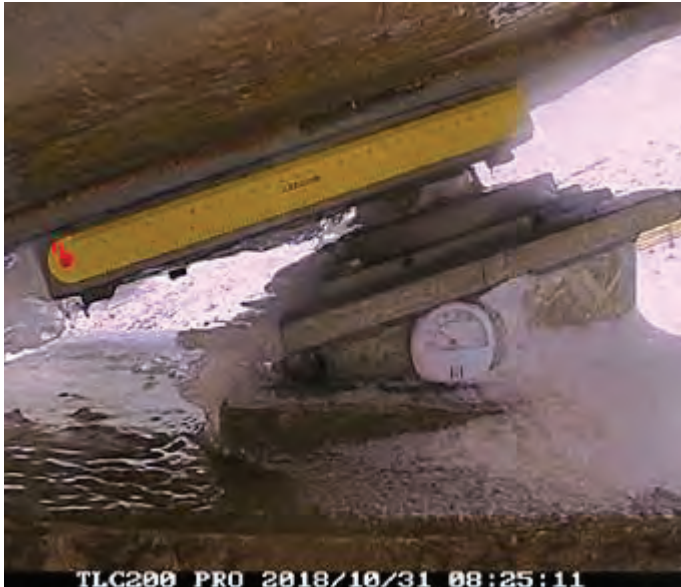
Figure 6 - Pier 61, extremity of movement

Site measurements from ADAC structures suggest that the bearing had approximately 10mm of available movement range at 13degC structural temperature.

Based on the movement range seen, the bearing exceeded the available sliding surface by around 15mm at the extremity of its movement range, which occurred at -3degC. This broadly agrees with measurements taken manually from the camera and those measured on-site by ADAC Structures/COWI though are less than theoretical. This suggests that the bearing will exceed its allowable sliding surface at 5degC.

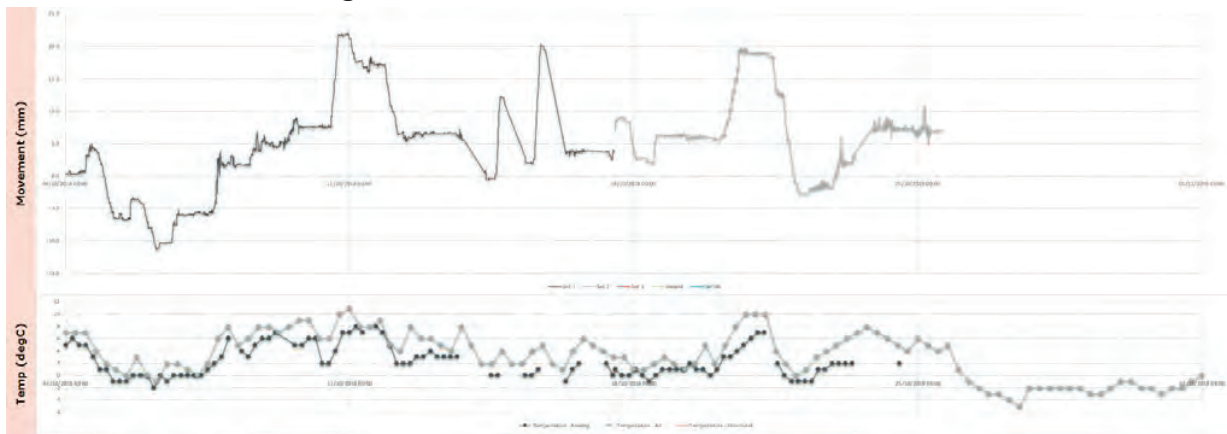
Figure 7 - Movement Range – P91

An approximate movement range of -12mm (contraction) and +22mm (expansion) was seen from the zero point (taken as the start of movement).

This pier is 220m from the point of fixity, which would suggest a theoretical movement of up to 2.6mm per degree. These results are considered similar and within the accuracy of this method. The results agree with those at Piers 44 and 61.

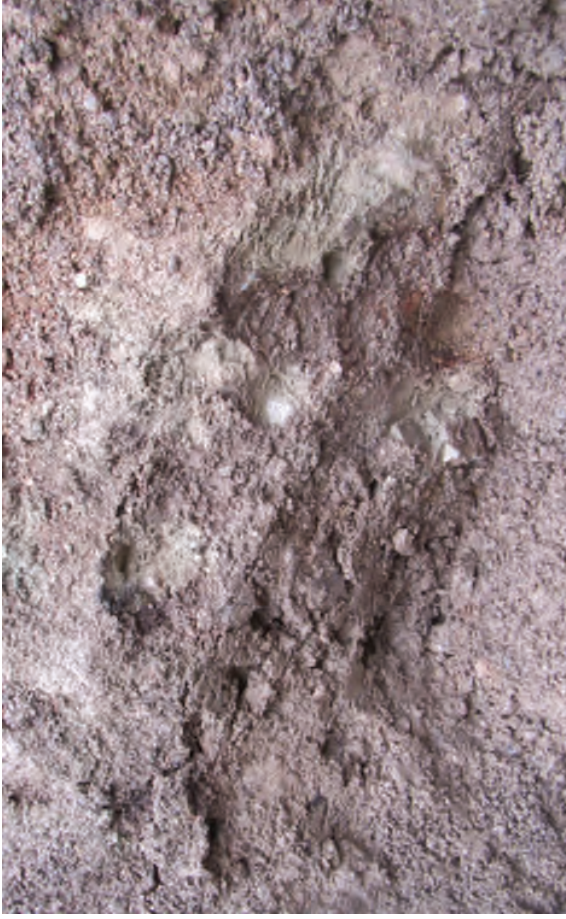
0.0-1.5m Light grey and orange brown gravelly SAND interlayered with yellow brown clayey silt and occasional cobbles and boulders. Assessed as medium dense. Gravel, cobbles and boulders are sub-angular to rounded of granite lithology occasionally decomposed to residual soil. (Glacial Deposits).

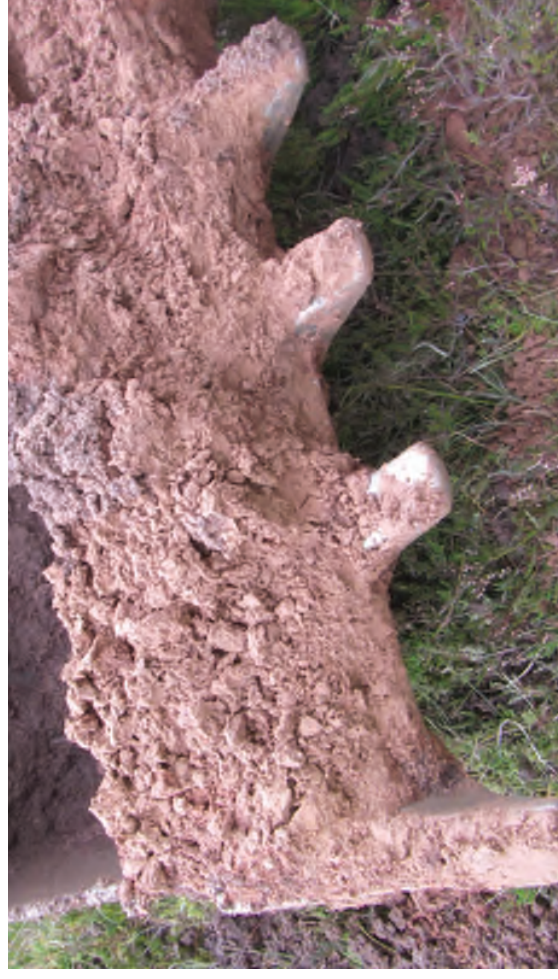
Below 1.5m red brown slightly silty medium to coarse SAND. Assessed as medium dense. (Glacial Deposits)

Sample D1 & B1 -1.3m-1.4m

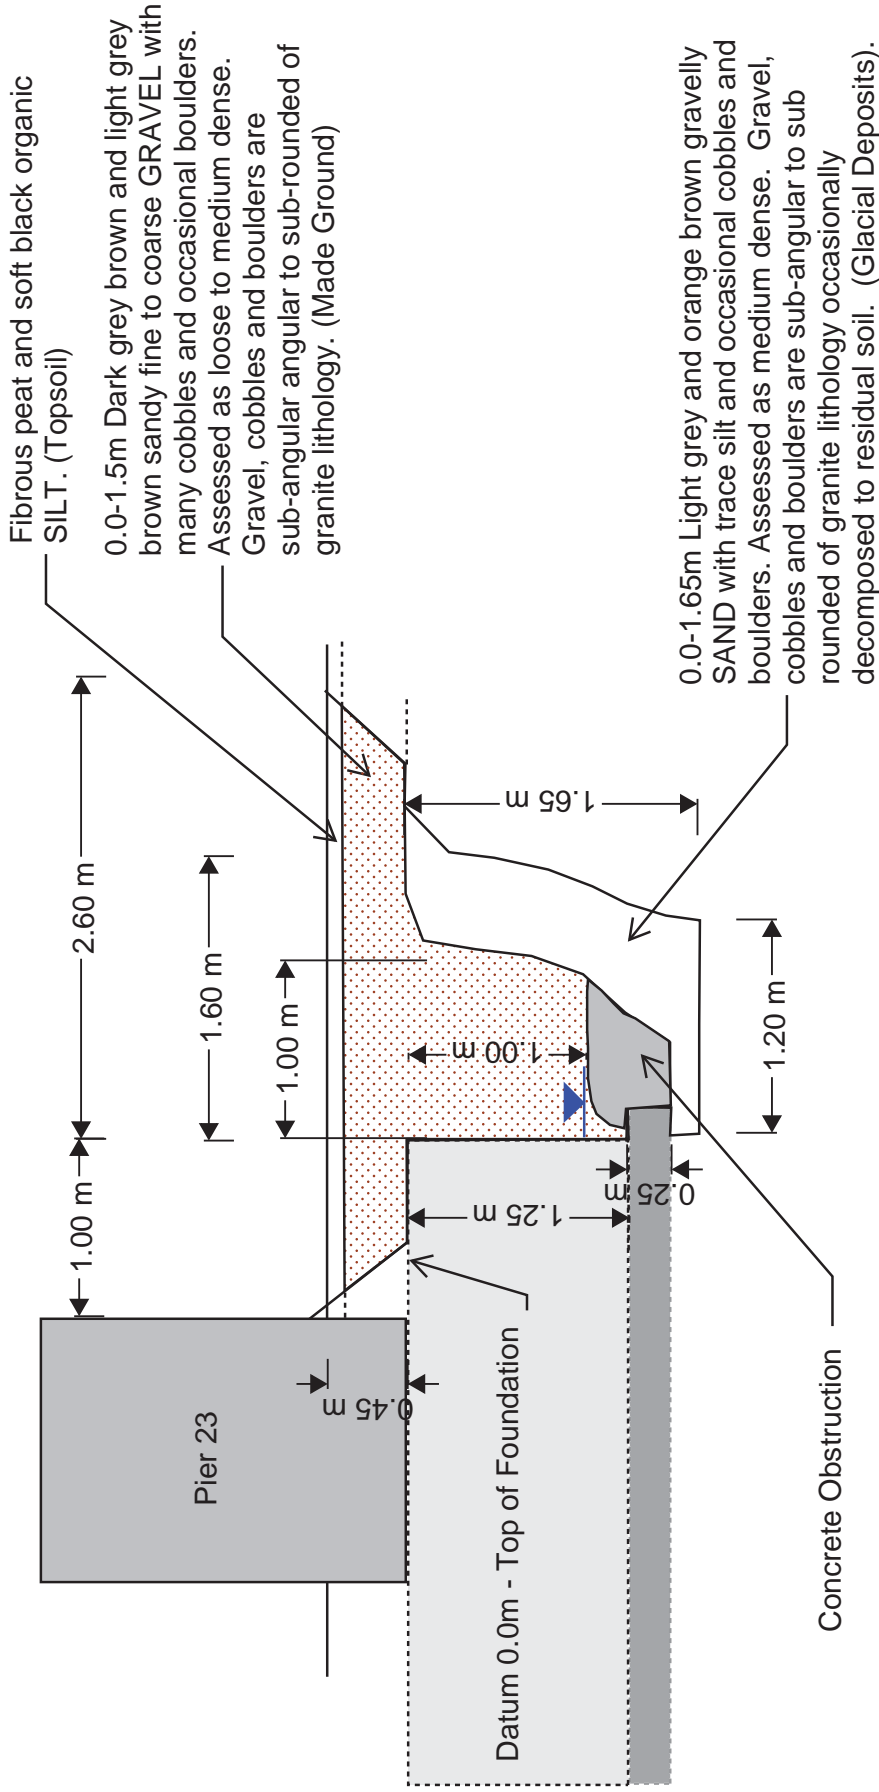
Sketch Title: Cairngorm Funicular Mountain Railway - Trial Pit Investigation - TP23 Section A-A

Seepage- low <1l/min @ 1m at interface between made and natural ground

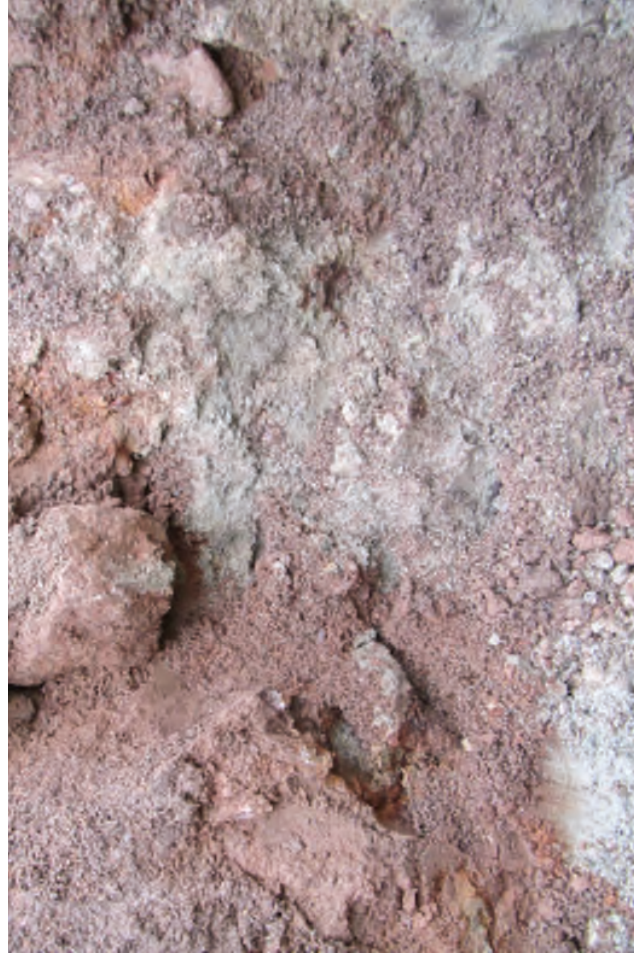
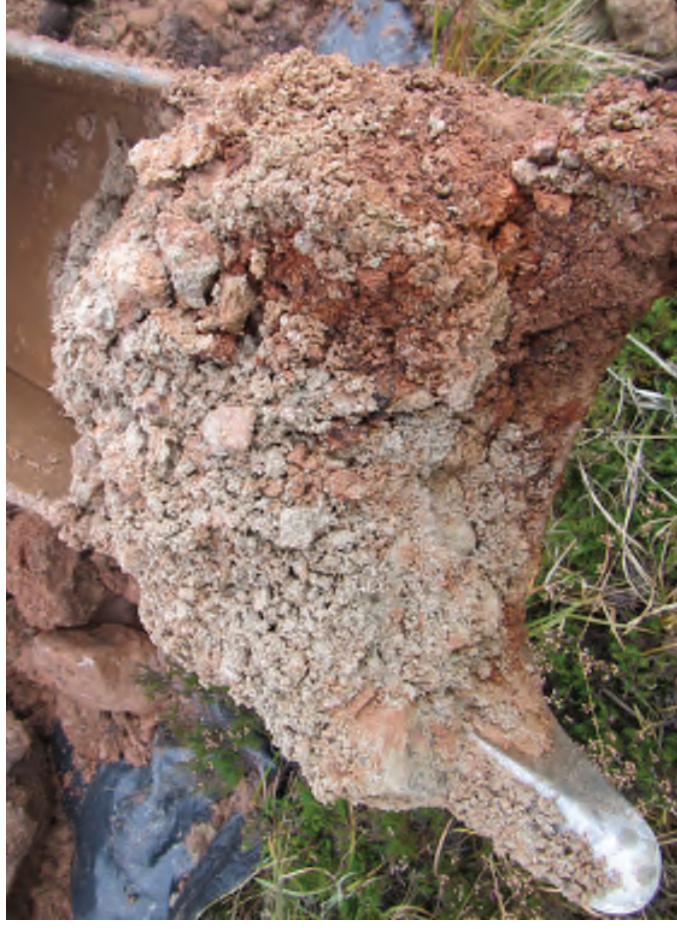
0.0-1.65m Light grey and orange/red brown gravelly SAND with trace silt and occasional cobbles and boulders. Assessed as medium dense. Gravel, cobbles and boulders are sub-angular to rounded of granite lithology occasionally decomposed to residual soil. (Glacial Deposits).

Formation - gravelly  
SAND with trace silt

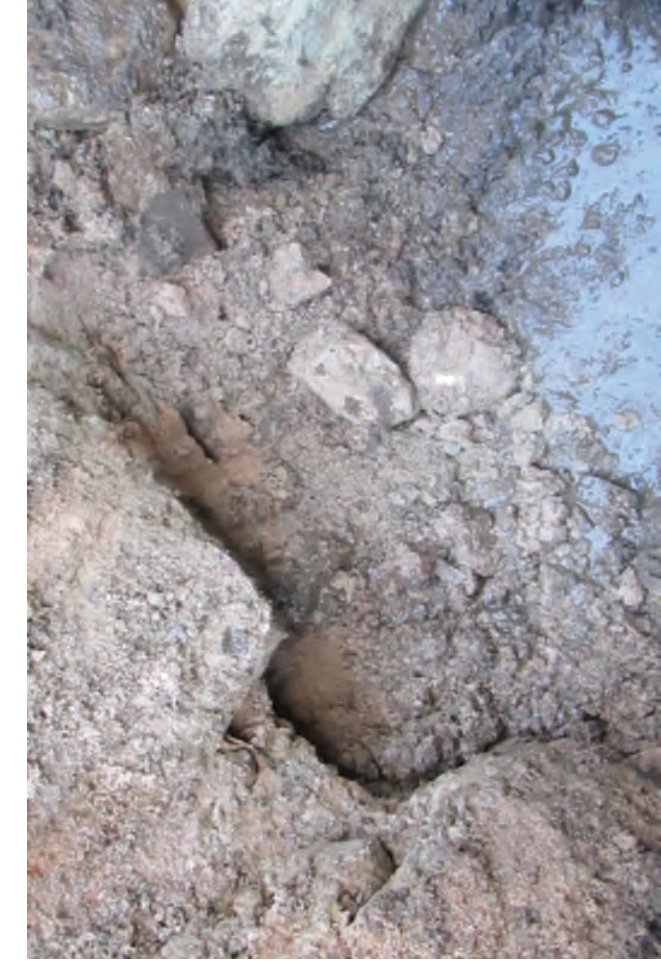
Red and orange brown gravelly SAND with interlayered yellow brown and light grey sandy SILT and occasional cobbles and boulders. Assessed as medium dense. Gravel, cobbles and boulders are sub-angular to rounded of granite lithology occasionally decomposed to residual soil. (Glacial Deposits).

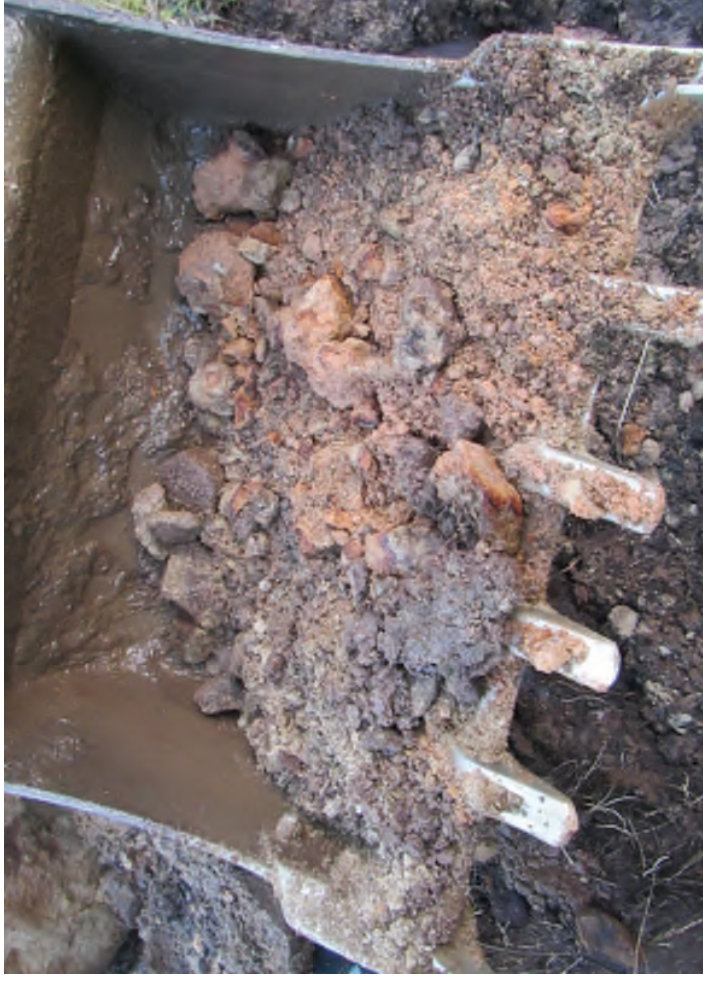
Sample D01 1.5-1.6m

Formation

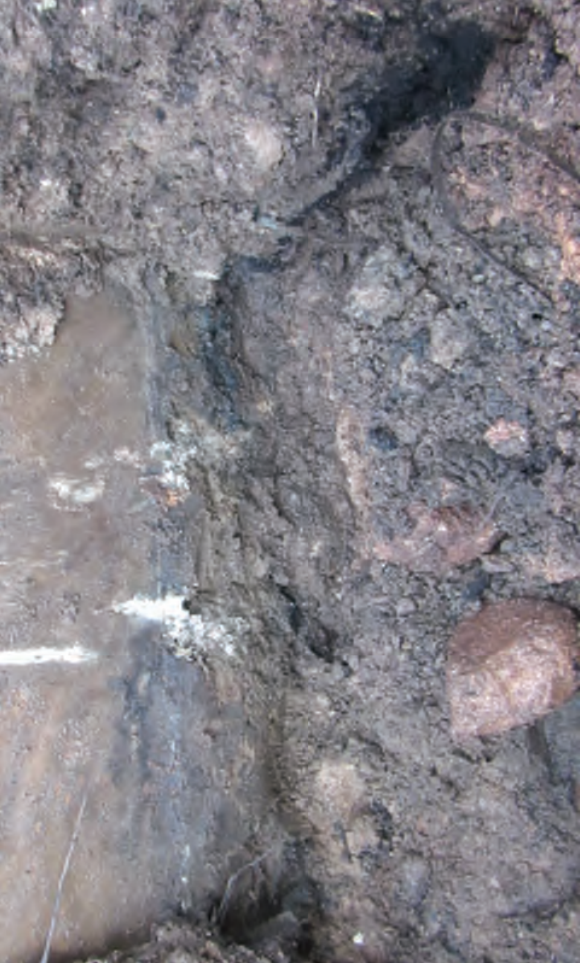
Formation: 200mm thick layer Dark grey black and light grey clayey SAND and fine to coarse GRAVEL with many cobbles . Assessed as medium dense. Gravel and cobbles are sub-angular angular to sub-rounded of granite lithology. Interlayered with firm to stiff clayey SILT with traces of soft black silt and clay below foundation base. (Made Ground)

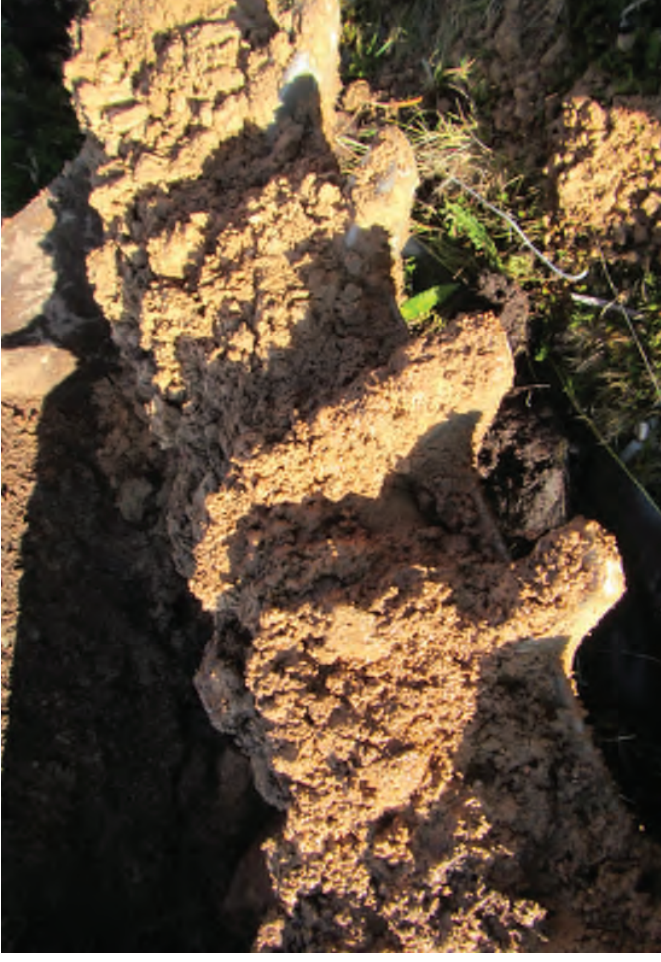
Below 2.0m red brown slightly silty fine to medium SAND. Assessed as medium dense. (Alluvium)

Formation

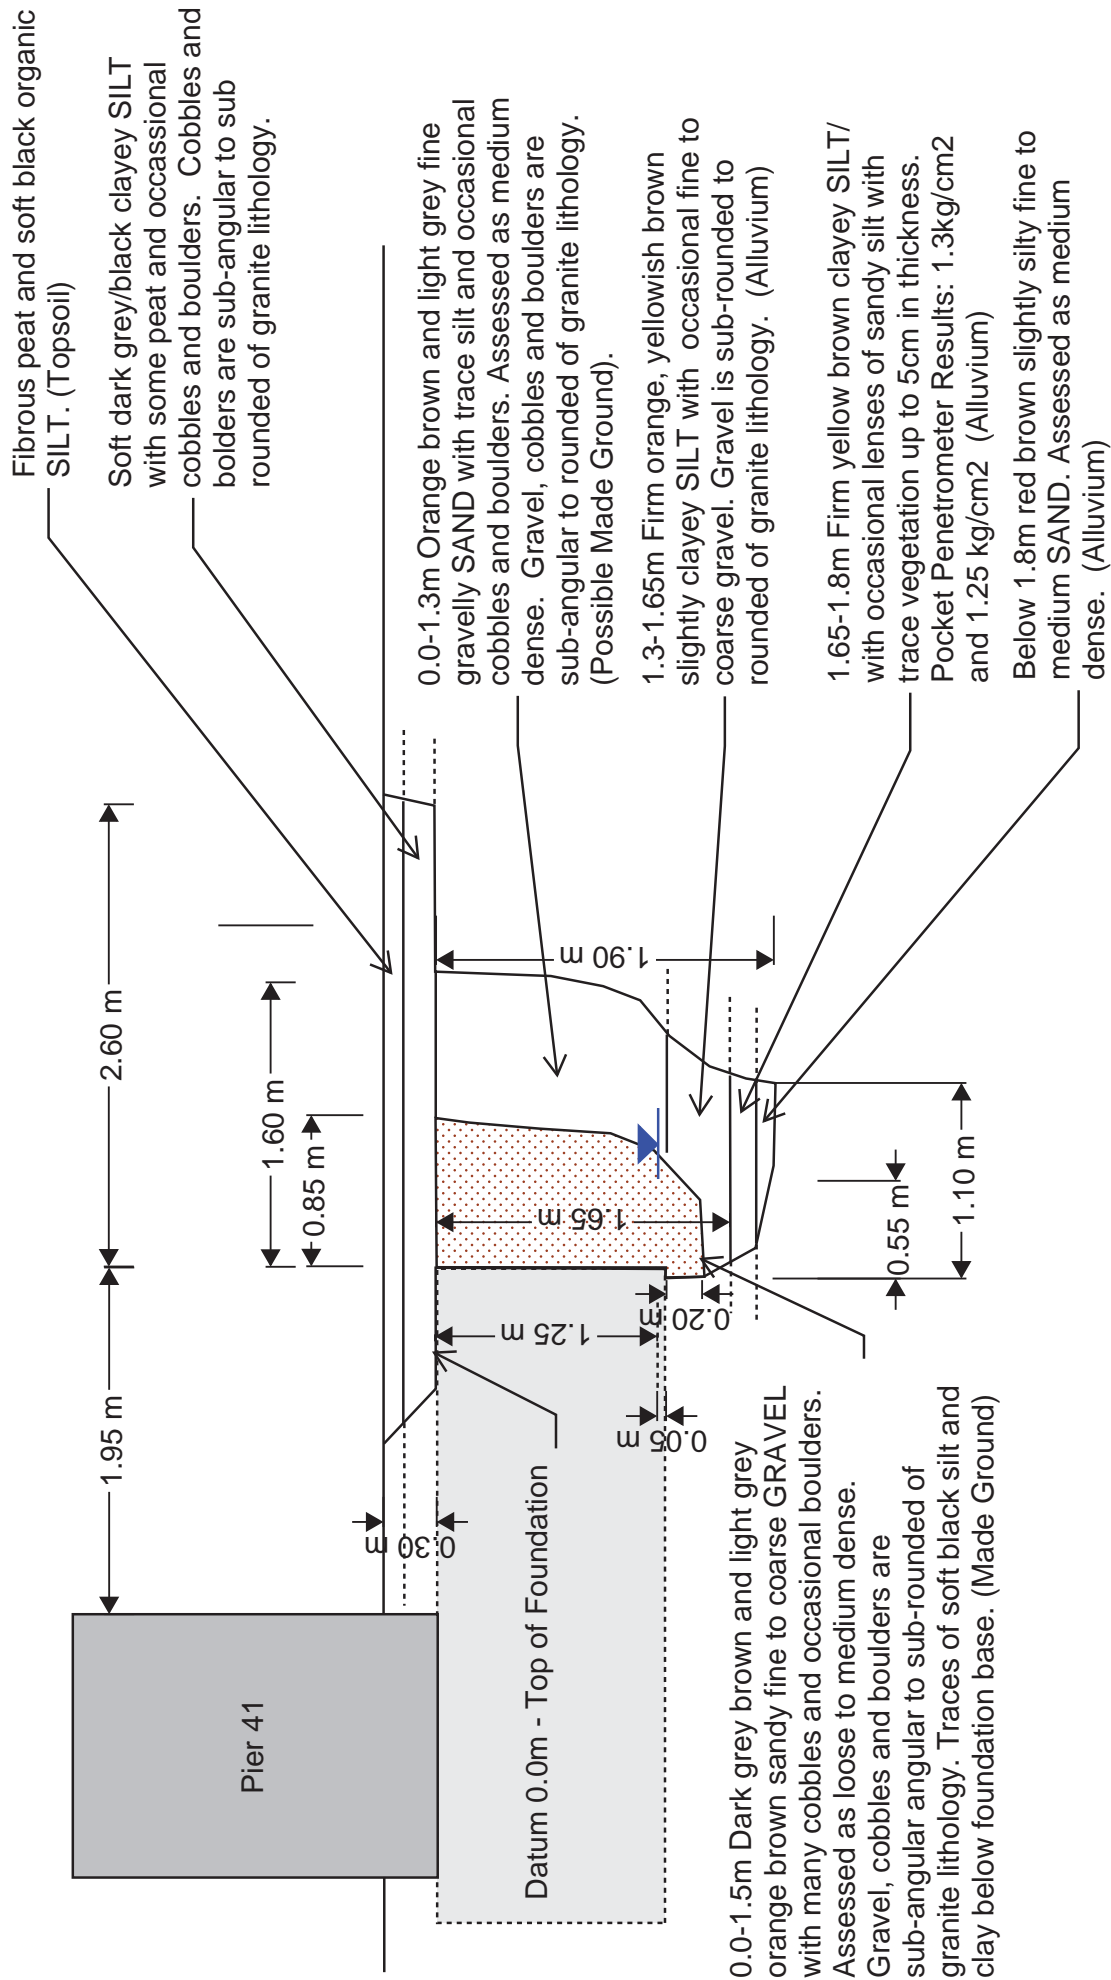
Fibrous peat and soft black organic SILT. (Topsoil)

Soft dark grey/black clayey SILT with some peat and occasional cobbles and boulders. Cobbles and boulders are sub-angular to sub rounded of granite lithology.

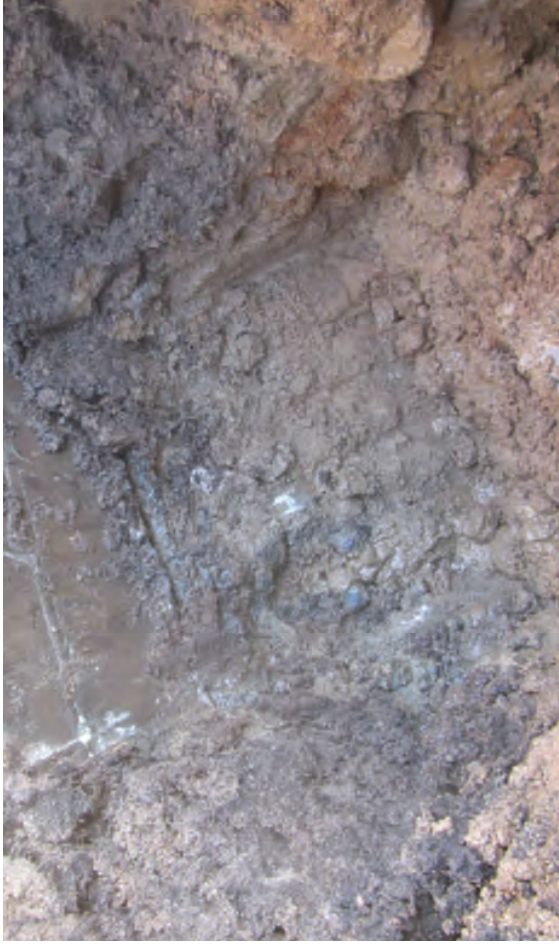
1.65-1.8m Firm yellow brown clayey SILT/ with occasional lenses of sandy silt with trace vegetation up to 5cm in thickness. Pocket Penetrometer Results: 1.3kg/cm2 and 1.25 kg/cm2 (Alluvium)

Samples: D1 - 1.65m-1.7m, B1 - 1.65m-1.7m

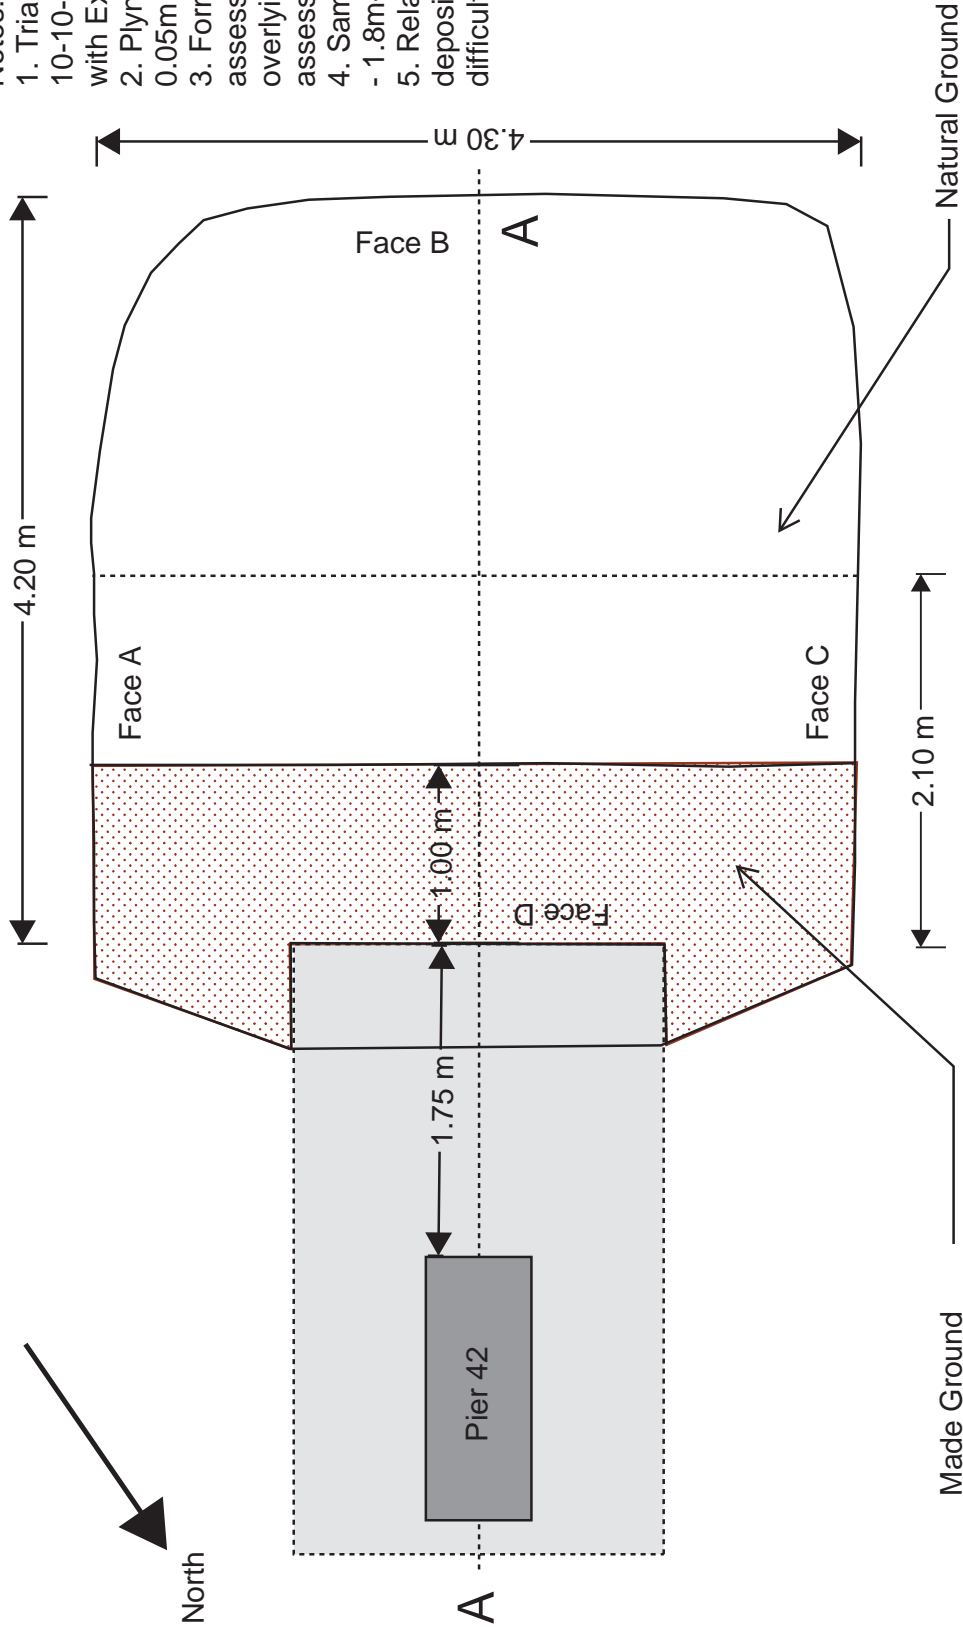
Sketch Title: Cairngorm Funicular Mountain Railway - Trial Pit Investigation - TP42 Layout

- Notes:
1. Trial Pit Excavated on 10-10-18 with Excavator Volvo ECR58D
  2. Plyth Thickness 1.25m with 0.05m blinding concrete
  3. Formation 0.4m granular fill, assessed as medium dense overlying slightly silty Sand, assessed as loose.
  4. Sampling: D1 - 1.8m-2.0m, B1 - 1.8m-2.0m
  5. Relative density of granular deposits assessed on basis of difficulty of excavation.

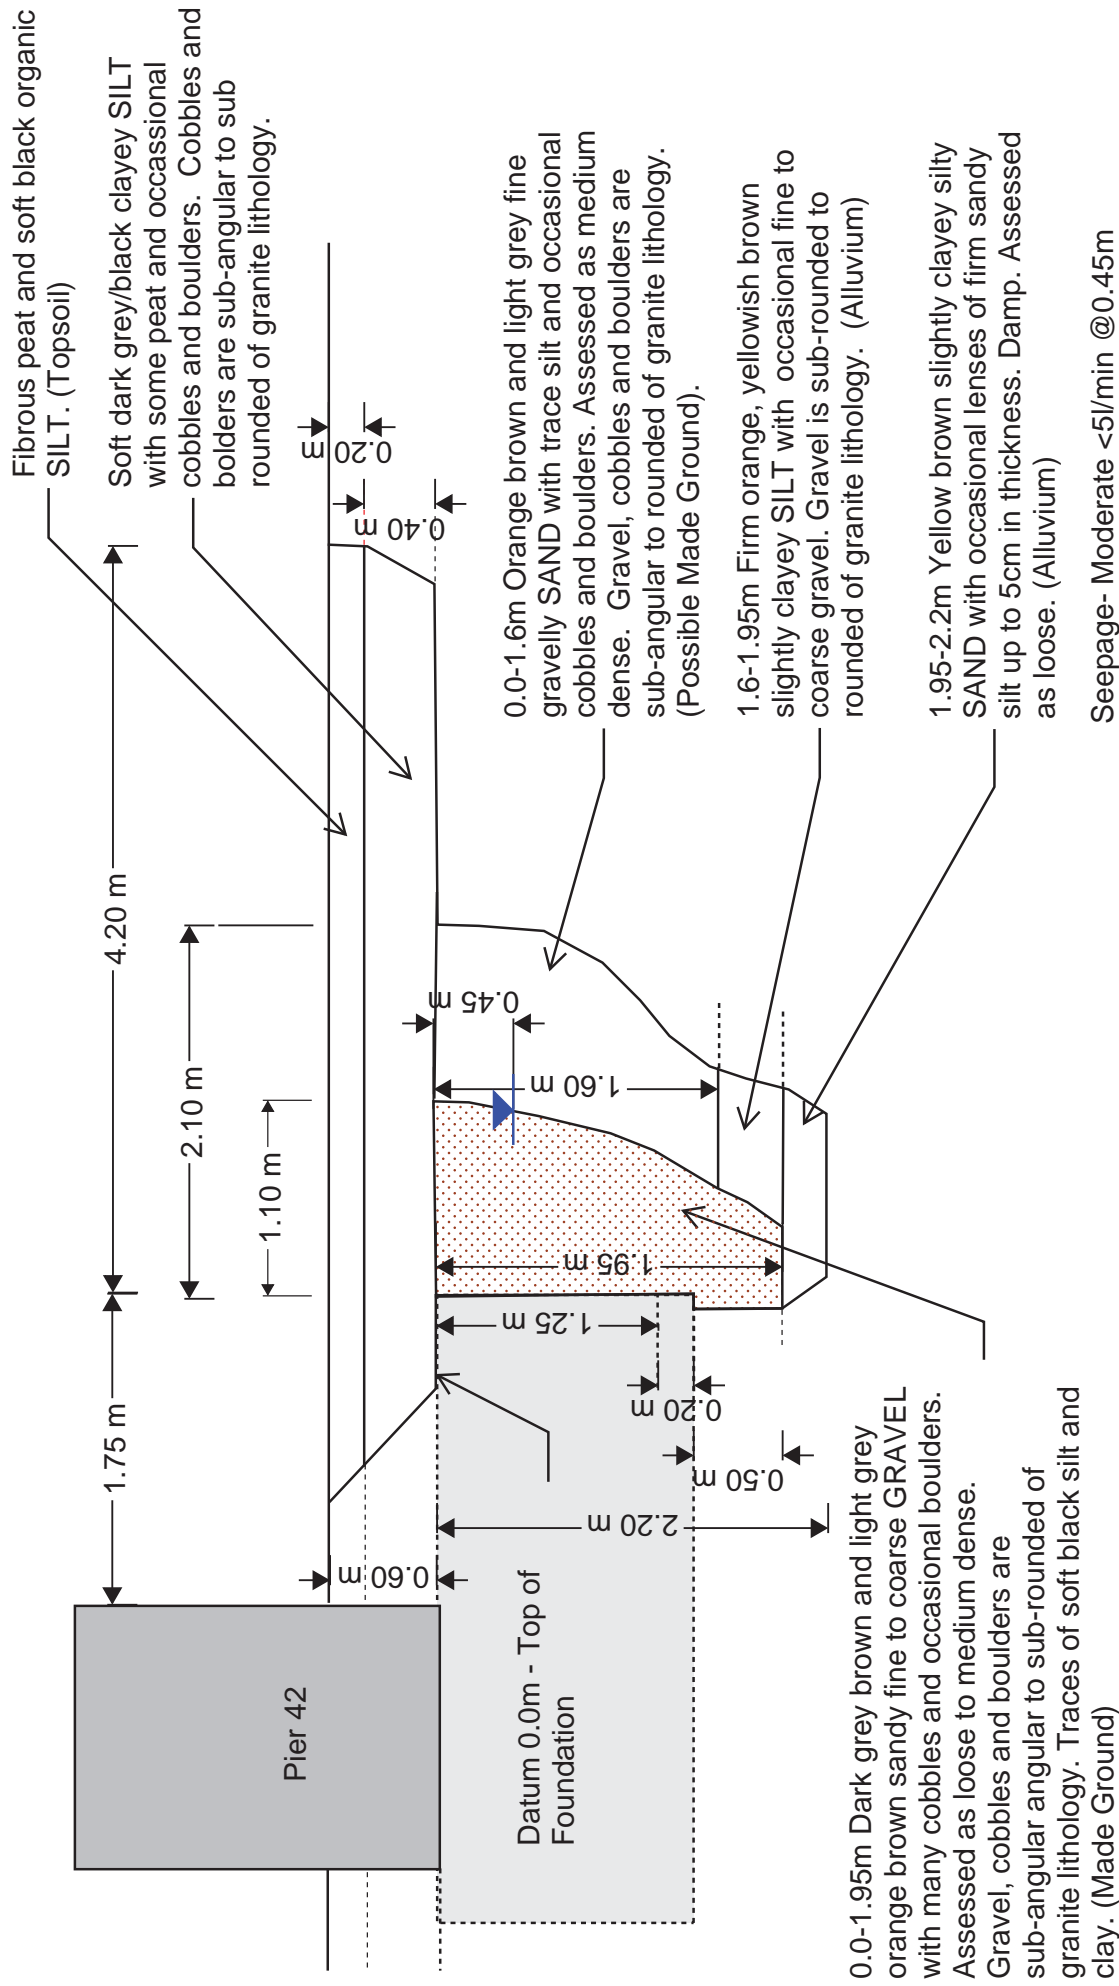
Sketch Title: Cairngorm Funicular Mountain Railway - Trial Pit Investigation - TP42 Section A-A

Below 1.8m red brown slightly silty fine to medium SAND. Assessed as loose. (Alluvium)

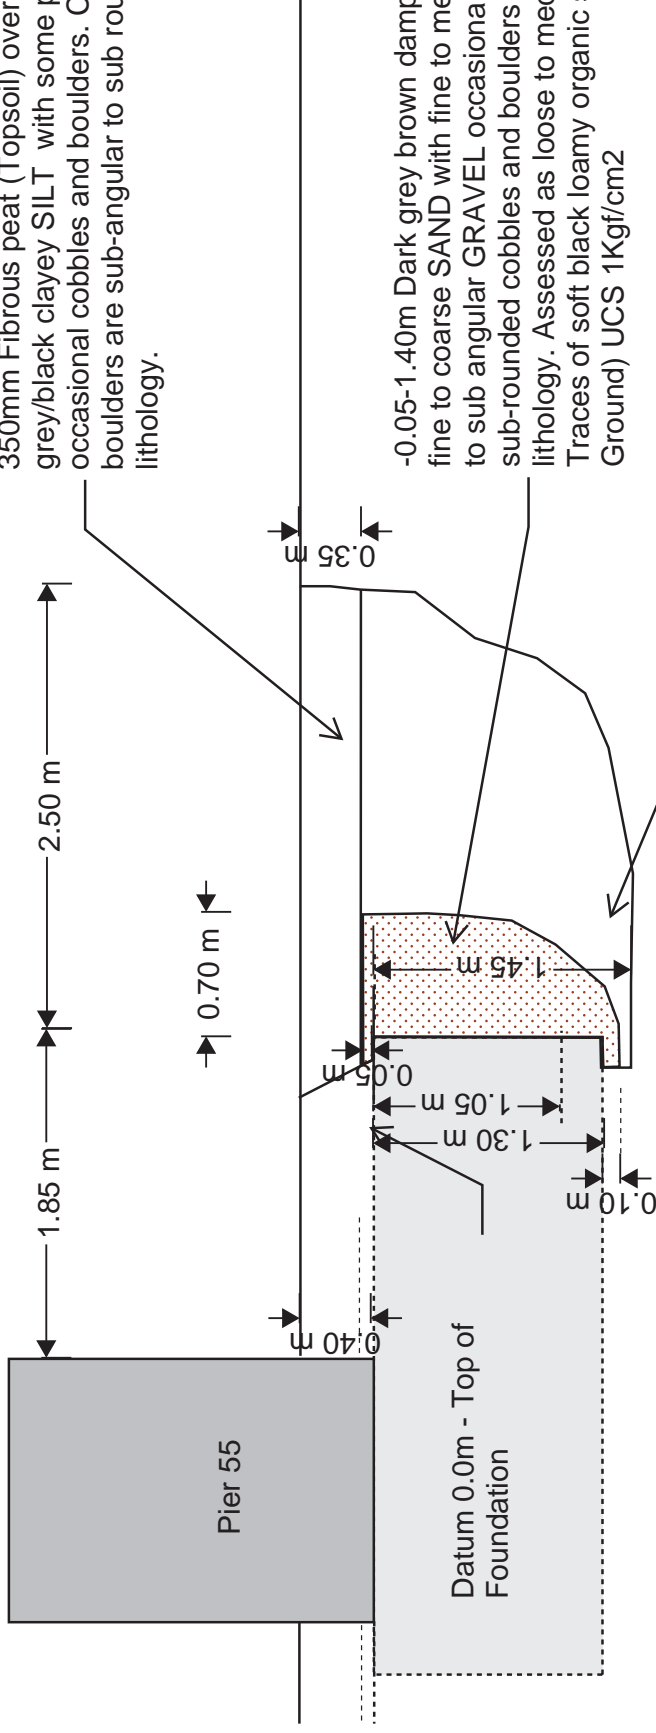
Sketch Title: Cairngorm Funicular Mountain Railway - Trial Pit Investigation - TP55 Section A-A

-0.05-1.40m Dark grey brown damp silty clayey fine to coarse SAND with fine to medium angular to sub angular GRAVEL occasional sub-angular to sub-rounded cobbles and boulders of granite lithology. Assessed as loose to medium dense. Traces of soft black loamy organic silt. (Made Ground) UCS 1Kgf/cm<sup>2</sup>

-0.05-1.45m Light orangey pinkish brown dry slightly clayey silty fine to coarse SAND with fine to coarse angular to sub angular GRAVEL occasional sub-angular to sub-rounded cobbles and boulders of granite lithology. Damp. Assessed as medium dense. UCS 1.5Kgf/cm<sup>2</sup>

Seepage- None

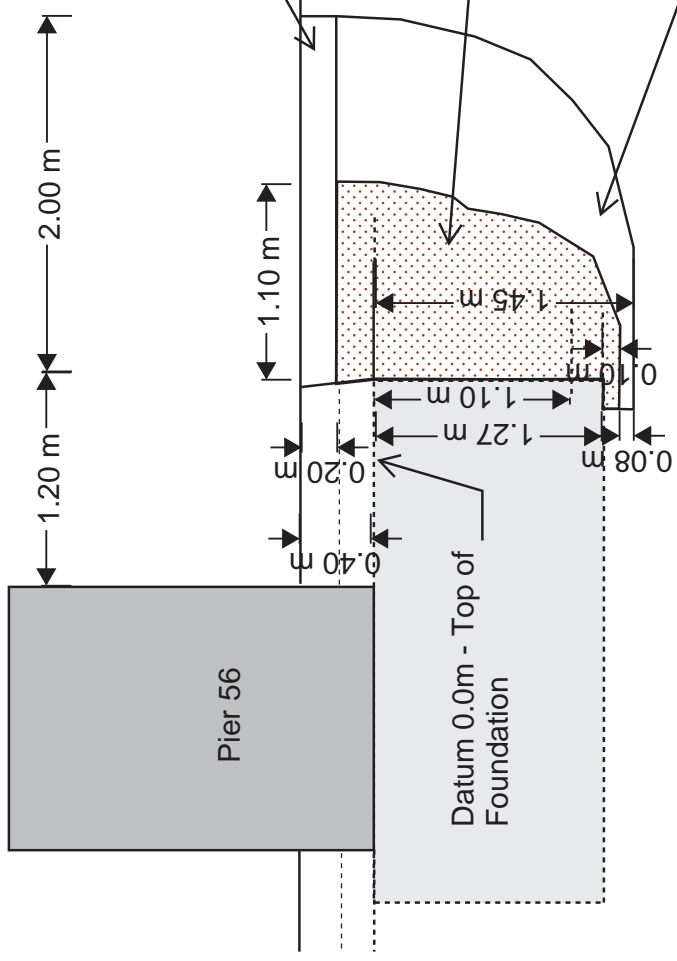
Sketch Title: Cairngorm Funicular Mountain Railway - Trial Pit Investigation - TP56 Section A-A

-0.2-1.37m Light orangey greyish brown damp clayey silty fine to coarse SAND with fine to medium angular to sub angular GRAVEL occasional sub-angular to sub-rounded cobbles and boulders of granite lithology. Assessed as loose. Traces of soft black loamy organic silt. (Made Ground)

-0.2-1.45m Light orangey pinkish brown dry organic silty fine to coarse SAND with fine to coarse angular to sub angular GRAVEL occasional sub-angular to sub-rounded cobbles and boulders of granite lithology. Assessed as medium dense.

Seepage- None, dry

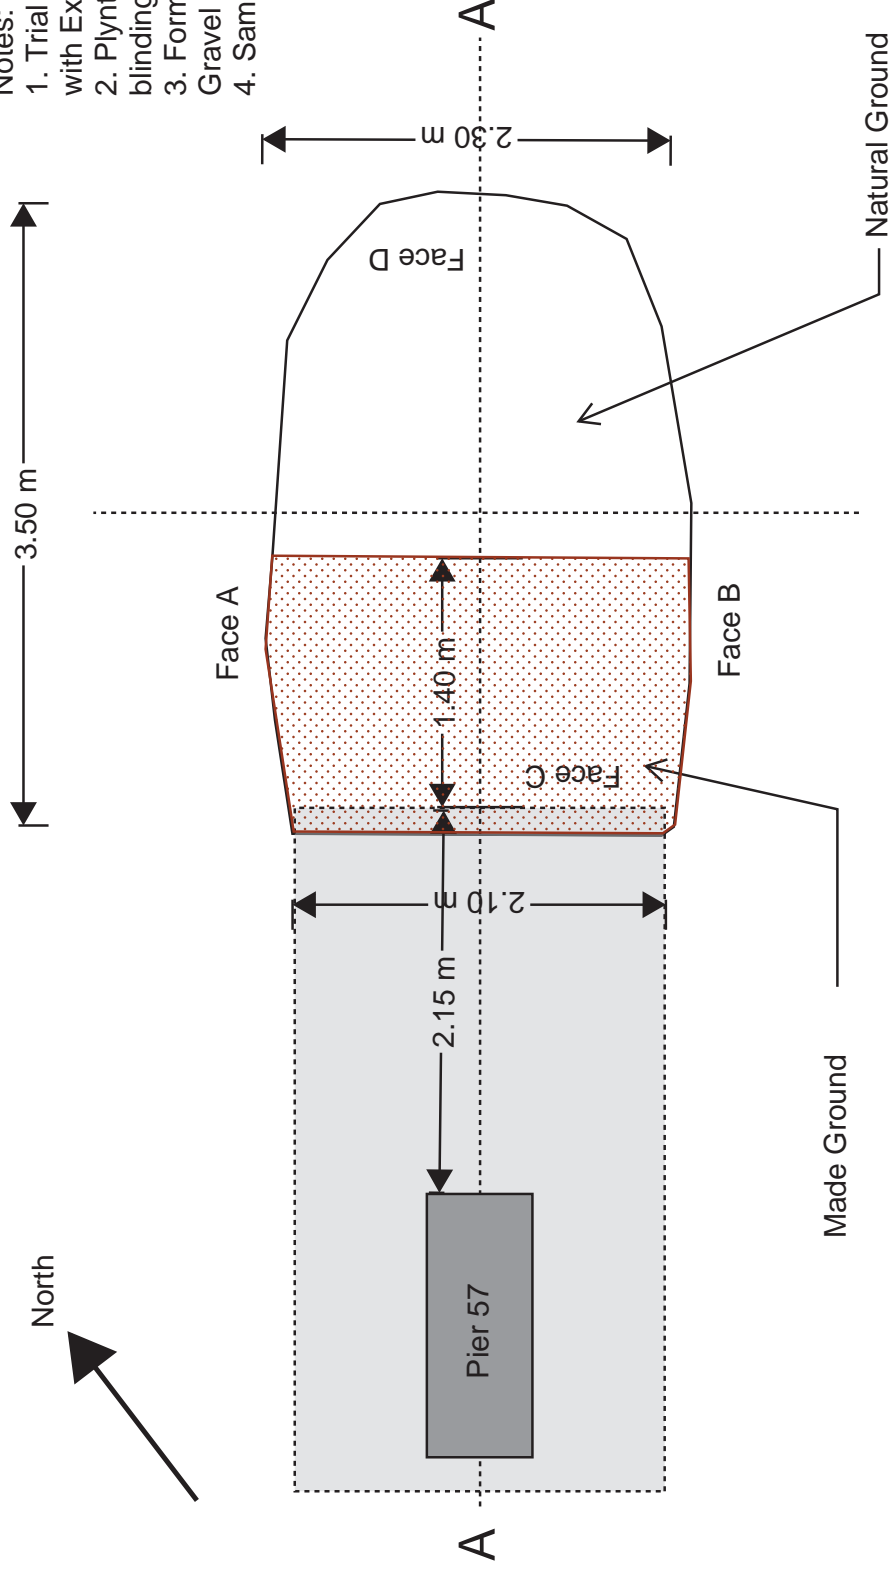
Cairngorm Funicular Mountain Railway -  
Trial Pit Investigation - TP57 Layout

- Notes:
1. Trial Pit Excavated on 19-10-18 with Excavator Menzi Muck A91
  2. Plynth Thickness 1.25m with 0.2m blinding concrete
  3. Formation medium dense Sand & Gravel
  4. Sampling: B1 - 1.5m.

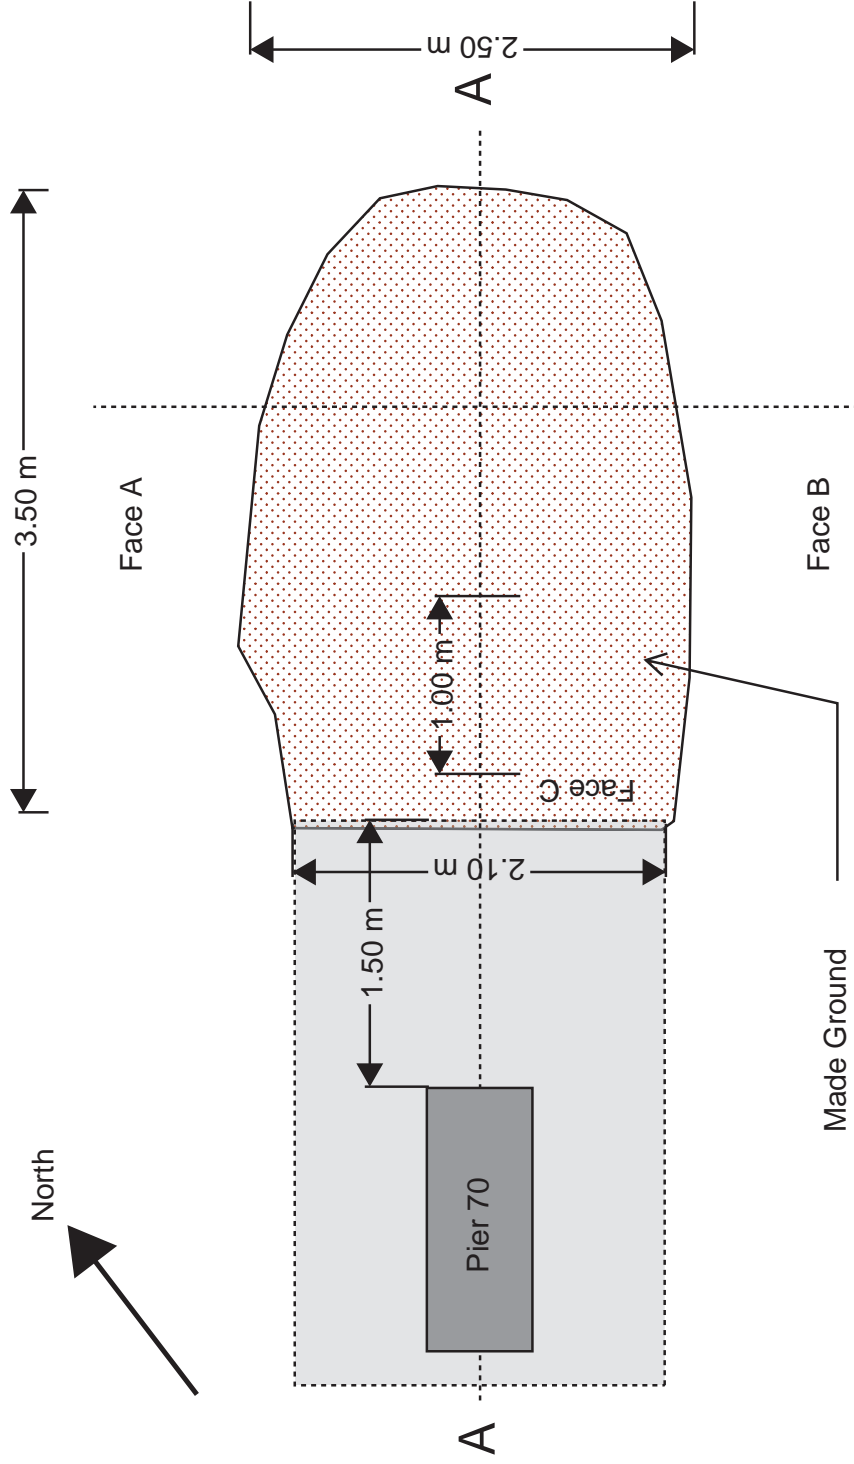
Sketch Title: Cairngorm Funicular Mountain Railway - Trial Pit Investigation - TP70 Layout

- Notes:
1. Trial Pit Excavated on 18-10-18 with Excavator Menzi Muck A91
  2. Plynth Thickness 1.2m with 0.25m blinding concrete
  3. Formation medium dense to dense Sand & Gravel
  4. Sampling: B1 - 1.8m. B2 - 2.0m

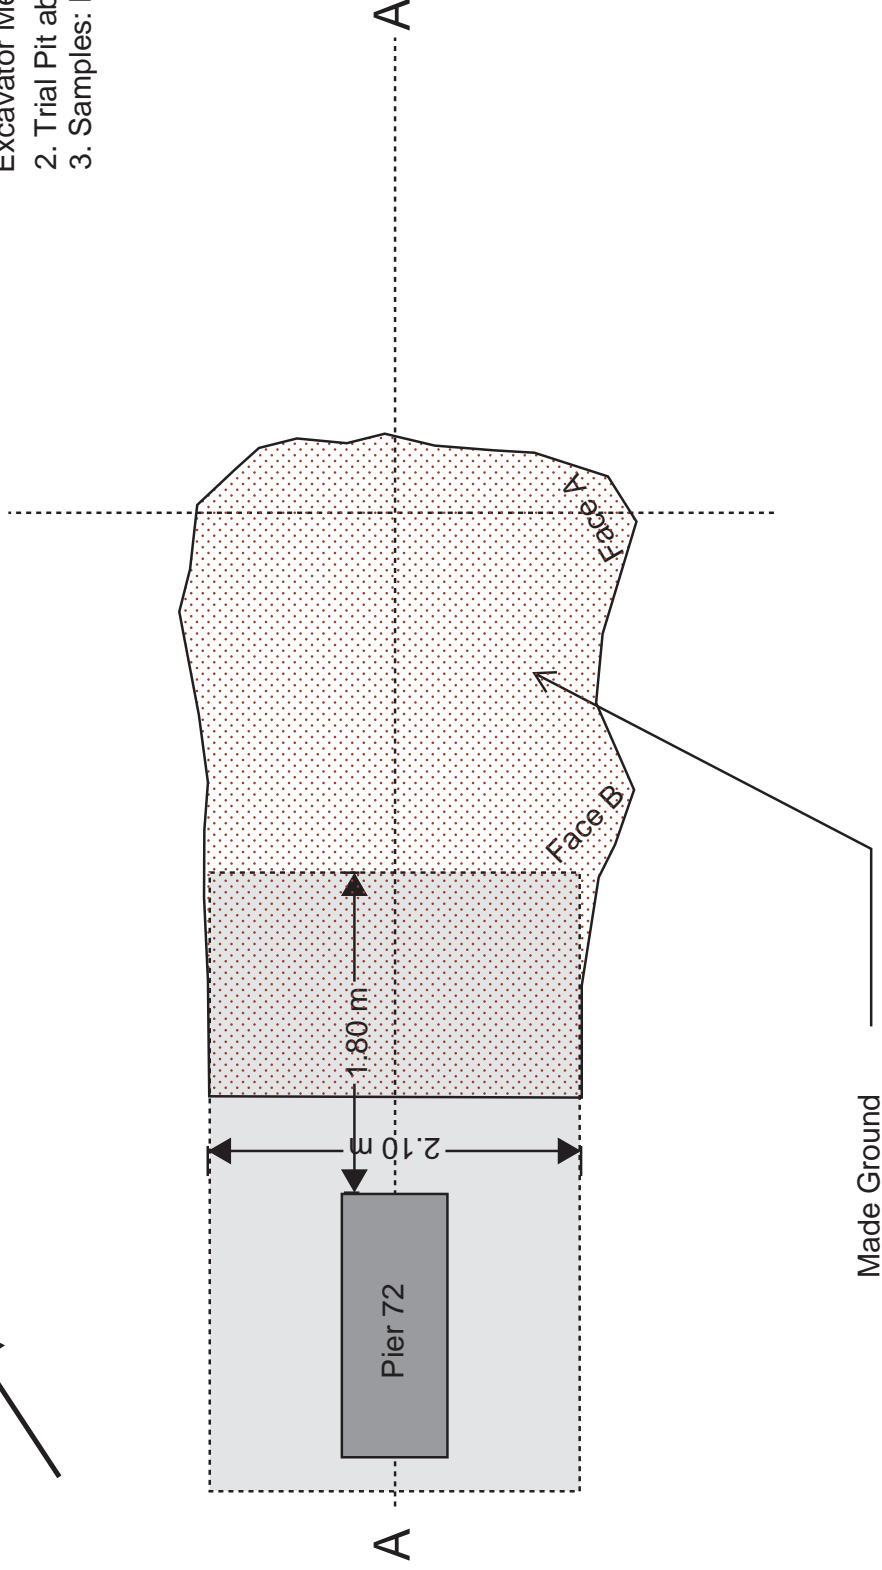
Cairngorm Funicular Mountain Railway -  
Trial Pit Investigation - TP72 Layout

1. Trial Pit Excavated on 17-10-18  
Excavator Menzi Muck A91
2. Trial Pit abandoned due to water ingress
3. Samples: B1 & T1 - 1m
