DECEMBER 2018  
HIGHLANDS AND ISLANDS ENTERPRISE

# CAIRNGORM FUNICULAR RAILWAY

## VIADUCT APPRAISAL REPORT

Rp01

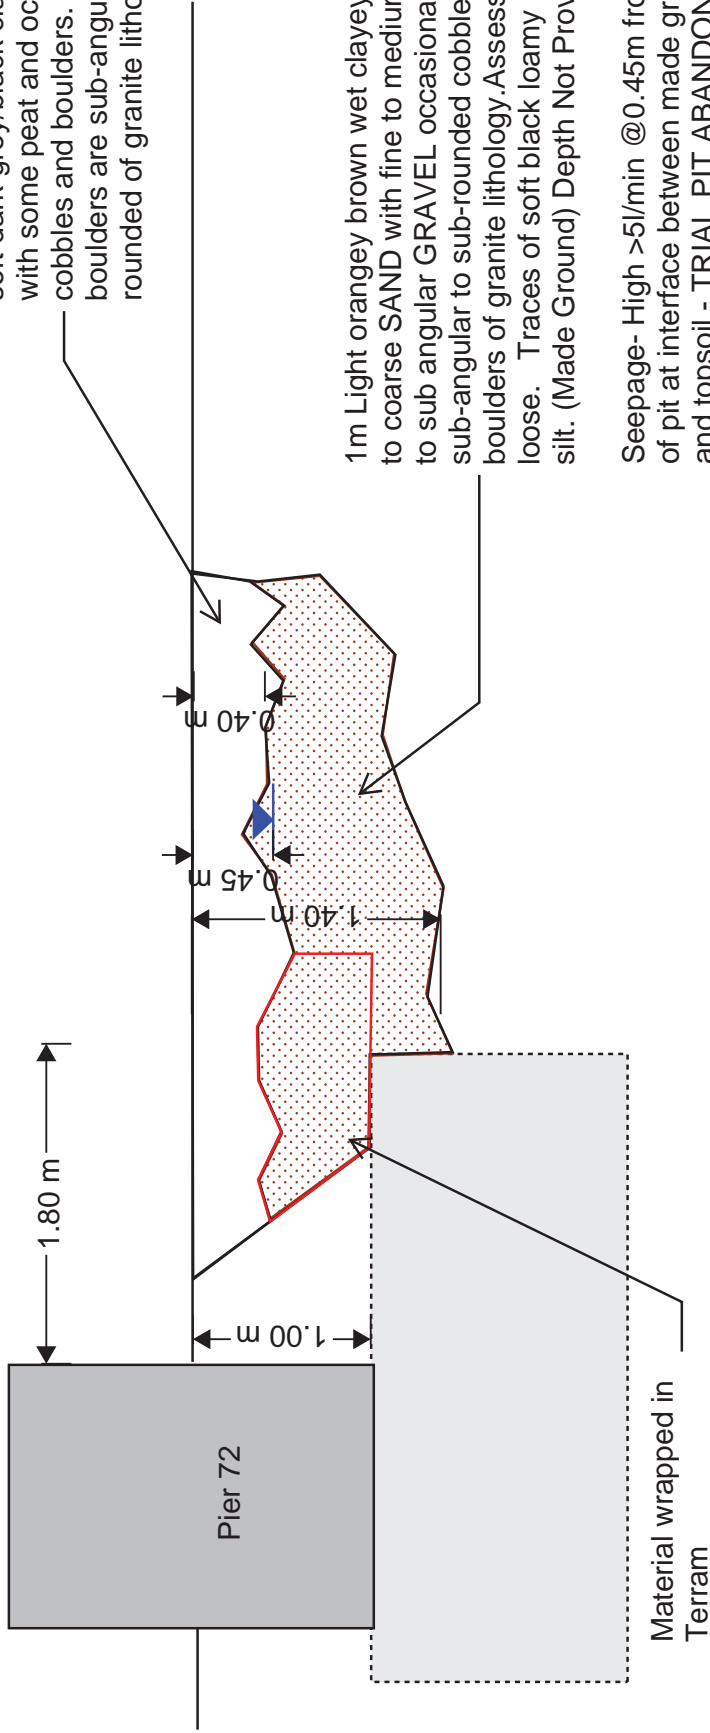
Sketch Title: Cairngorm Funicular Mountain Railway - Trial Pit Investigation - TP72 Section A-A

1m Light orangey brown wet clayey silty fine to coarse SAND with fine to medium angular to sub angular GRAVEL occasional sub-angular to sub-rounded cobbles and boulders of granite lithology. Assessed as loose. Traces of soft black loamy organic silt. (Made Ground) Depth Not Proven

Seepage- High >5l/min @0.45m from top of pit at interface between made ground and topsoil - TRIAL PIT ABANDONED

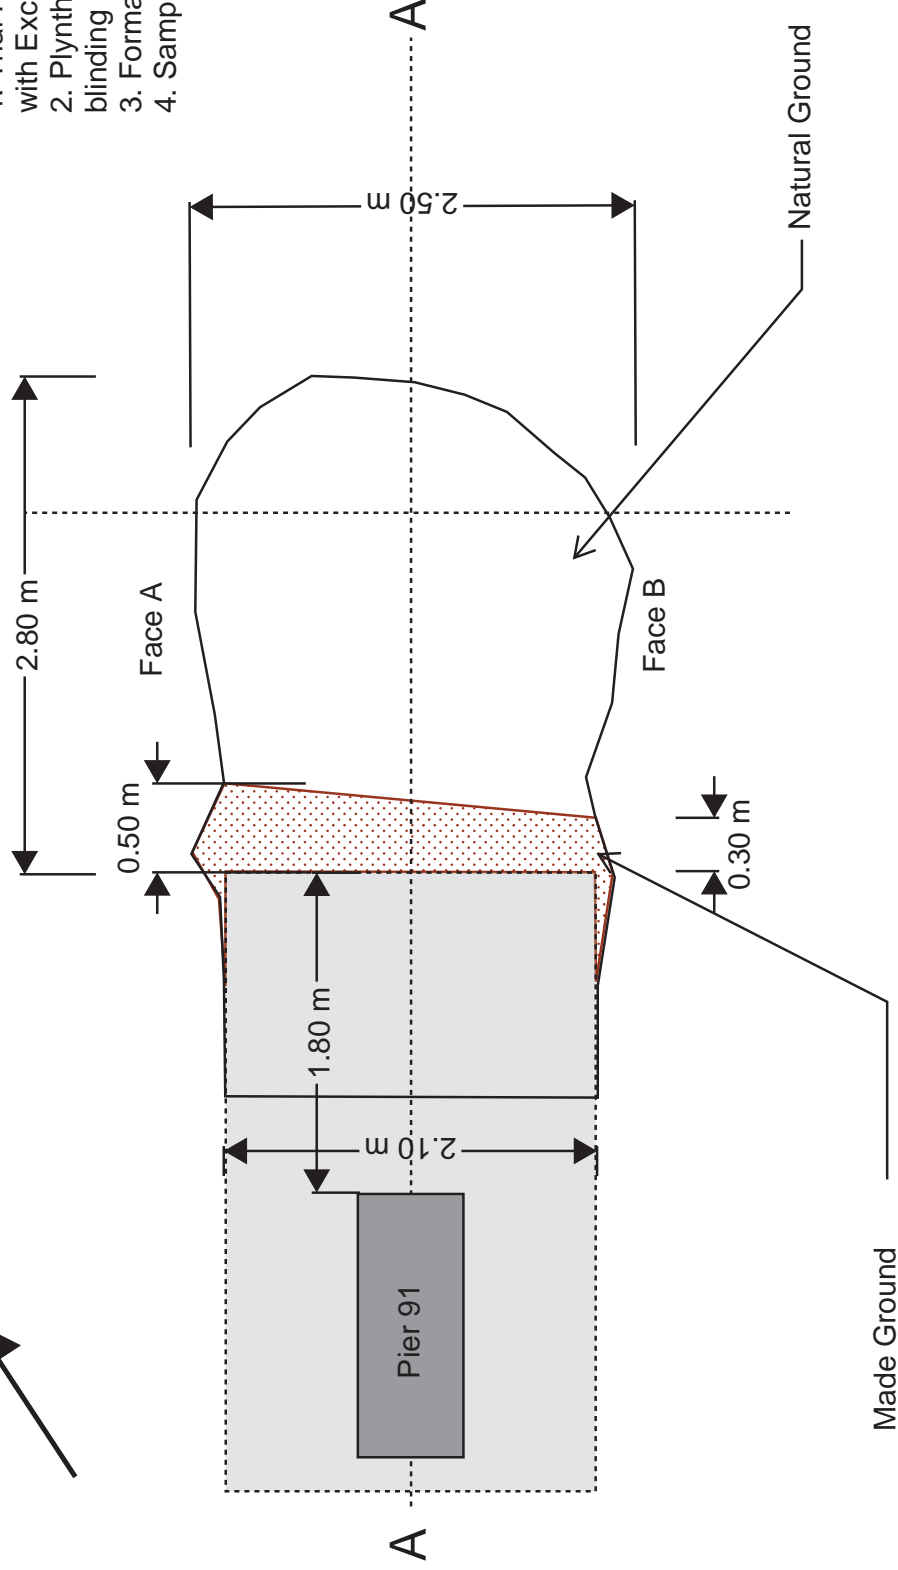
Sketch Title: Cairngorm Funicular Mountain Railway - Trial Pit Investigation - TP91 Layout

- Notes:
1. Trial Pit Excavated on 17-10-18 with Excavator Menzi Muck A91
  2. Plynth Thickness 1.25m with 0.2m blinding concrete
  3. Formation weathered granite bedrock.
  4. Sampling: B1 - 1.2m.

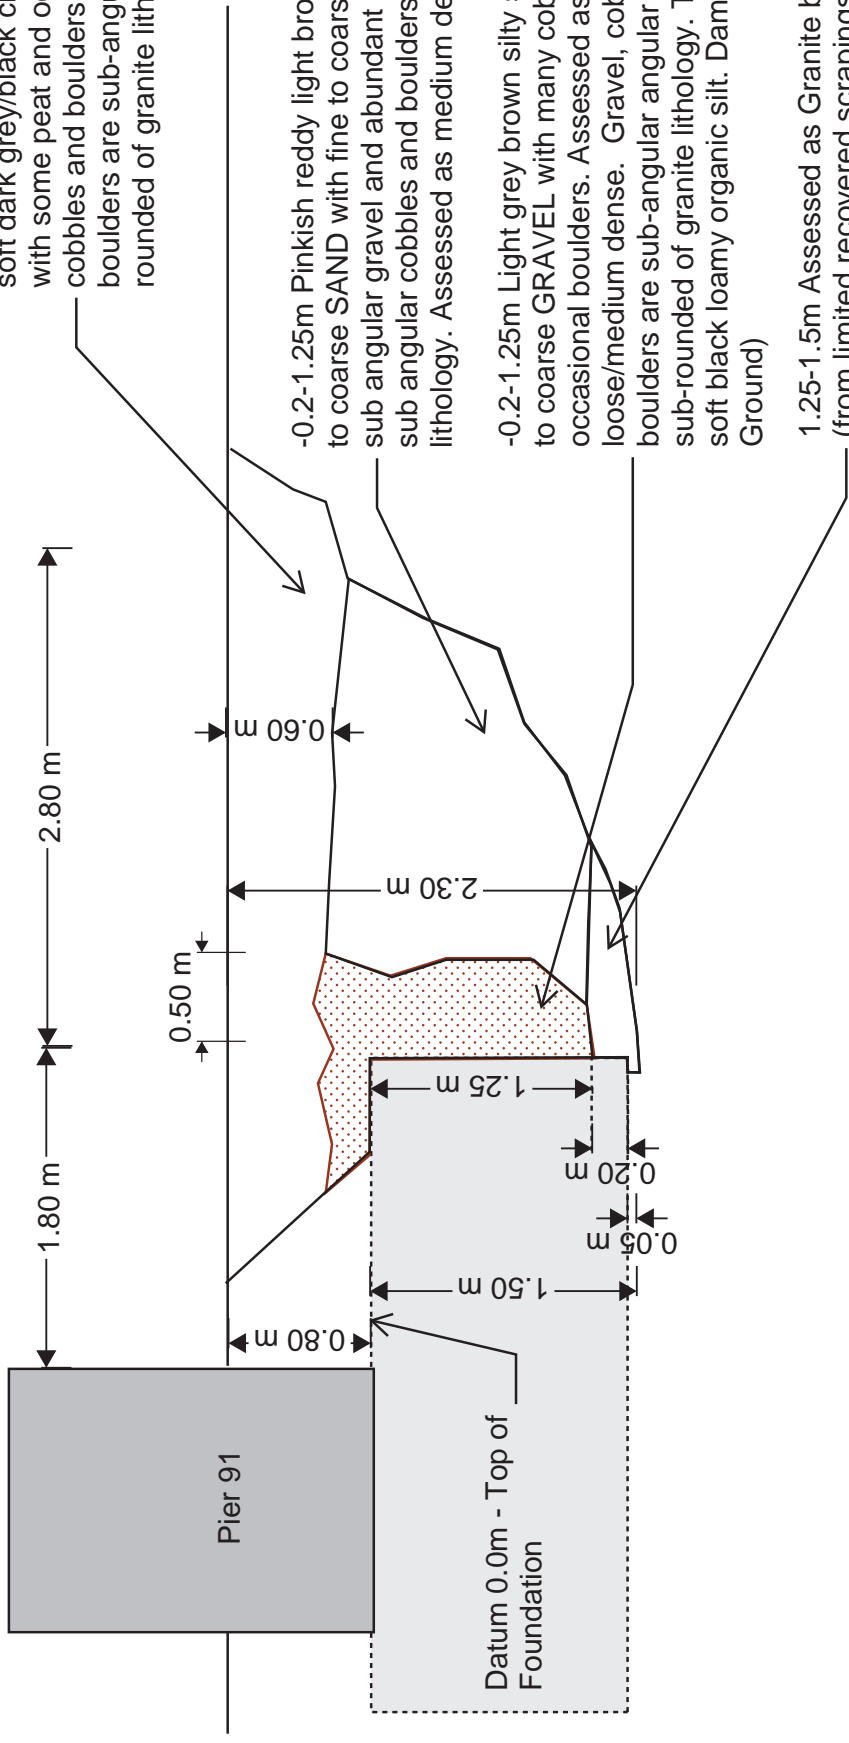
Sketch Title: Cairngorm Funicular Mountain Railway - Trial Pit Investigation - TP91 Section A-A

-0.2-1.25m Light grey brown silty sandy fine to coarse GRAVEL with many cobbles and occasional boulders. Assessed as loose/medium dense. Gravel, cobbles and boulders are sub-angular angular to sub-rounded of granite lithology. Traces of soft black loamy organic silt. Damp. (Made Ground)

1.25-1.5m Assessed as Granite bedrock (from limited recovered scrapings of broken rock bound in coarse sand matrix).

Dry Excavation

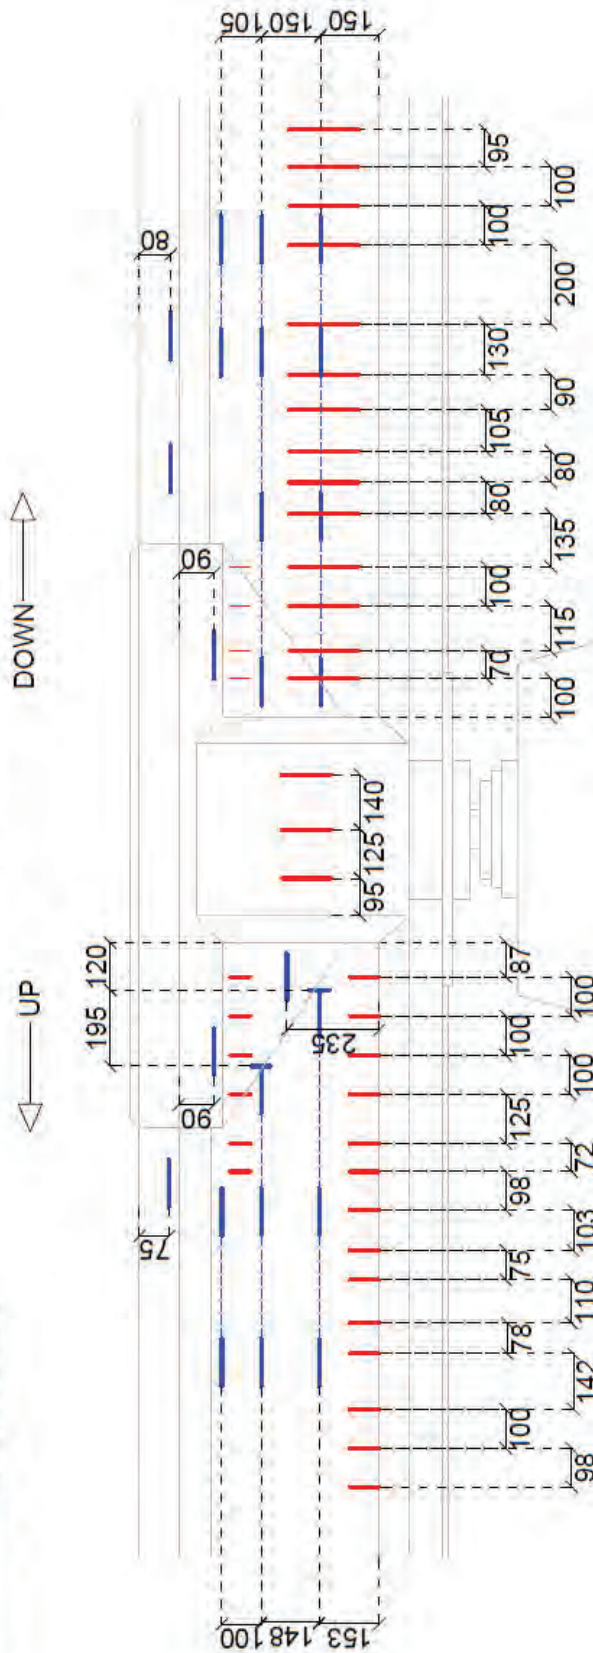
**FIGURE 1**

Outside Elevation, Up, Link Bar Cover: 31, 31, 37, 31, 37, 28, 40, 29, 28, 36, 37, 36 and 37mm

Inside Elevation, Up, Link Bar Cover: 34, 44, 32, 37, 36, 37, 32, 39, 35, 40, 32 and 34mm

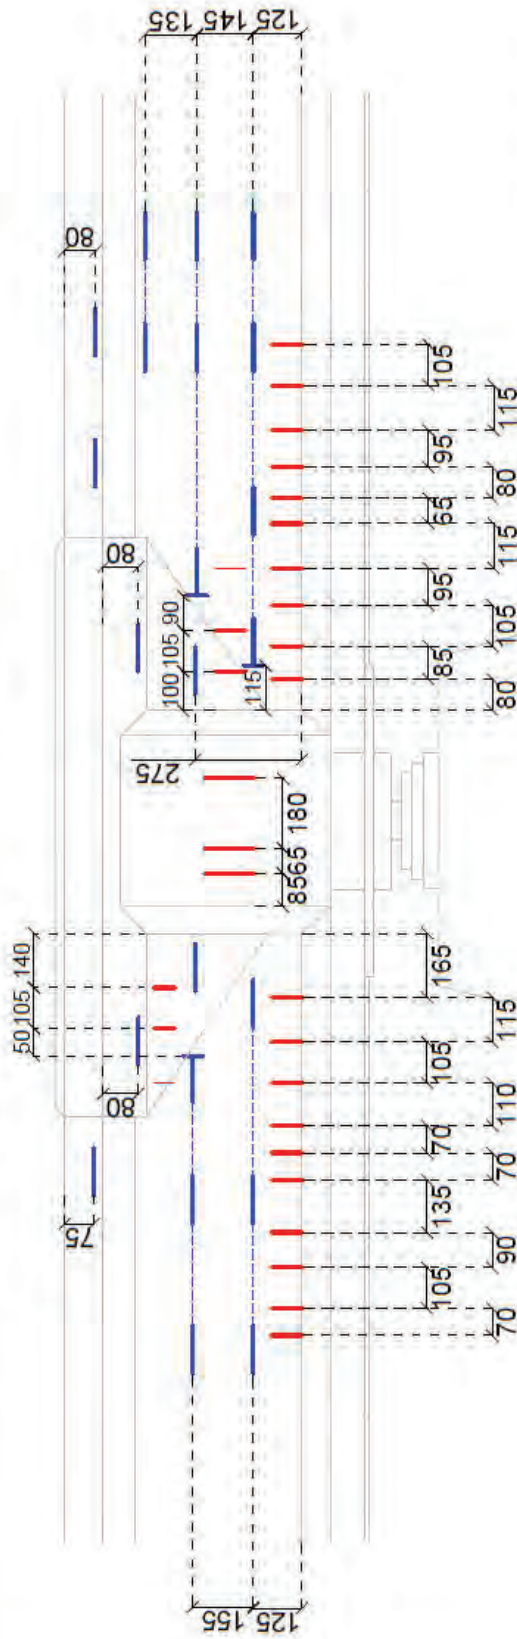
FIGURE 2

Outside Elevation, Up, Link Bar Cover: 40, 40, 46, 35, 36, 37, 37, 32, 36, 34, 33, 28, 31, 33, 31, 34 and 29mm

Inside Elevation, Up, Link Bar Cover: 35, 37, 34, 33, 31, 29, 31, 30, 38, 27, 39, 30, 38, 30, 35, 30, 37, 28, 36 and 29mm

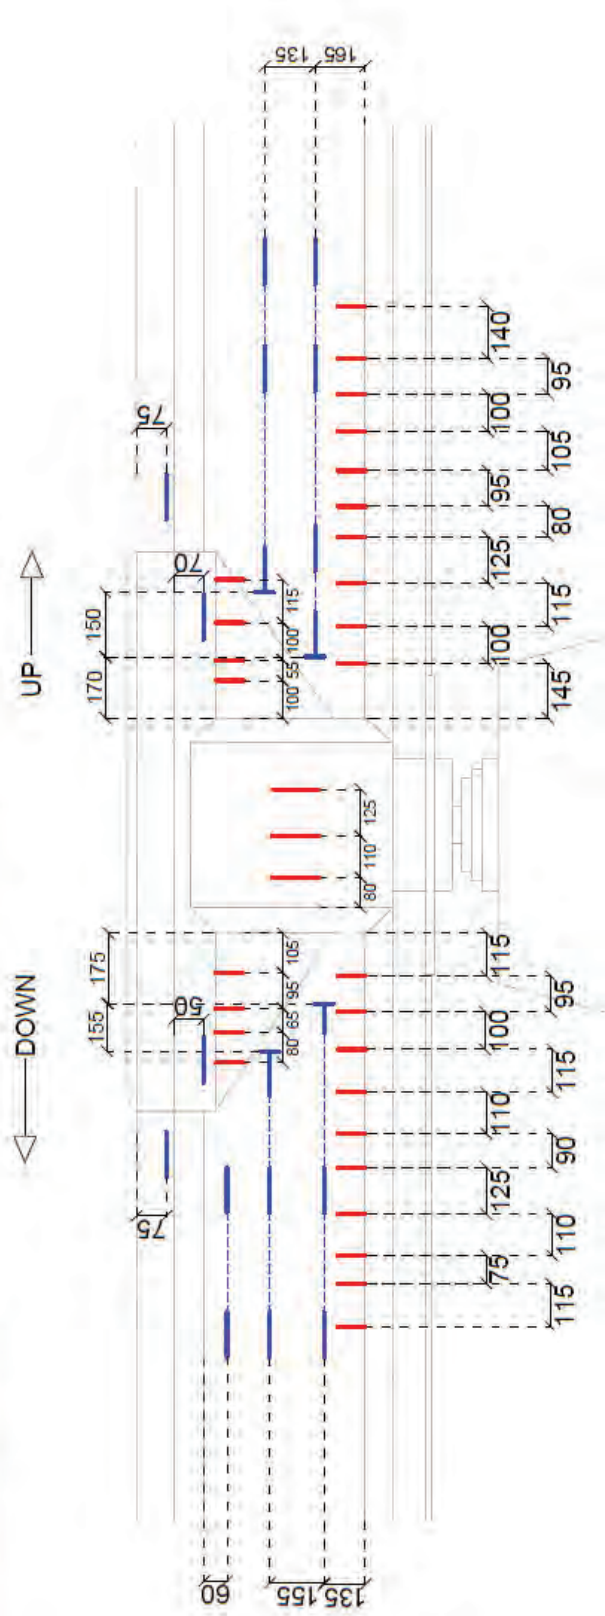
**FIGURE 3**

Outside Elevation, Up, Link Bar Cover: 29, 31, 21, 32, 33, 30, 34, 30, 32 and 31mm

Inside Elevation, Up, Link Bar Cover: 50, 49, 40, 50, 39, 48, 35, 40, 36, 35 and 35mm

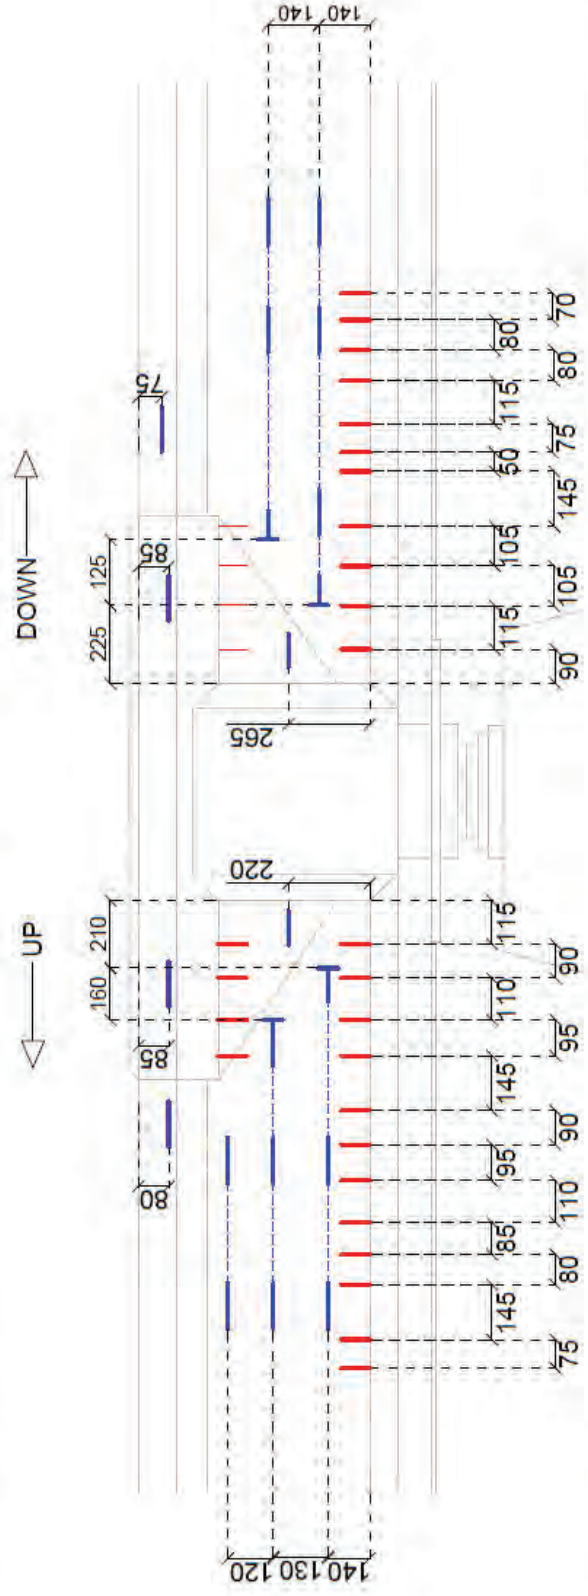
**FIGURE 5**

Outside Elevation, Up, Link Bar Cover: 34, 36, 46, 34, 38, 33, 35, 35, 42, 34, 41, 35, 35, 46, 36, 36, 34 and 41mm

Inside Elevation, Up, Link Bar Cover: 27, 41, 26, 38, 33, 40, 33, 27, 23, 46 and 29mm

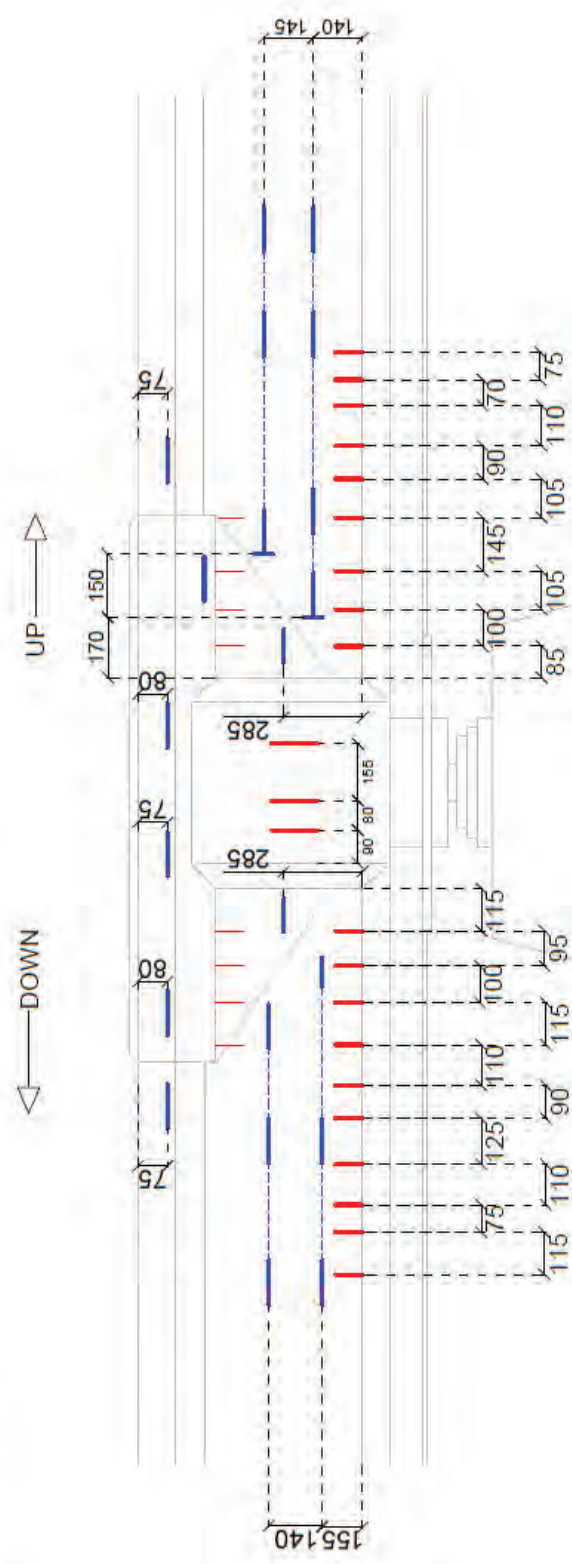
**FIGURE 7**

Outside Elevation, Up, Link Bar Cover: 51, 35, 44, 37, 47, 38, 45, 31, 26, 46, 25 and 32mm

Inside Elevation, Up, Link Bar Cover: 42, 37, 41, 35, 41, 32, 38, 30, 35, 24, 37, 26, 33, 27, 30, 26 and 38mm

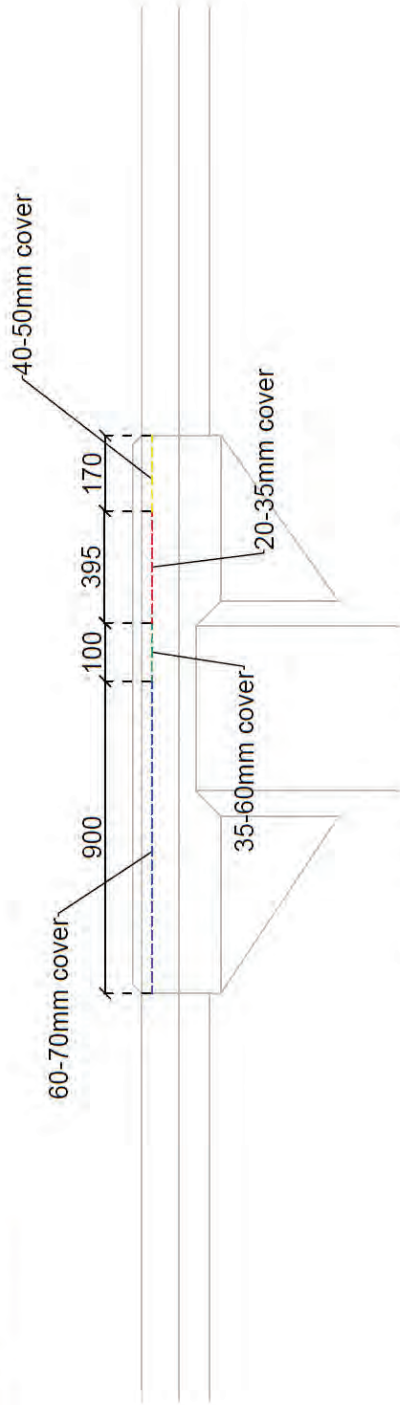
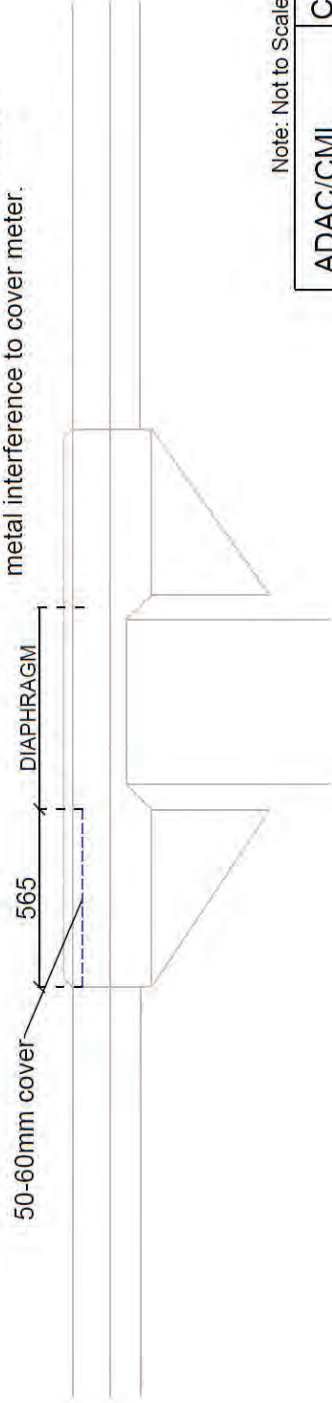
**FIGURE 8**

Inside Face (Upside) inaccessible due to metal interference to cover meter.

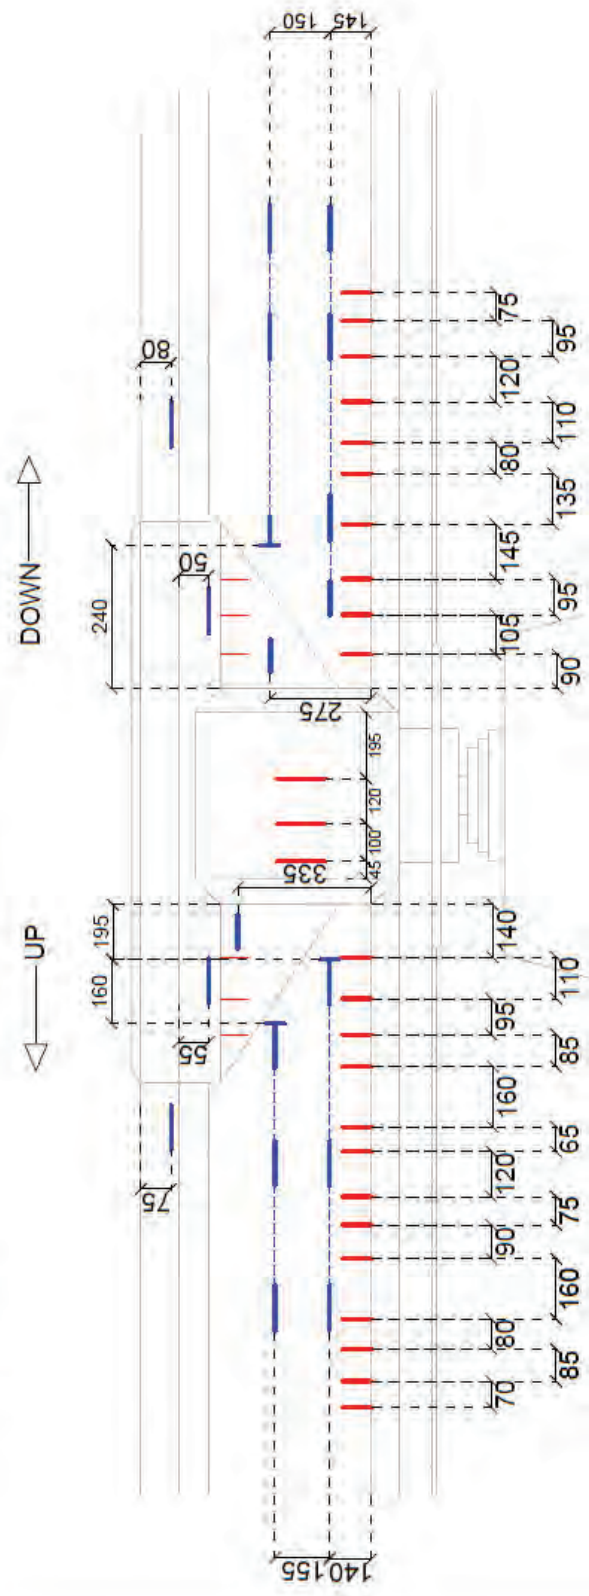
**FIGURE 9**

Outside Elevation, Up, Link Bar Cover: 40, 29, 35, 31, 47, 29, 31, 27, 51, 39, 45, 43, 49, 54 and 44mm

Inside Elevation, Up, Link Bar Cover: 44, 32, 36, 31, 36, 30, 42, 34, 44, 33, 35, 32 and 41mm

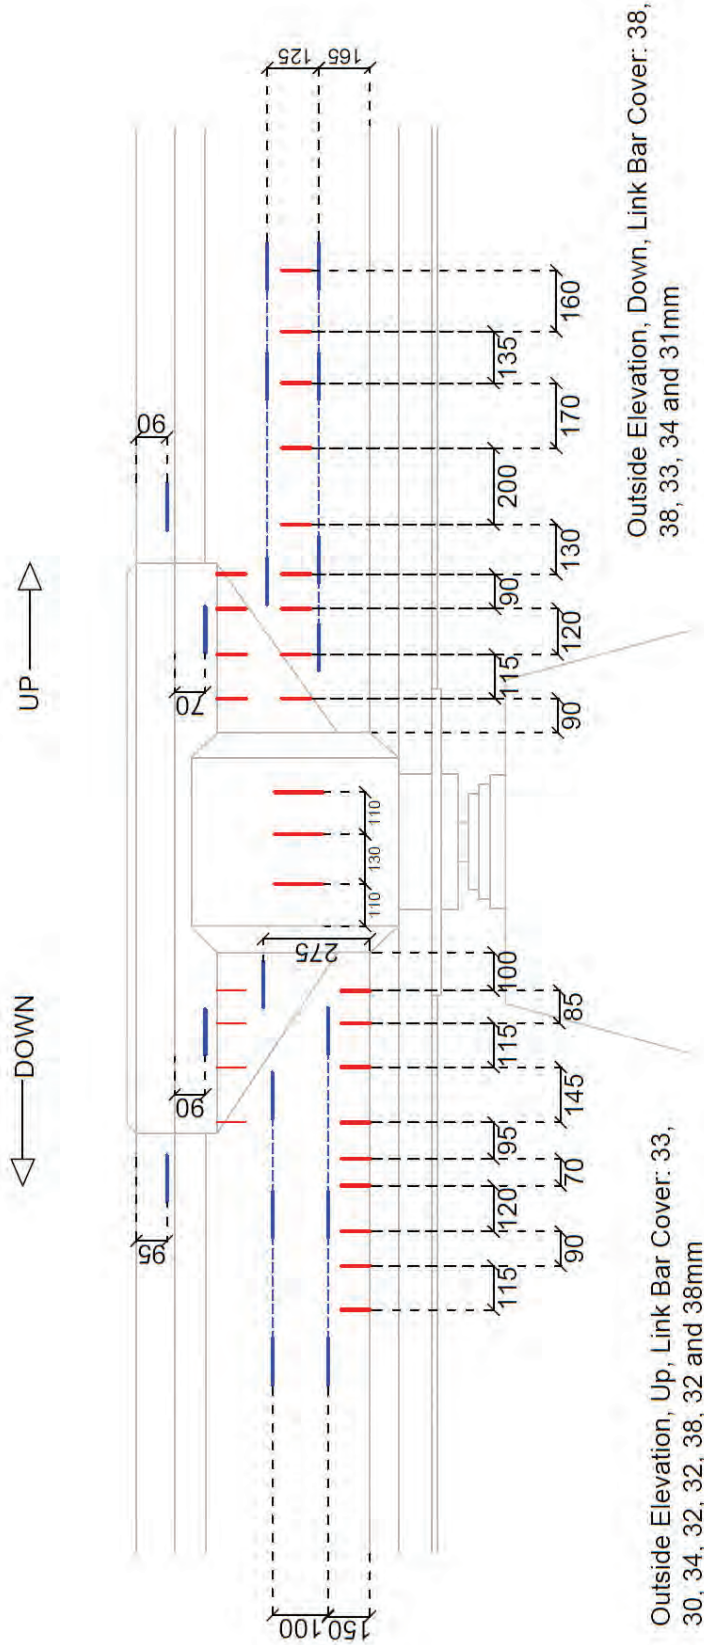
**FIGURE 11**

Note :-  
Impulse radar equipment was unable to fit beneath the running rail at this location to scan the top flange.

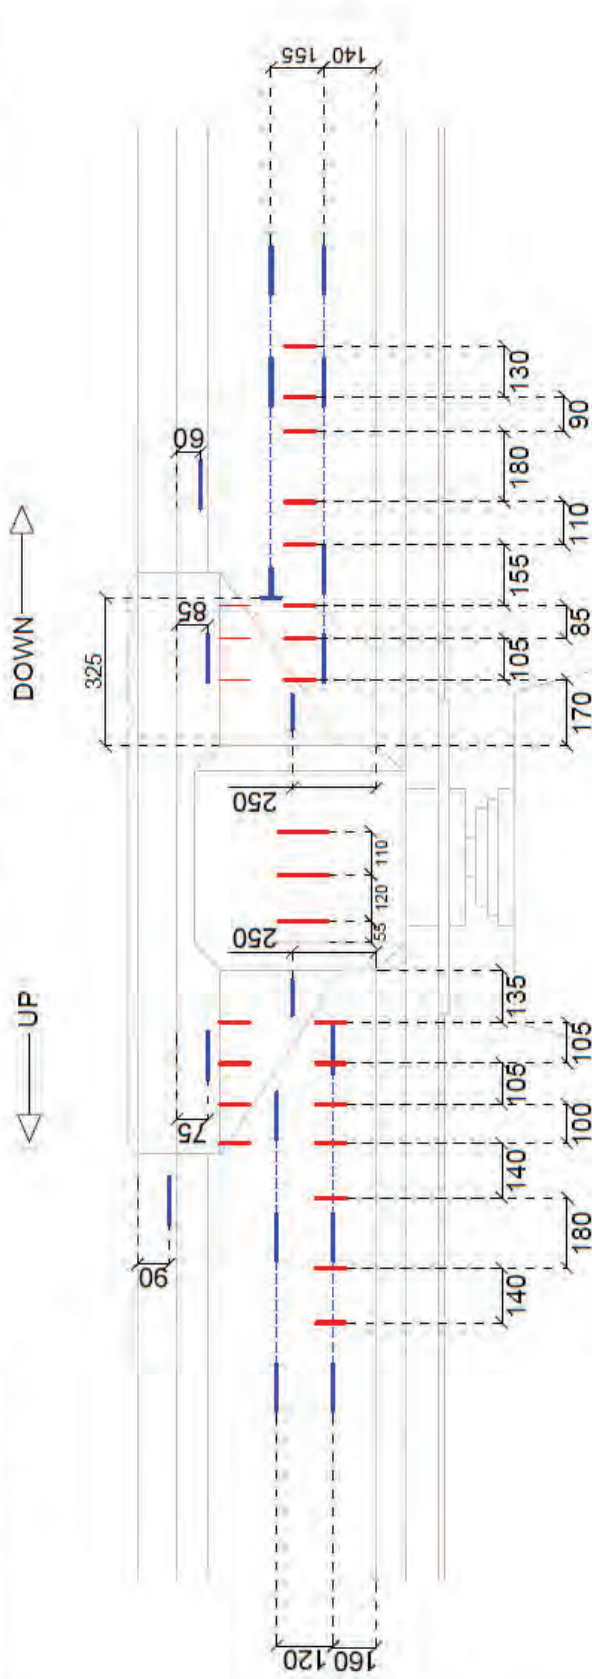
**FIGURE 12**

Outside Elevation, Up, Link Bar Cover: 41, 38, 30, 40, 47 and 26mm

Inside Elevation, Up, Link Bar Cover: Unable to determine due to presence of cross beams.

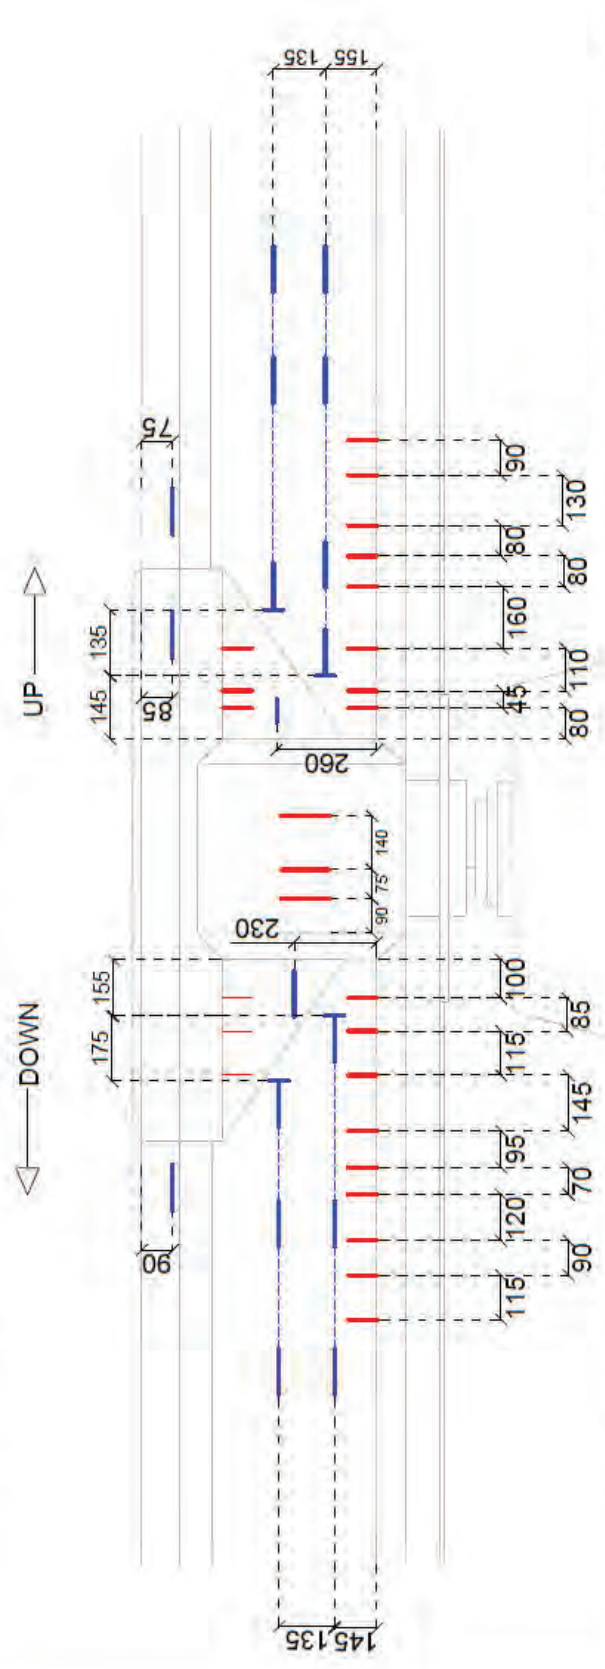
**FIGURE 13**

Outside Elevation, Down, Link Bar Cover: 38, 38, 37, 35, 34, 33, 33, 34, 34 and 34mm

Inside Elevation, Down, Link Bar Cover: 33, 36, 44, 33, 41, 30, 46, 33, 28, 45, 36 and 47mm

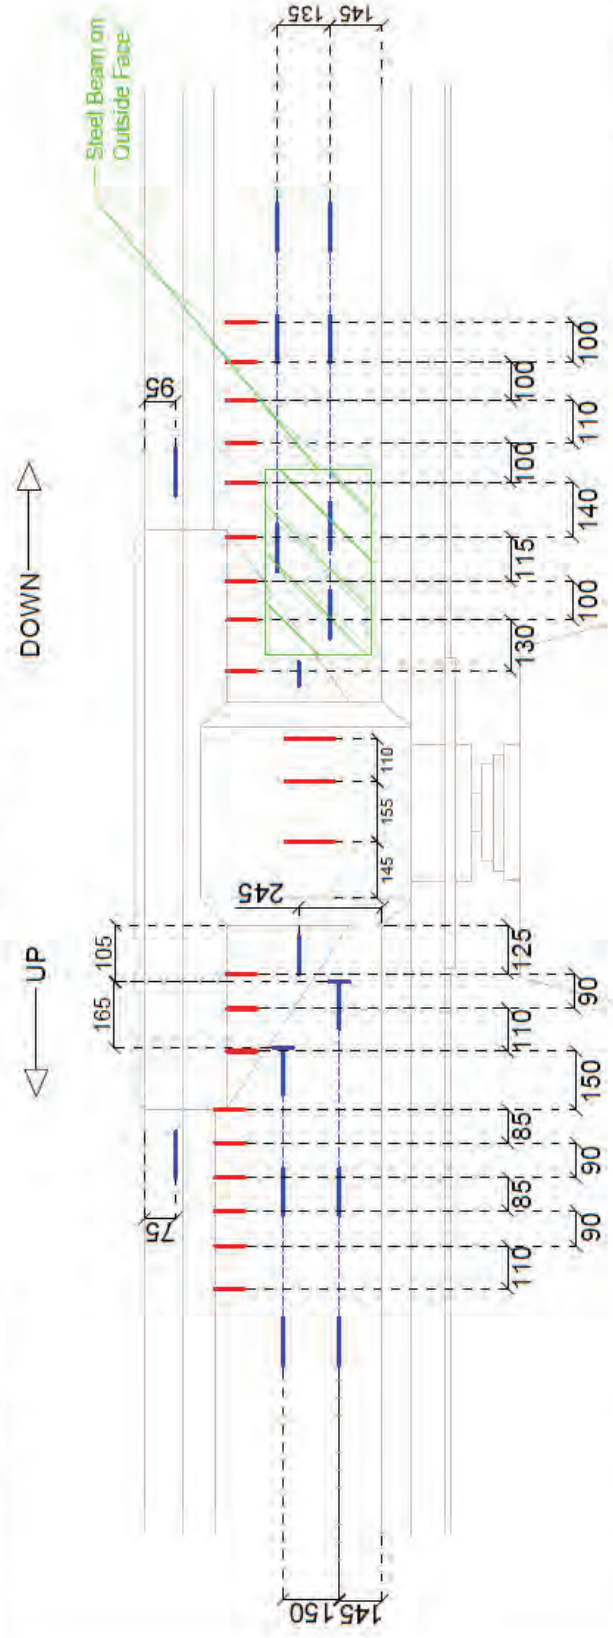
FIGURE 14

Outside Elevation, Up, Link Bar Cover: 40, 28, 21, 41, 40, 40, 40, 40 and 40mm

Inside Elevation, Up, Link Bar Cover: 34, 45, 28, 25, 41, 23, 38, 37 and 25mm

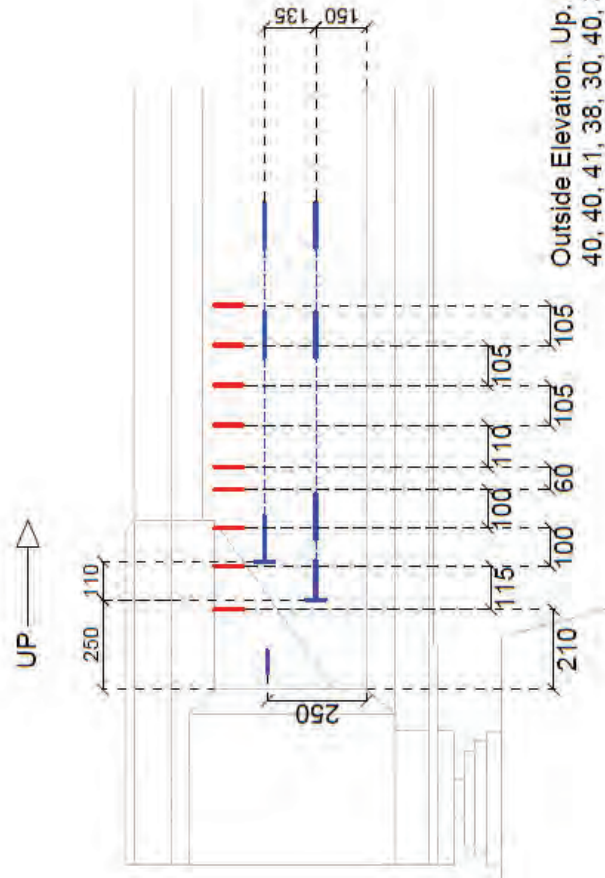
FIGURE 16

Outside Elevation, Up, Link Bar Cover: 42.  
40, 40, 41, 38, 30, 40, 35 and 35mm

Inside Elevation, Up, Link Bar Cover: 38, 29,  
40, 30, 39, 30, 43, 35, 41, 33 and 44mm

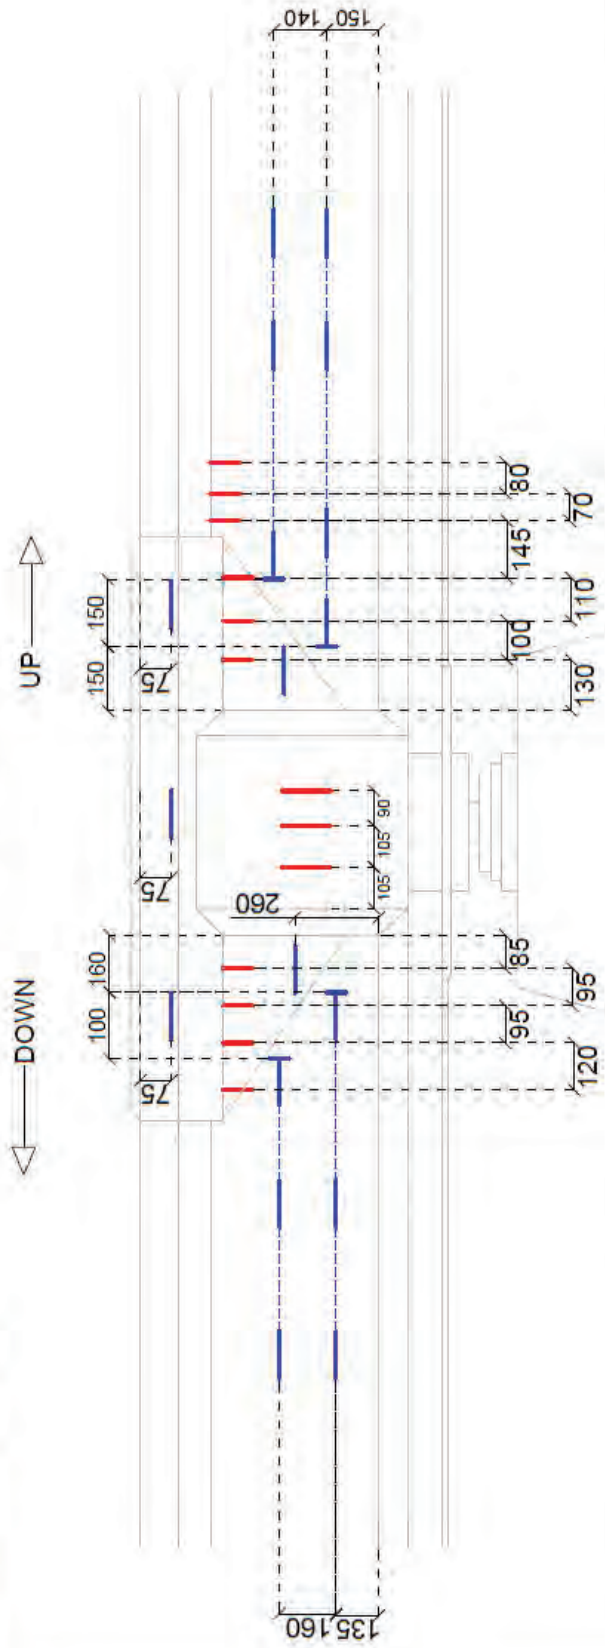
**FIGURE 17**

Outside Elevation, Up, Link Bar Cover: 35,  
39, 33, 31, 29 and 32mm

Inside Elevation, Up, Link Bar Cover: 41, 37,  
34, 31, 44, 30 and 29mm

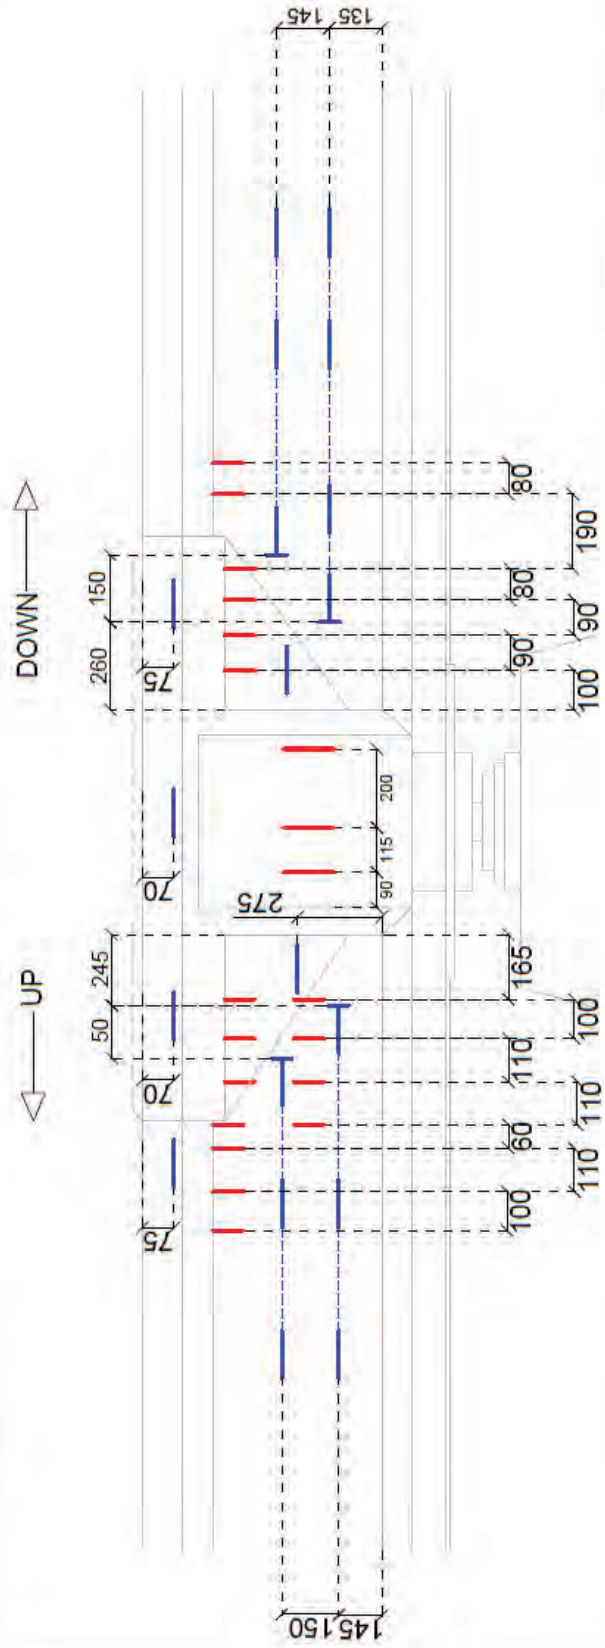
**FIGURE 18**

Outside Elevation, Down, Link Bar Cover: 41, 40, 40, 40, 39 and 45mm

Inside Elevation, Down, Link Bar Cover: 42, 34, 48, 31, 41, 32, 42, 32 and 30mm

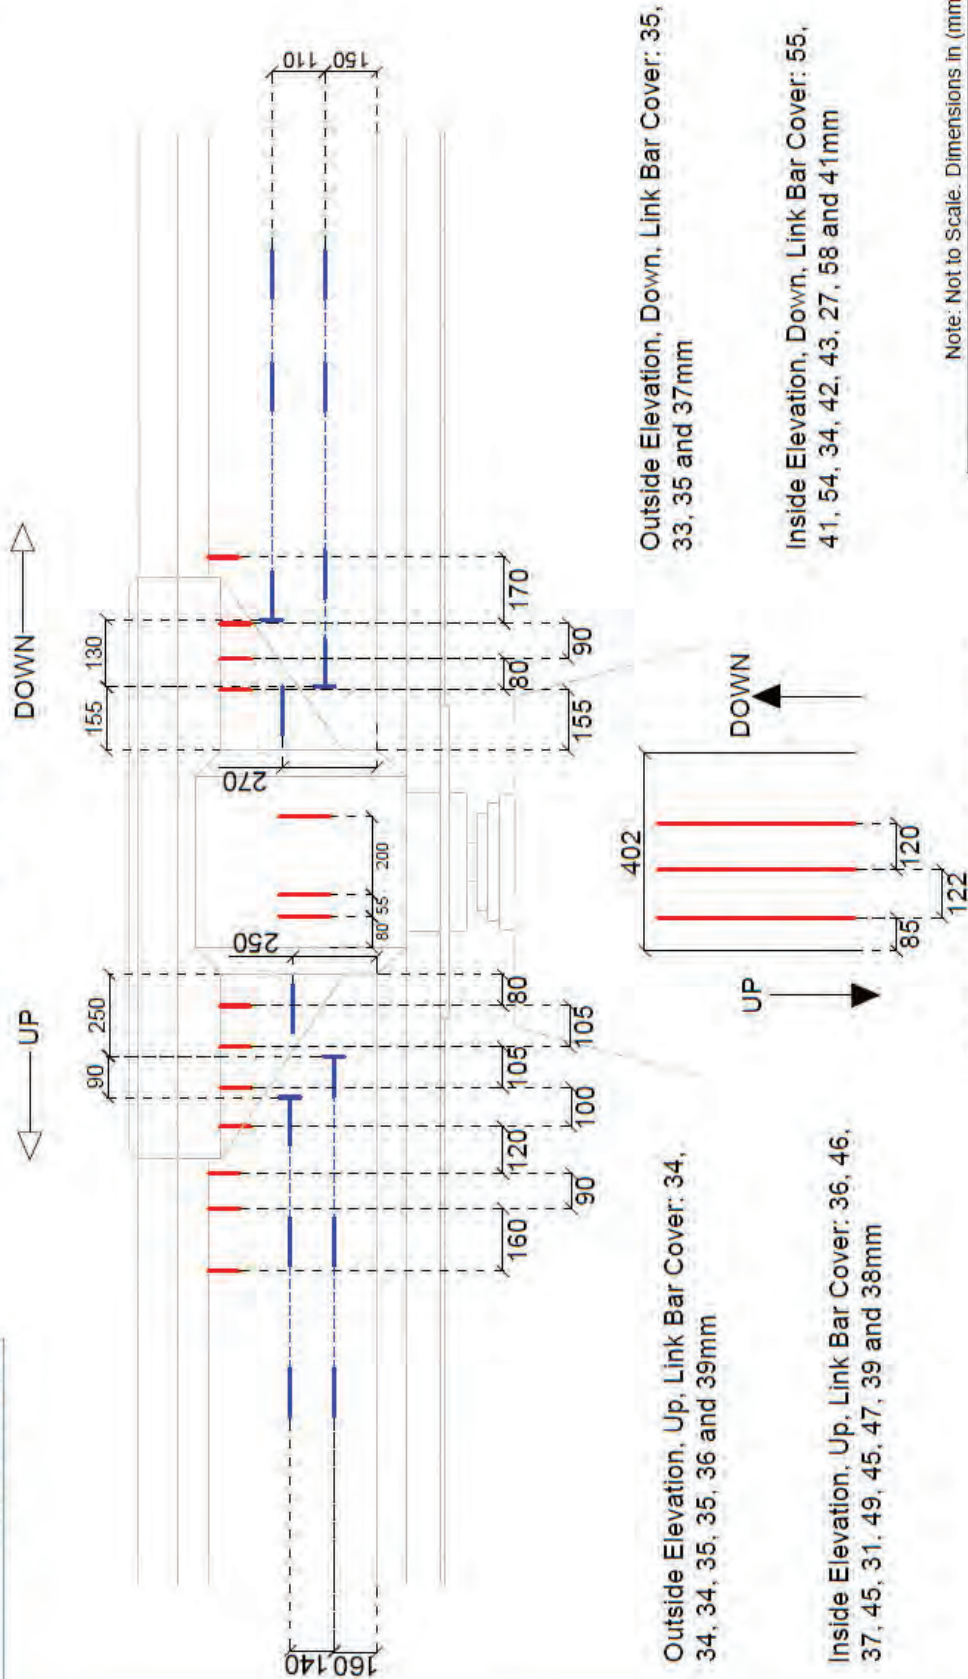
FIGURE 19

Outside Elevation, Up, Link Bar Cover: 34, 34, 34, 35, 35, 36 and 39mm  
 Inside Elevation, Up, Link Bar Cover: 36, 46, 37, 45, 31, 49, 45, 47, 39 and 38mm

Outside Elevation, Down, Link Bar Cover: 35, 33, 35 and 37mm  
 Inside Elevation, Down, Link Bar Cover: 55, 41, 54, 34, 42, 43, 27, 58 and 41mm

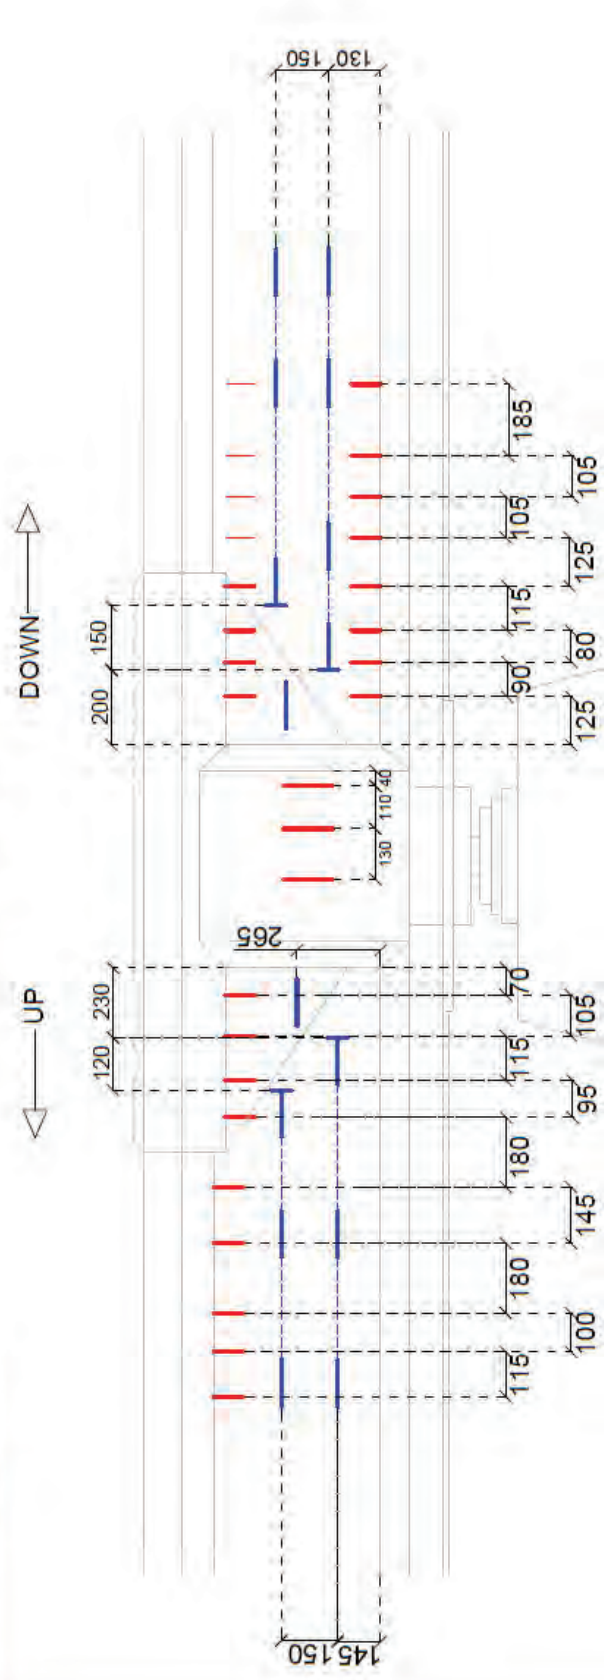
**FIGURE 22**

Outside Elevation, Up, Link Bar Cover: 30,  
33, 29, 28, 30, 29, 27 and 27mm

Inside Elevation, Up, Link Bar Cover: 46, 41,  
42, 48, 34, 43, 35 and 52mm

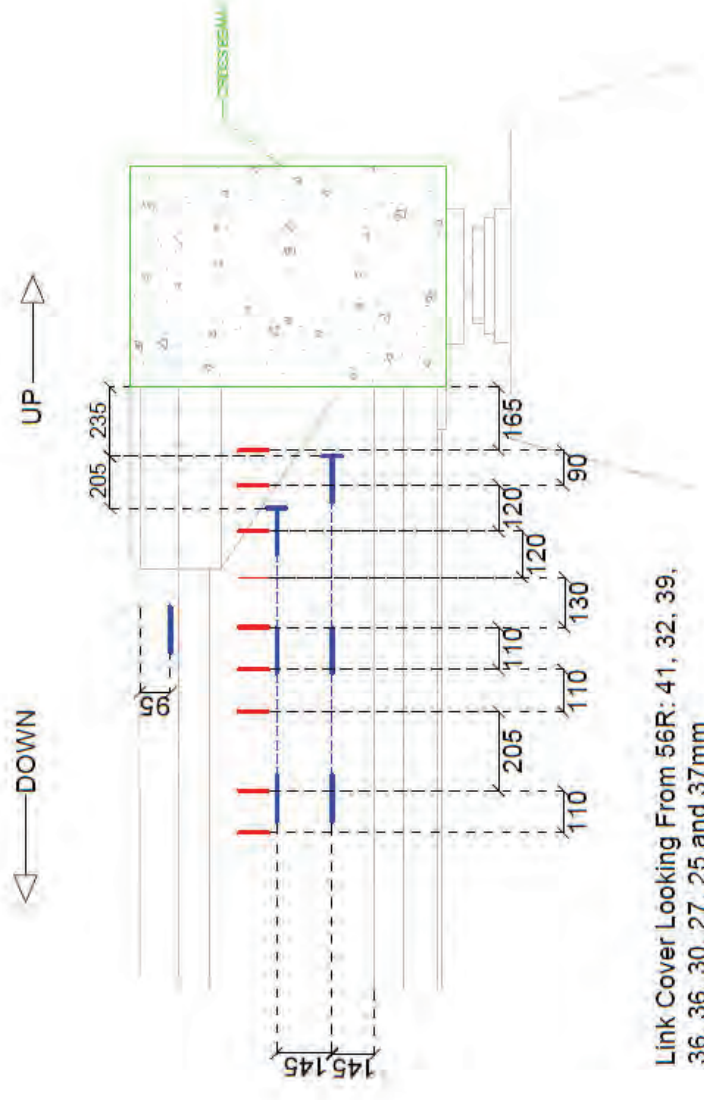
**FIGURE 23**

Link Cover Looking From 56R: 41, 32, 39, 36, 36, 30, 27, 25 and 37mm

Link Cover Looking From 56L: 42, 42, 37, 42, 35, 42, 36, 44 and 26mm

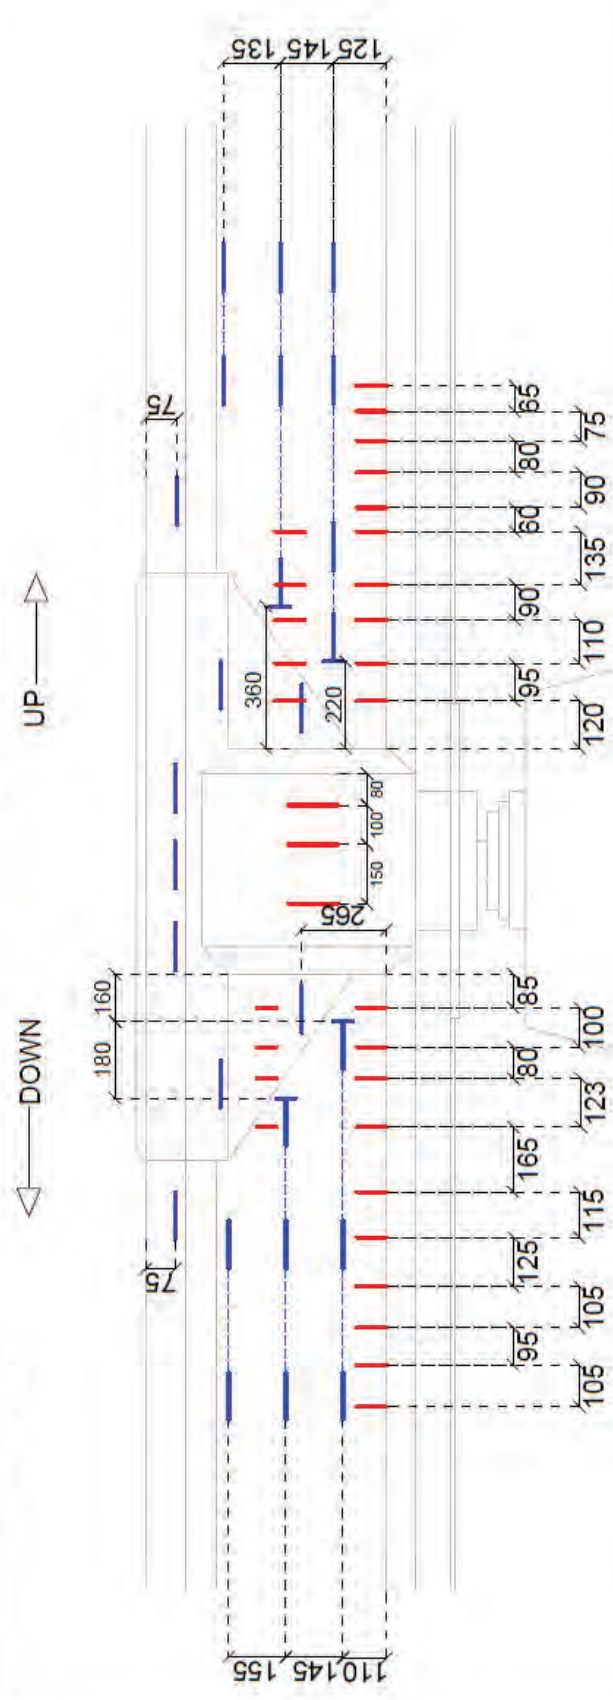
**FIGURE 28**

Outside Elevation, Up, Link Bar Cover: 31, 31, 37, 31, 37, 28, 40, 29, 28, 36, 37, 36 and 37mm

Inside Elevation, Up, Link Bar Cover: 34, 44, 32, 37, 36, 37, 32, 39, 35, 40, 32 and 34mm
