DECEMBER 2018  
HIGHLANDS AND ISLANDS ENTERPRISE

# CAIRNGORM FUNICULAR RAILWAY

## VIADUCT APPRAISAL REPORT

Rp01

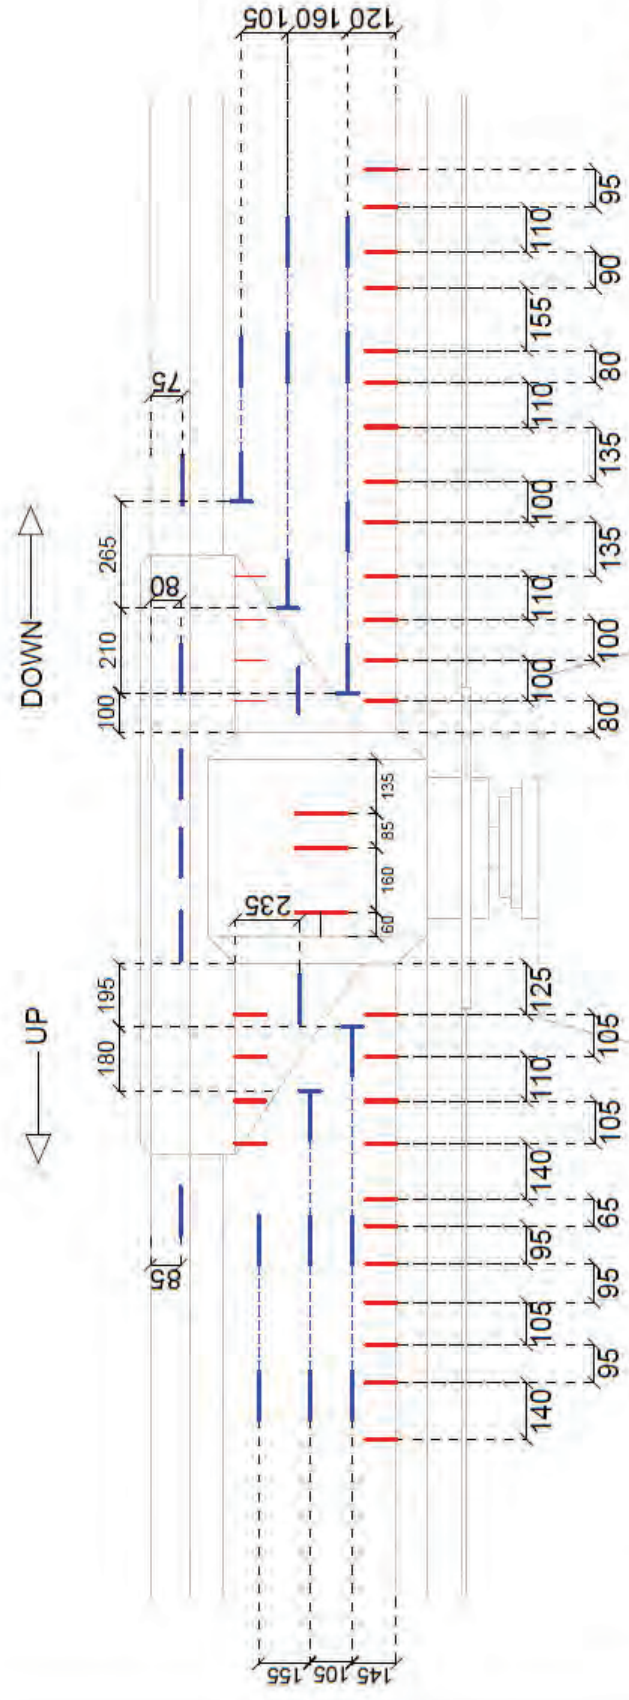
**FIGURE 30**

Outside Elevation, Up, Link Bar Cover: 32, 34, 35, 43, 31, 35, 50, 41, 41 and 42mm

Inside Elevation, Up, Link Bar Cover: 27, 42, 27, 28, 28, 30, 32, 43 and 32mm

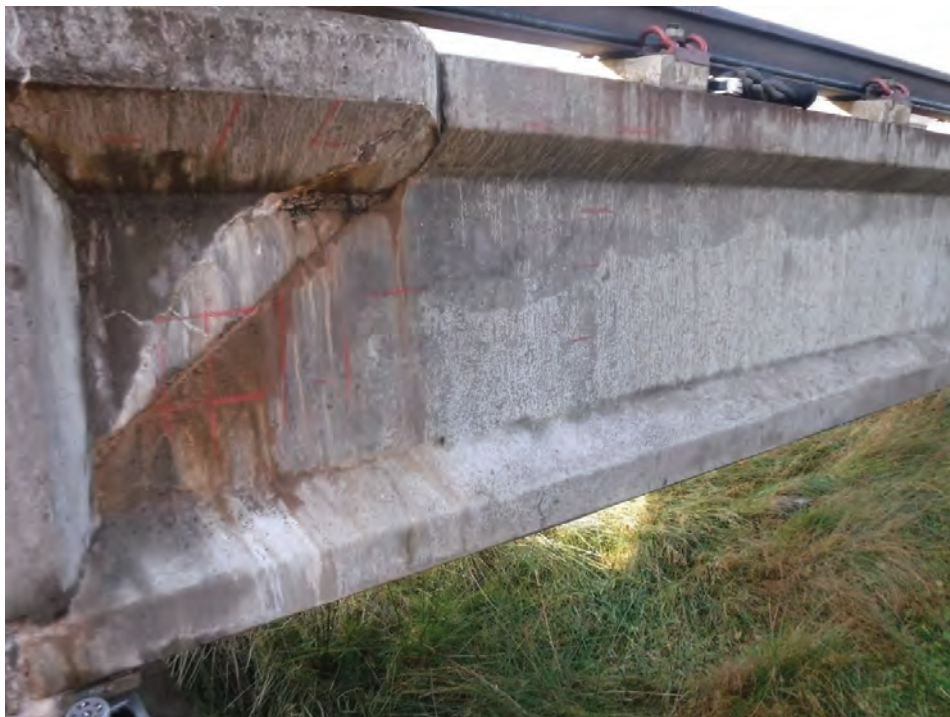
**Plate 2** – General view of surface markings to Pier 9 Left Beam down.

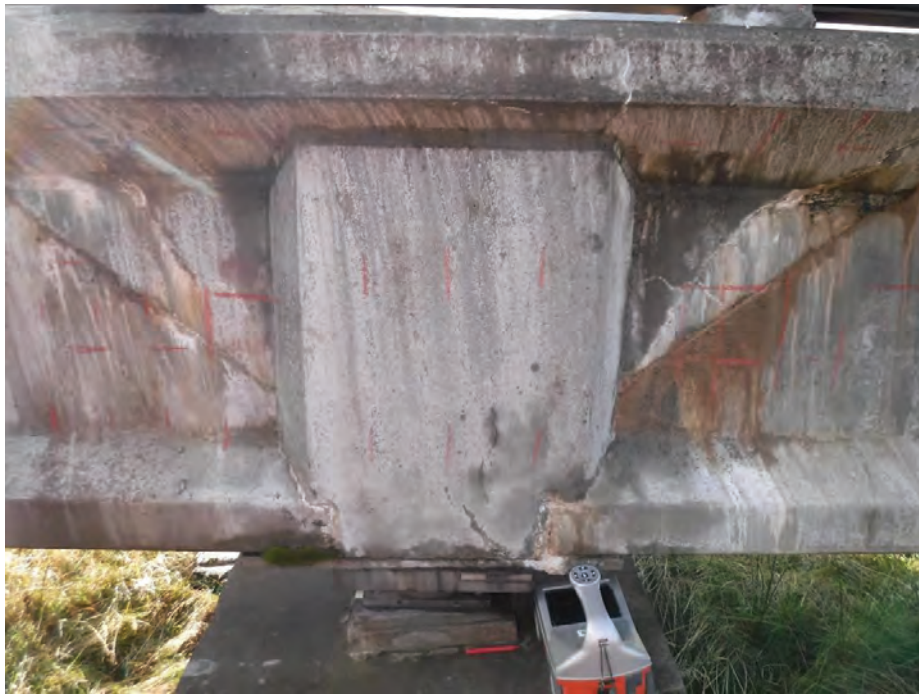
**Plate 3** – General view of surface markings to Pier 9 Left beam connection.

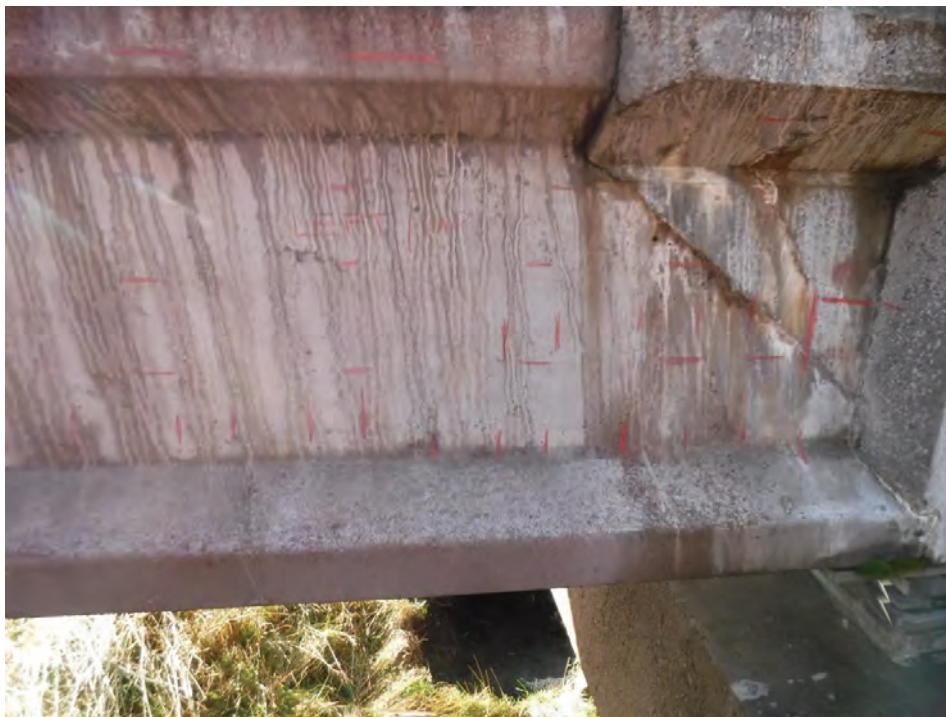
**Plate 4** – General view of surface markings to Pier 9 Left Beam up.

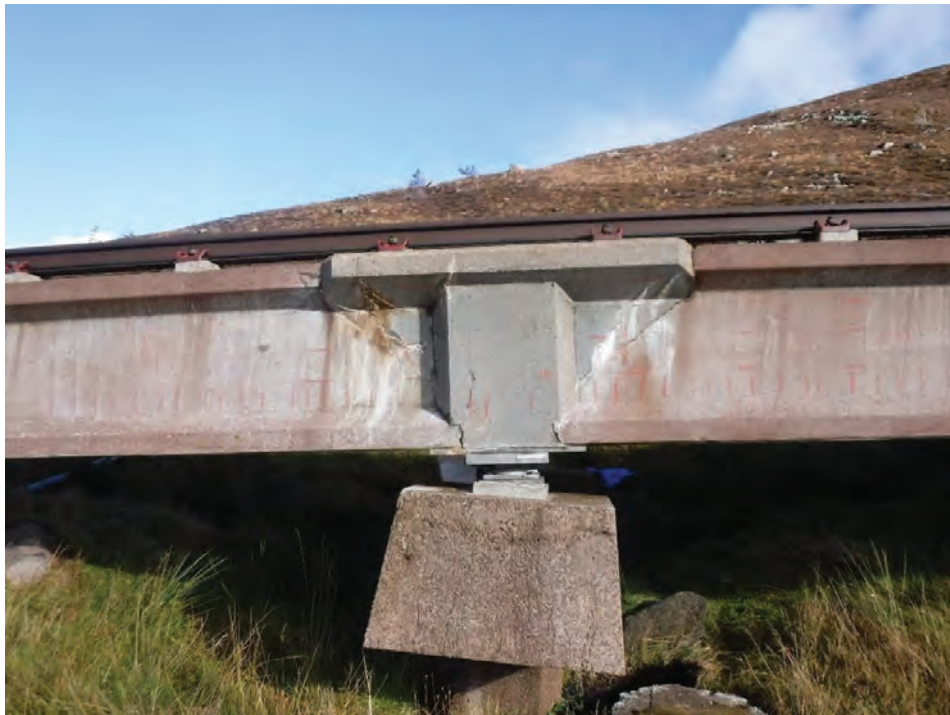
**Plate 5** – General view of surface markings to Pier 9 Right Beam up/down.

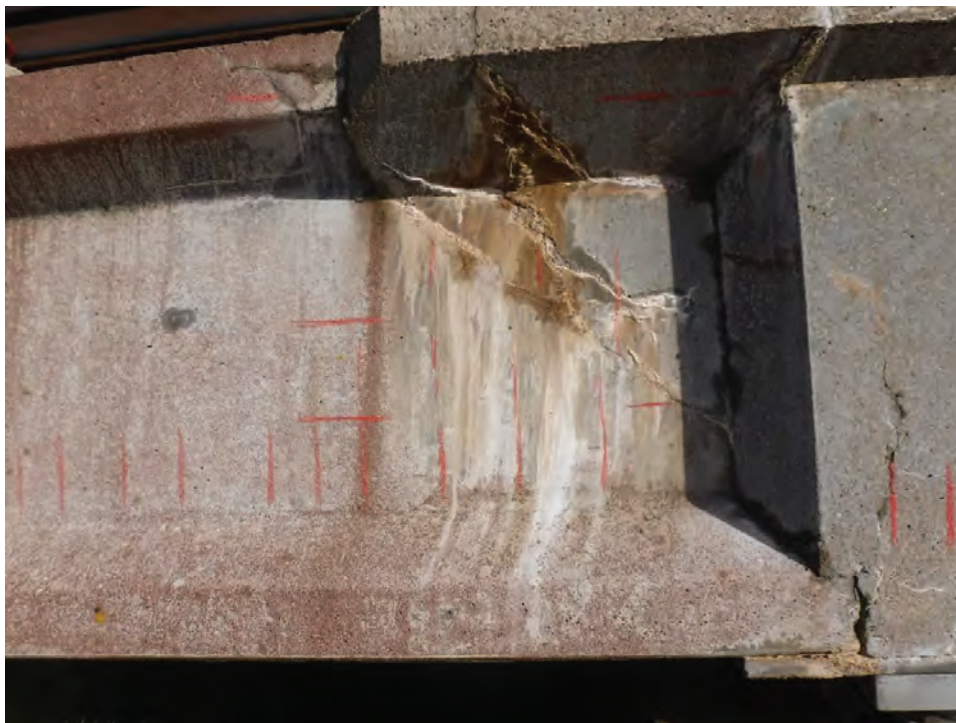
**Plate 6** – General view of surface markings to Pier 9 Right Beam down

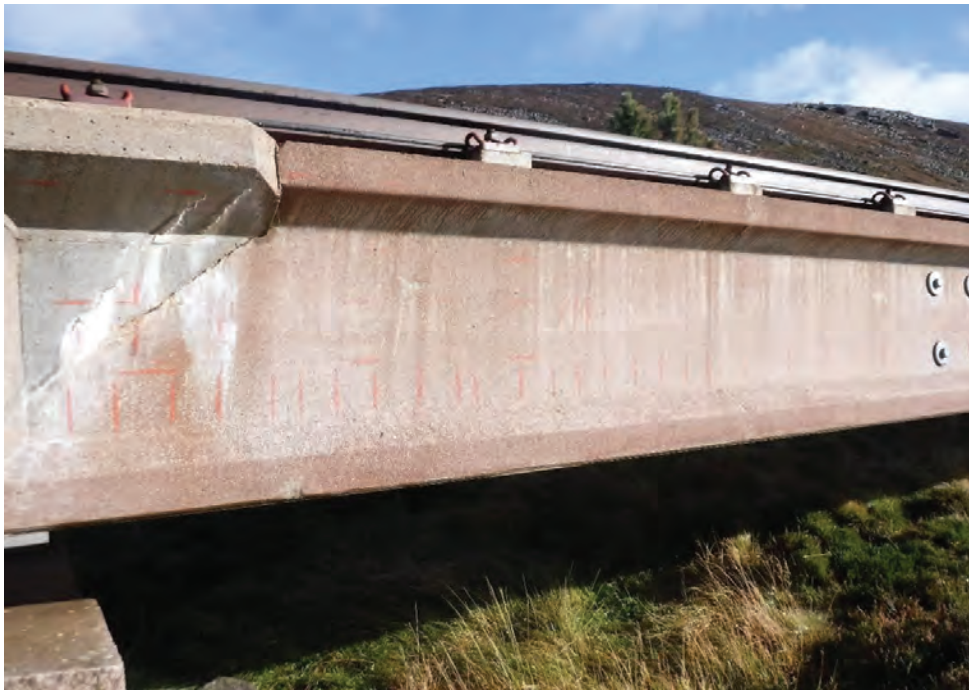
Plate 7 – General view of surface markings to Pier 9 Right Beam up

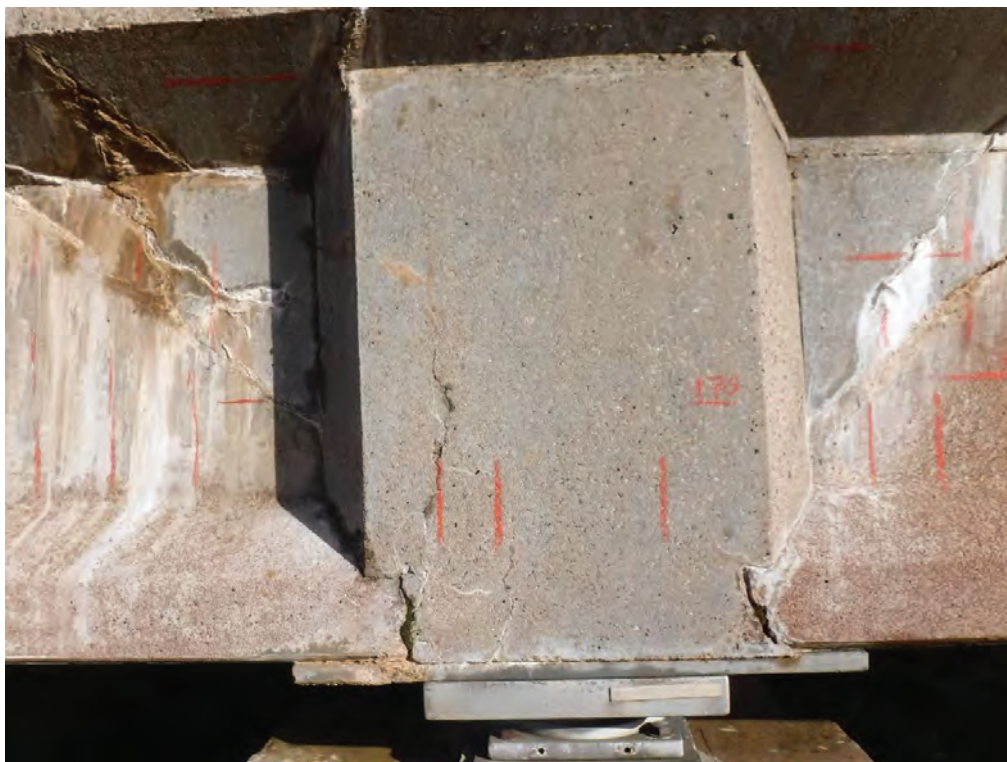
Plate 8 – General view of surface markings to Pier 9 Right Beam up/down.

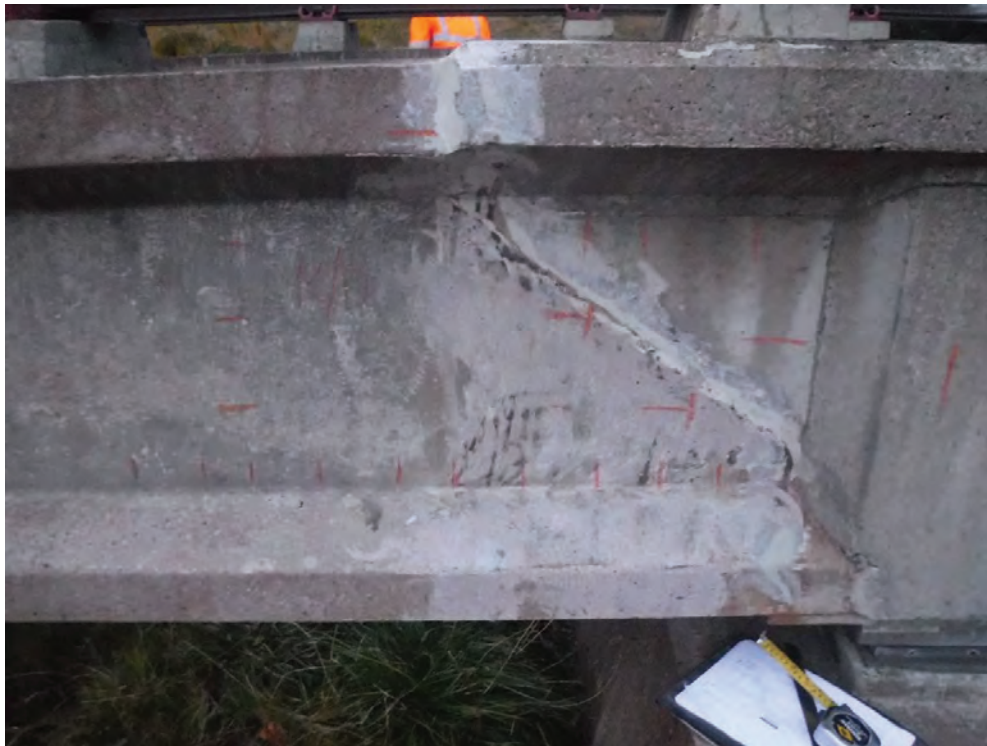
**Plate 9** – General view of surface markings to Pier 22 Right Beam down

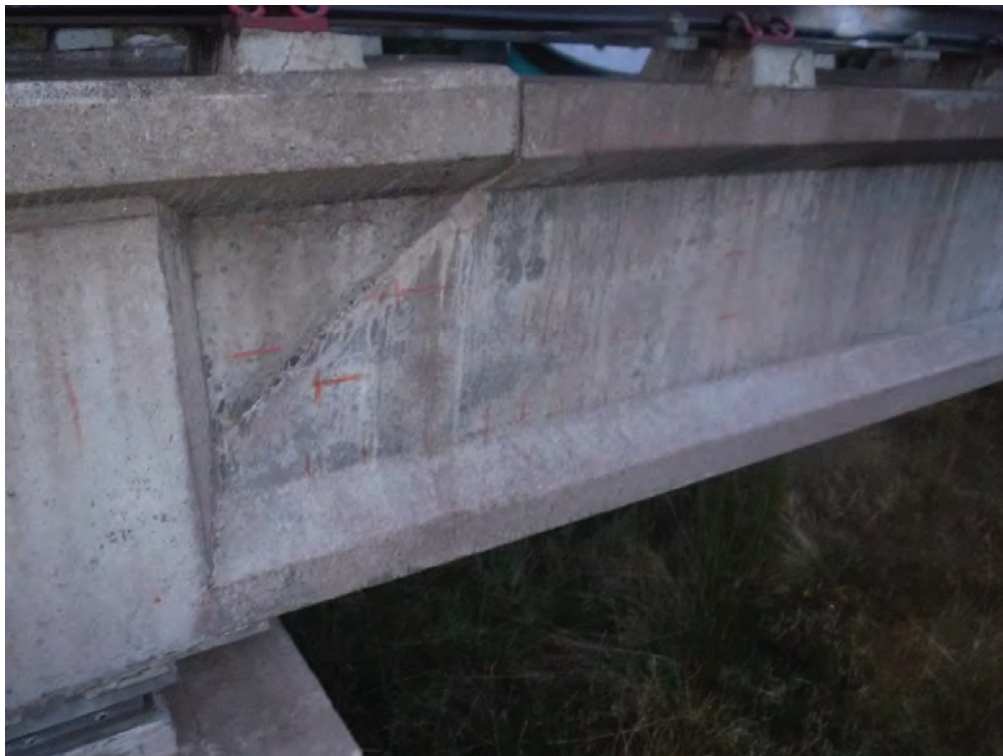
**Plate 10** – General view of surface markings to Pier 22 Right Beam up

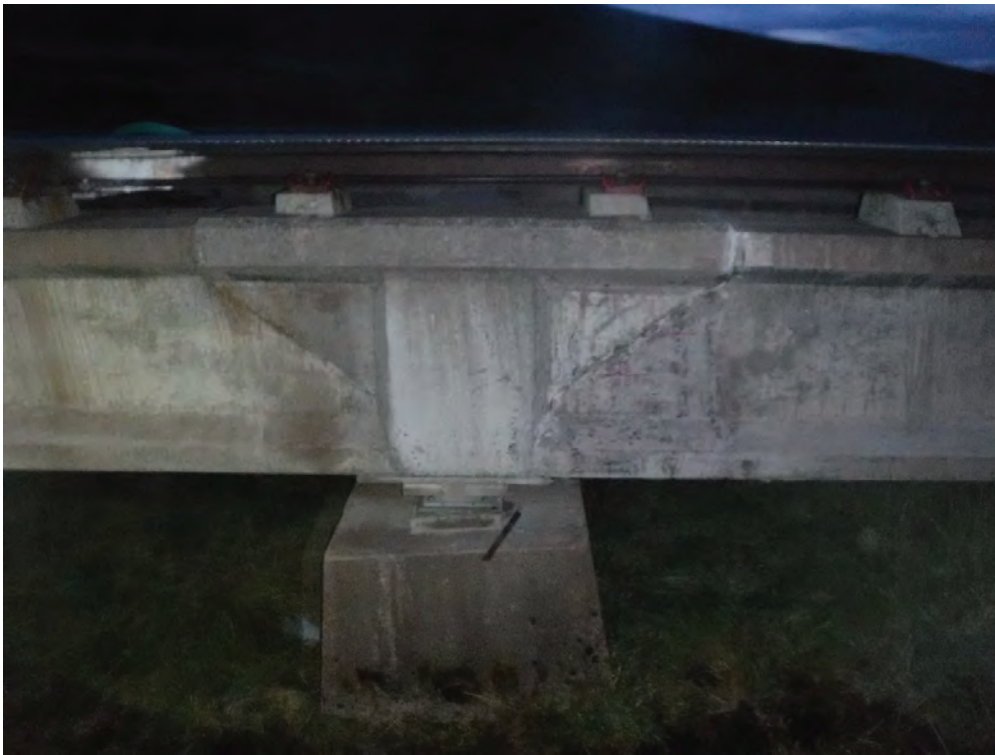
**Plate 11** – General view of surface markings to Pier 22 Left Beam up/down

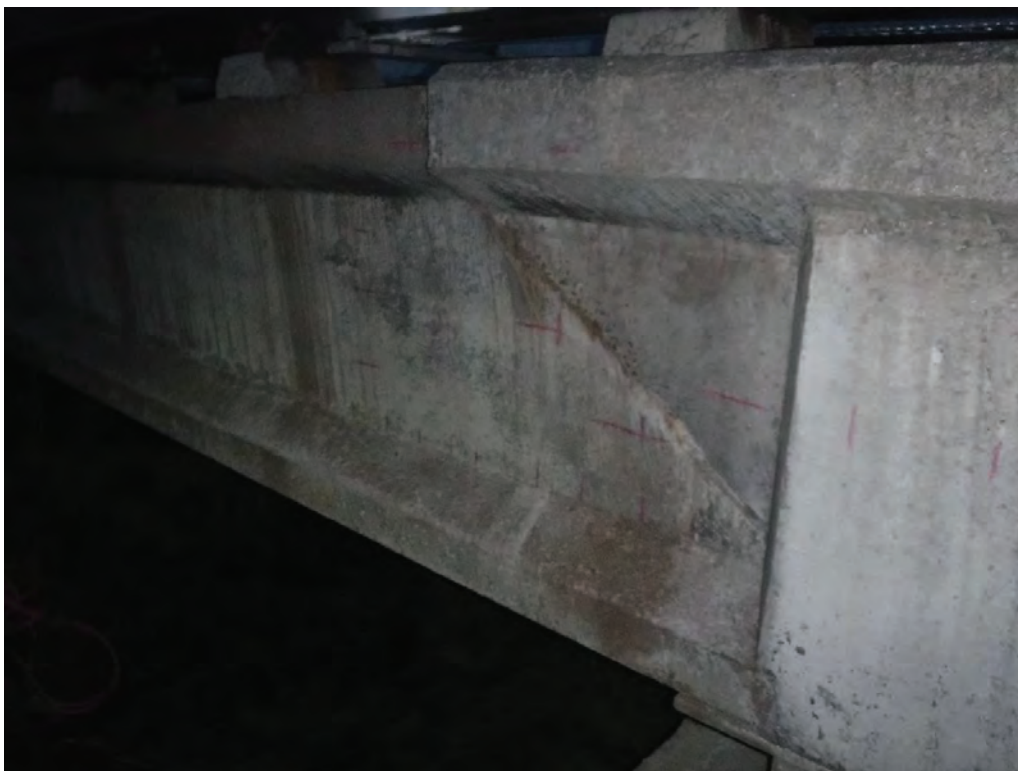
**Plate 12** – General view of surface markings to Pier 22 Left Beam up

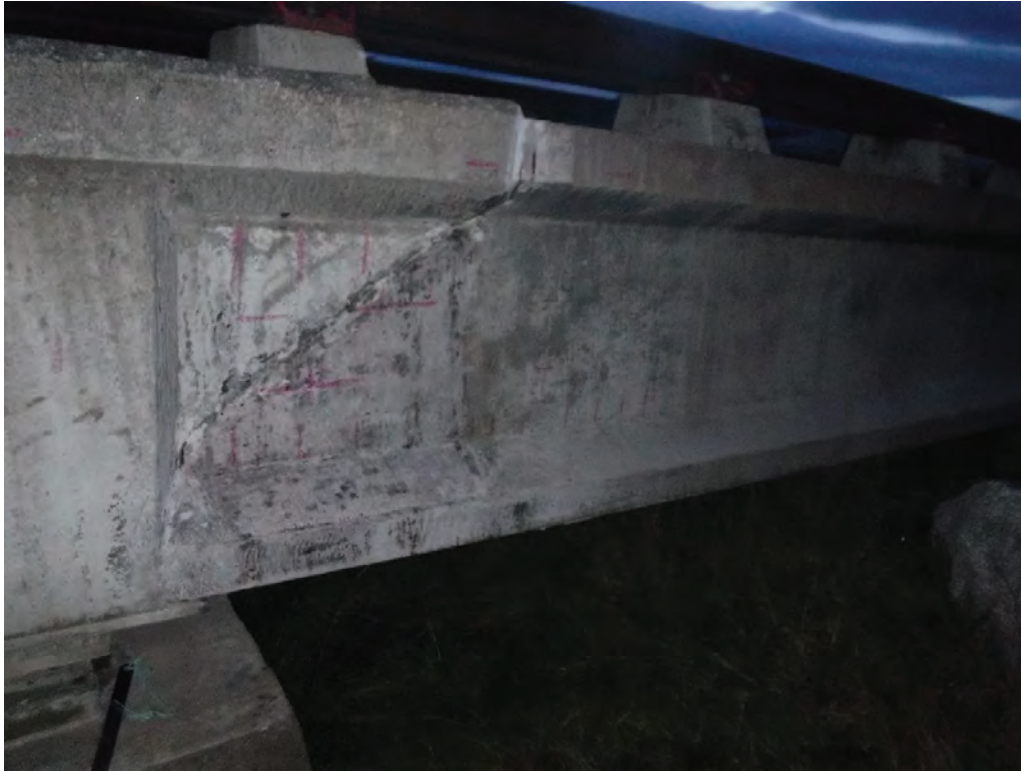
Plate 13 – General view of surface markings to Pier 22 Left Beam down

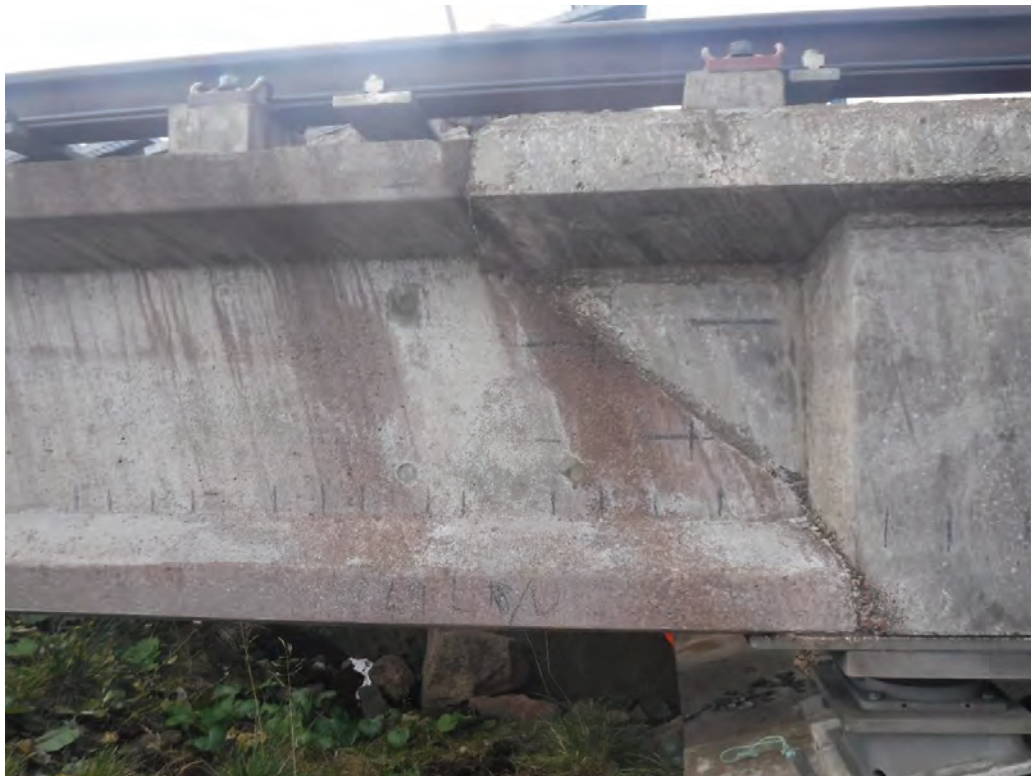
Plate 14 – General view of surface markings to Pier 49 Left Beam up

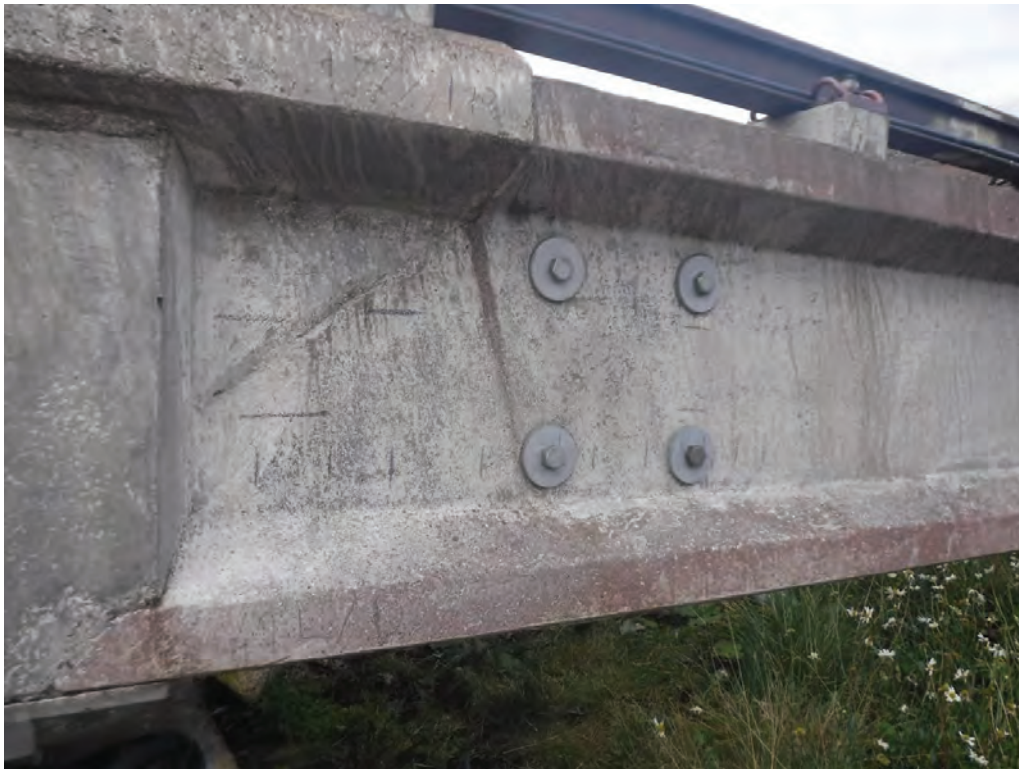
**Plate 15** – General view of surface markings to Pier 49 Left Beam down

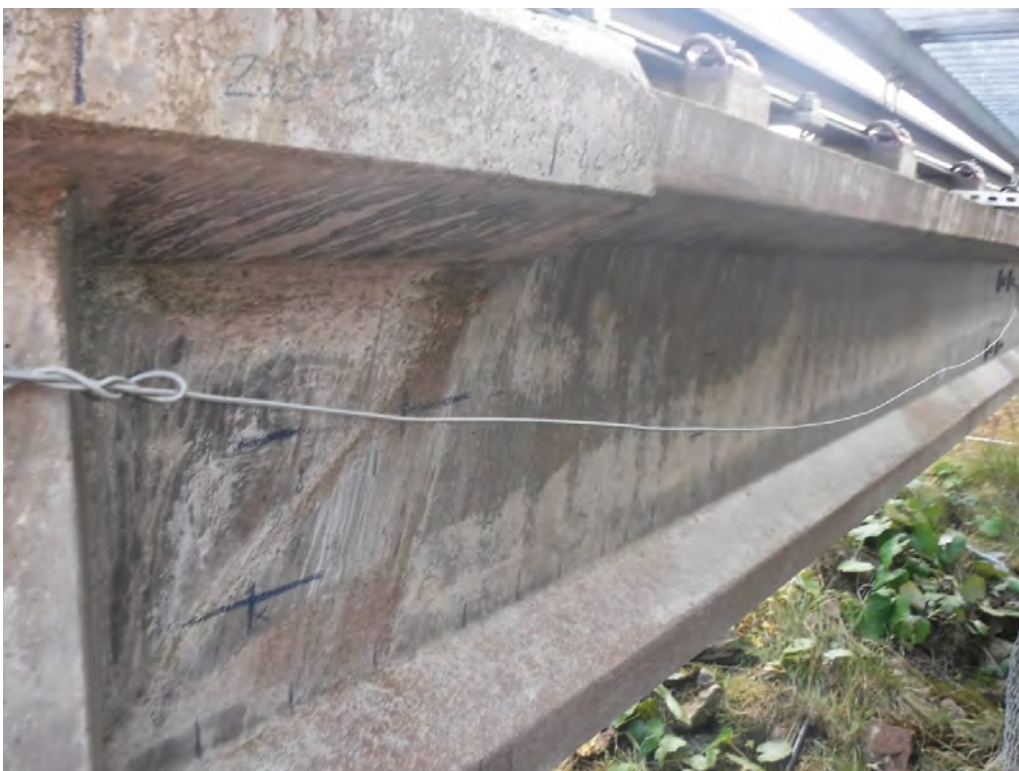
**Plate 16** – General view of surface markings to Pier 49 Right Beam up

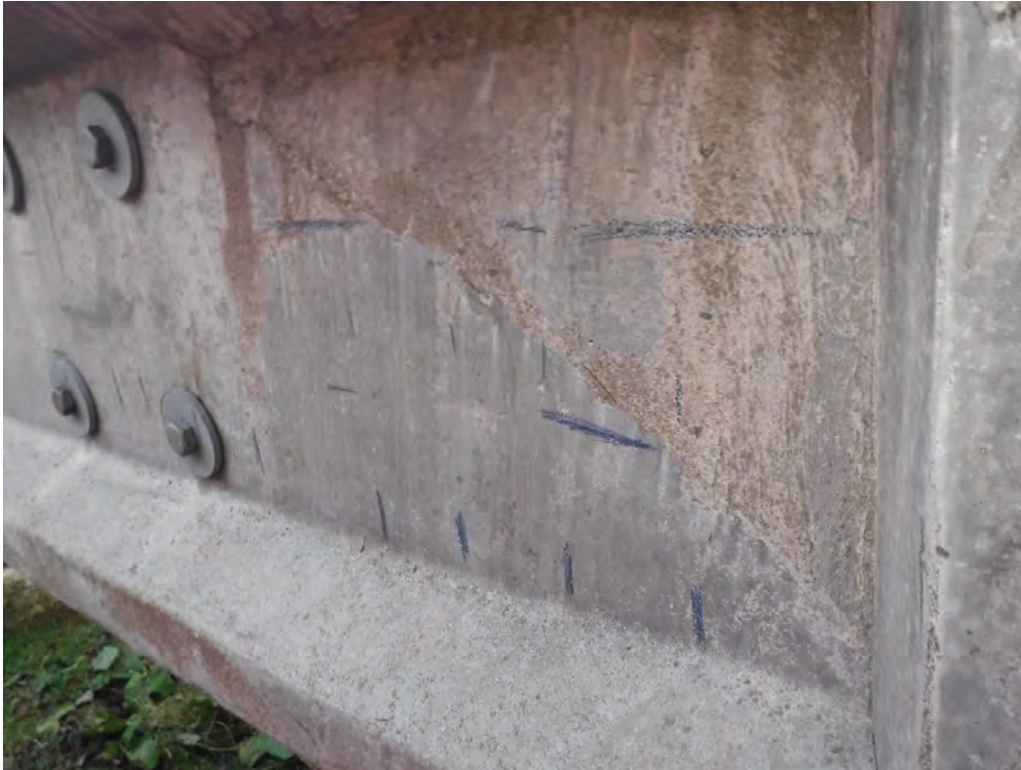
Plate 17 – General view of surface markings to Pier 49 Right Beam down

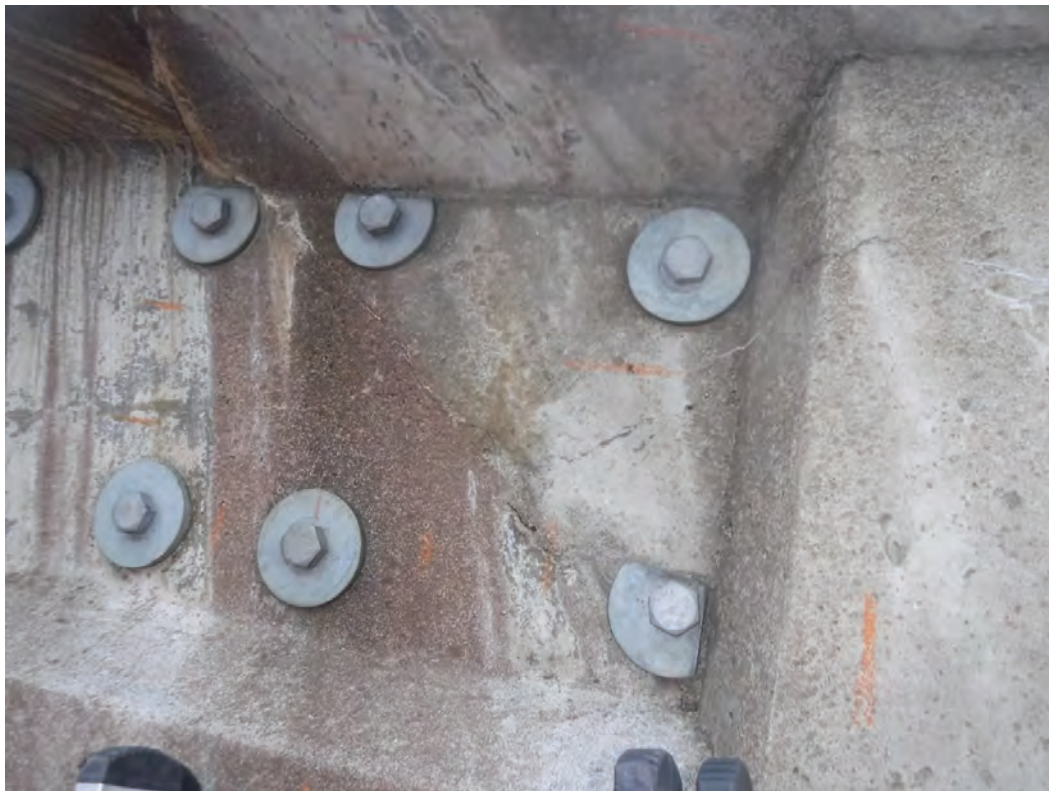
Plate 18 – General view of surface markings to Pier 51 Left Beam up

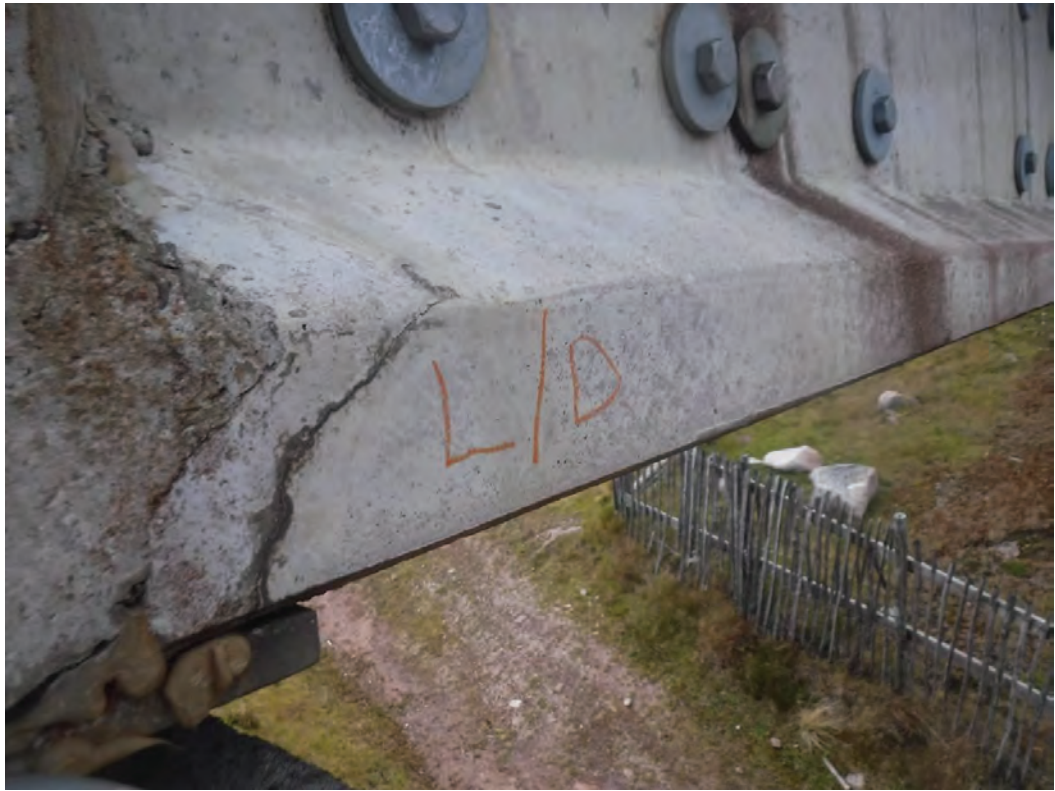
Plate 19 – General view of surface markings to Pier 51 Left Beam down

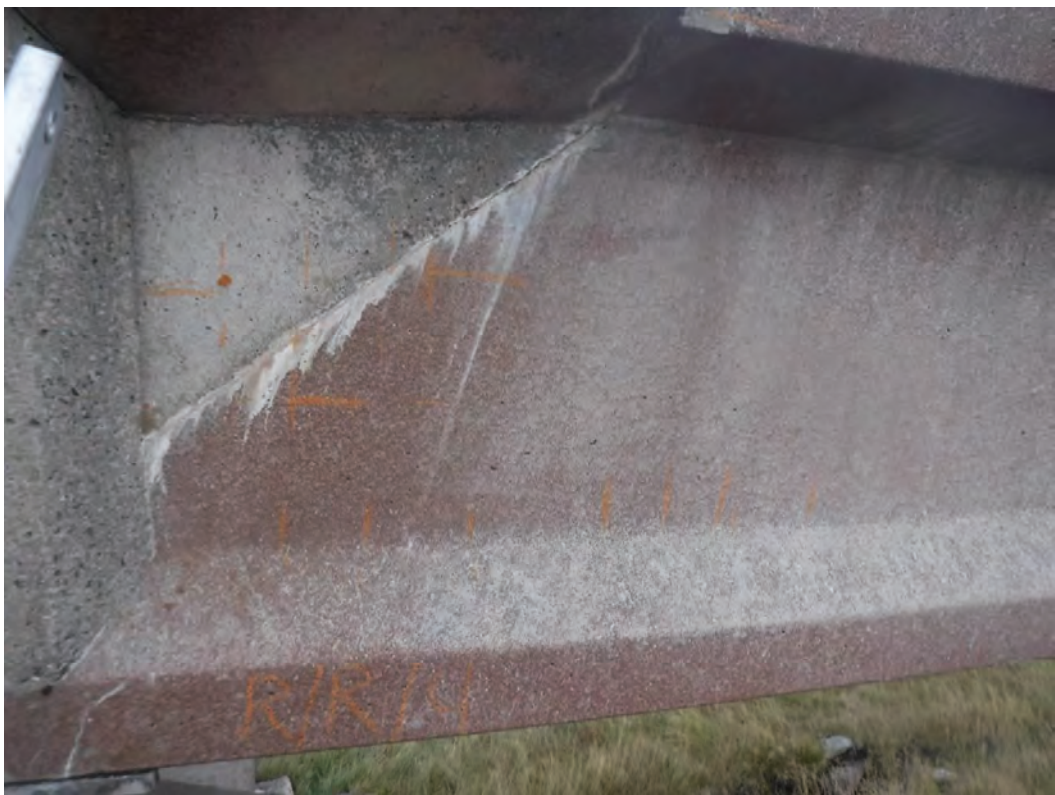
Plate 20 – General view of surface markings to Pier 51 Right, Beam right support up

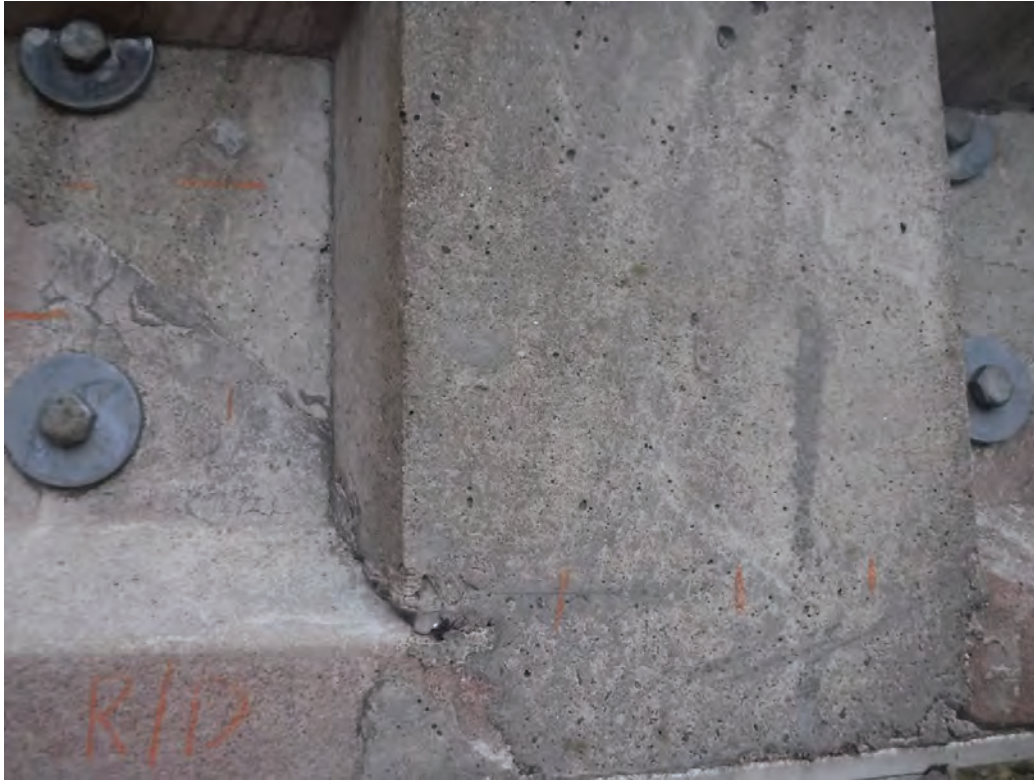
**Plate 21** – General view of surface markings to Pier 51 Right Beam down

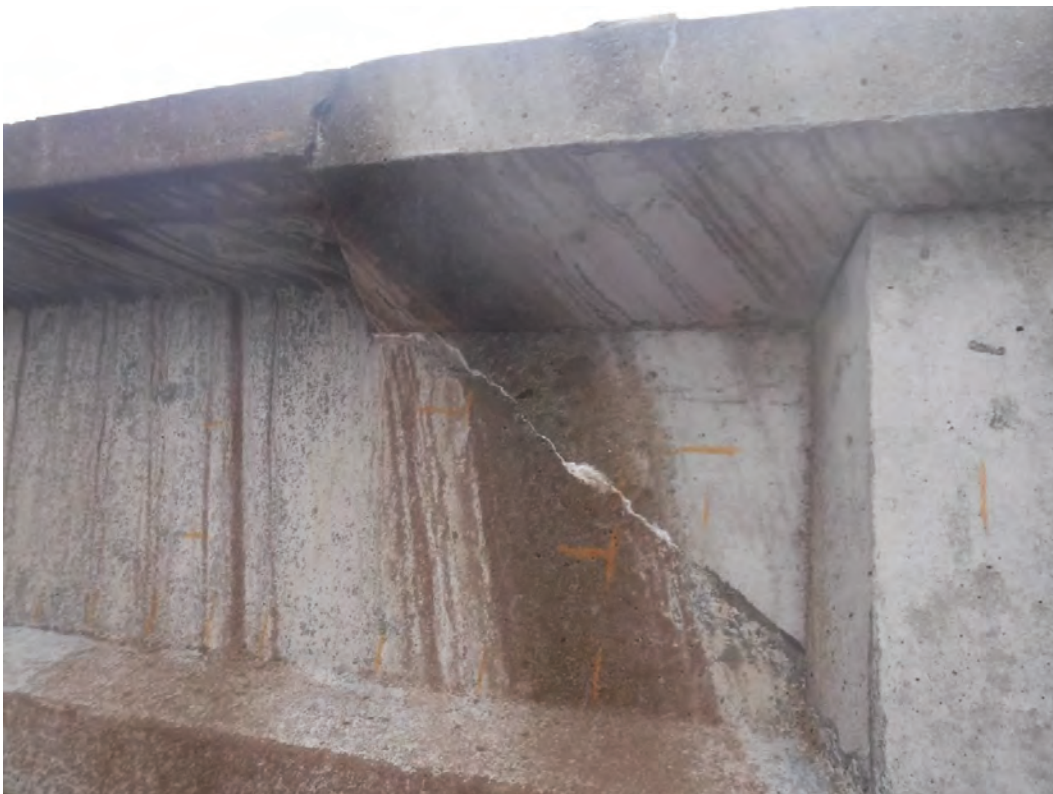
**Plate 22**– General view of surface markings to Pier 53 Left Beam, left support up

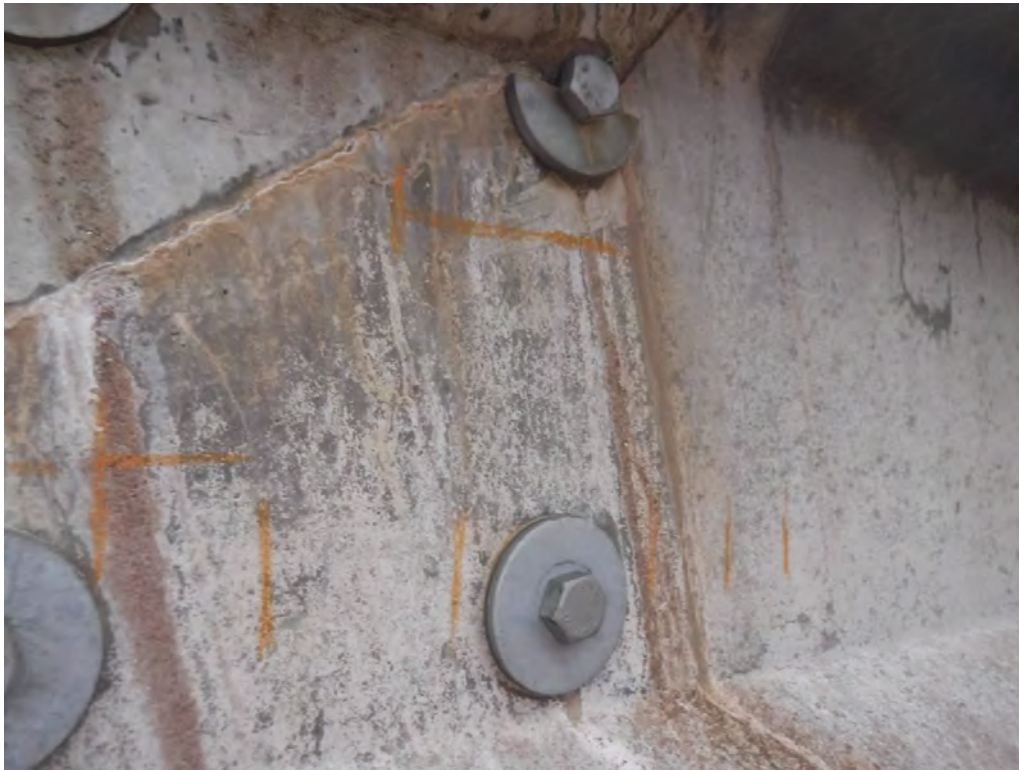
**Plate 23**– General view of surface markings to Pier 53 Left Beam, Left support down

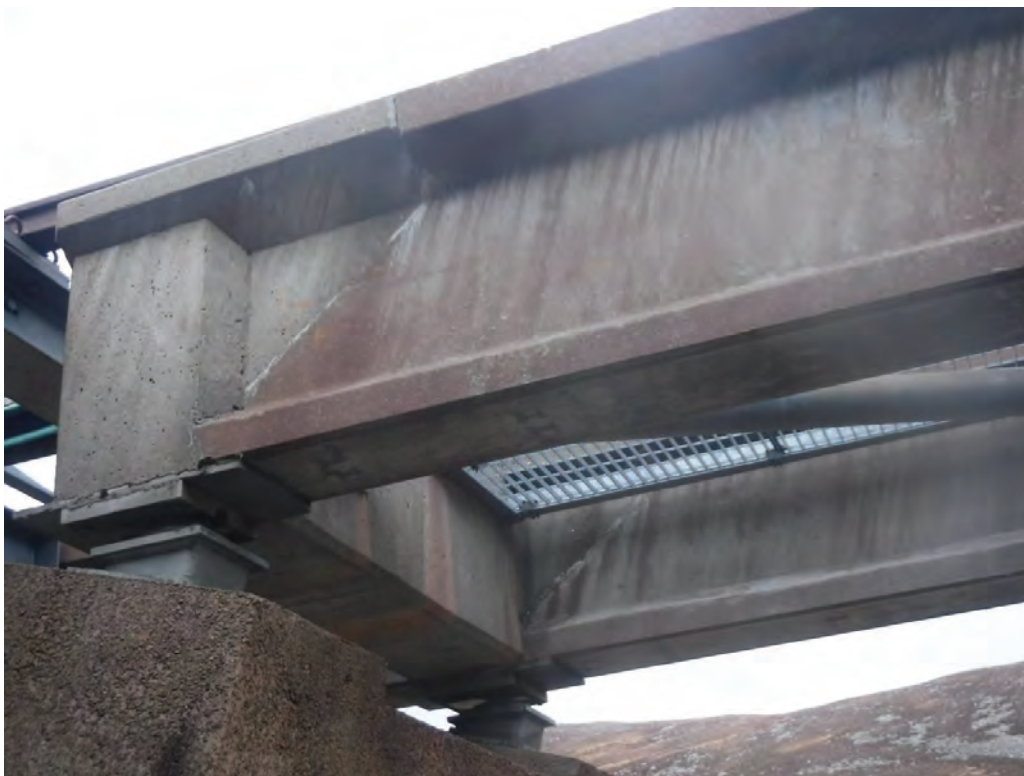
**Plate 24** - General view of surface markings to Pier 53 Right Beam, left support up.

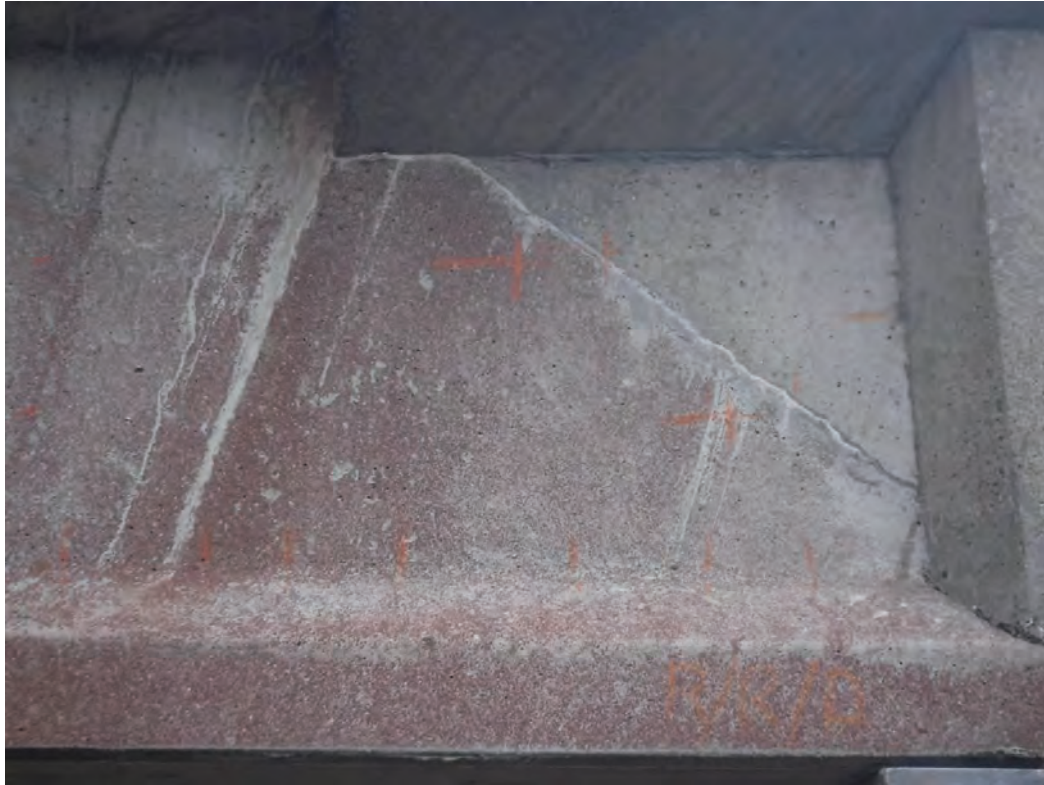
**Plate 25** - General view of surface markings to Pier 53 Right Beam, right support down.

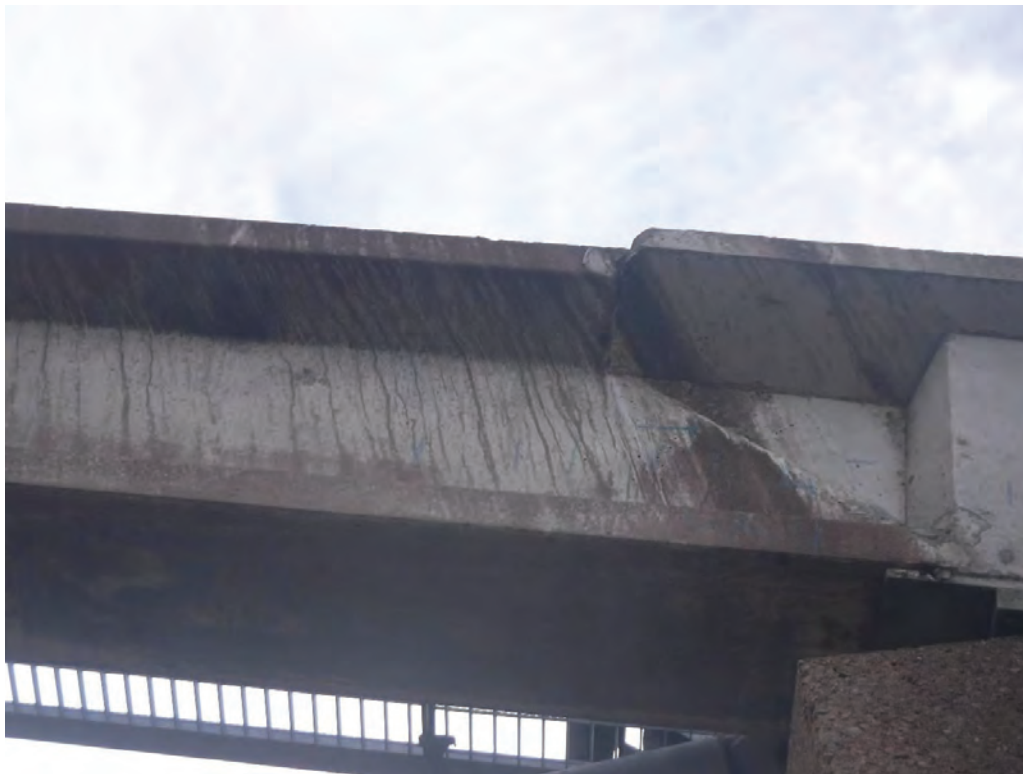
**Plate 26** - General view of surface markings to Pier 54 Right Beam down

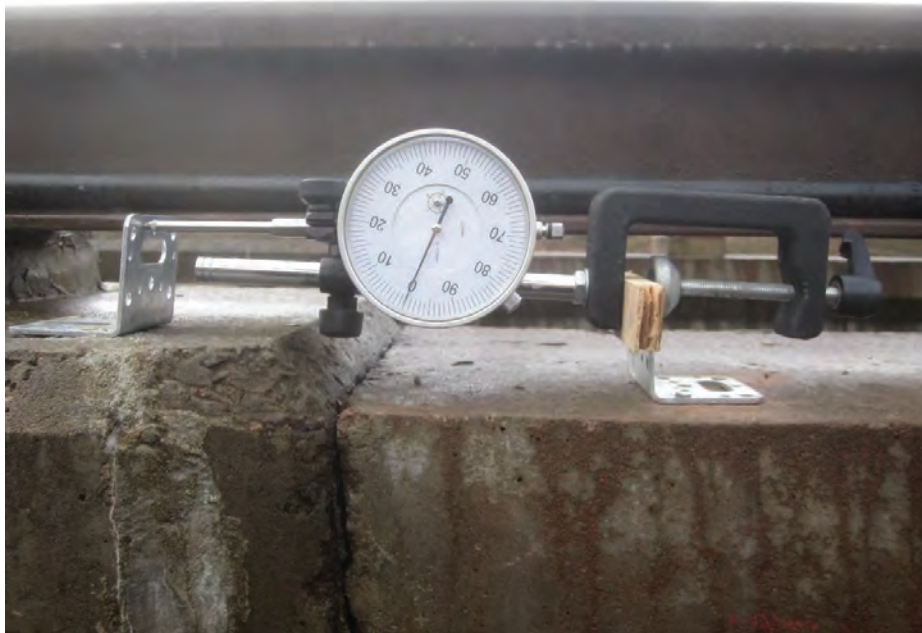
- 1 Crack widths at the in-situ to precast interface (see Figure 1). The dial gauge connection points were two steel angles fixed to the concrete on either side of the interface. These measurements were conducted at 13 No. locations. At three of the in-situ joints, measurements were taken on both the downhill and uphill interfaces of the joint, i.e. 2 No. locations at each joint. These locations allowed the total cracking deformation across the two interfaces to be assessed.

Figure 1 Type 1: General setup for crack width measurement tests

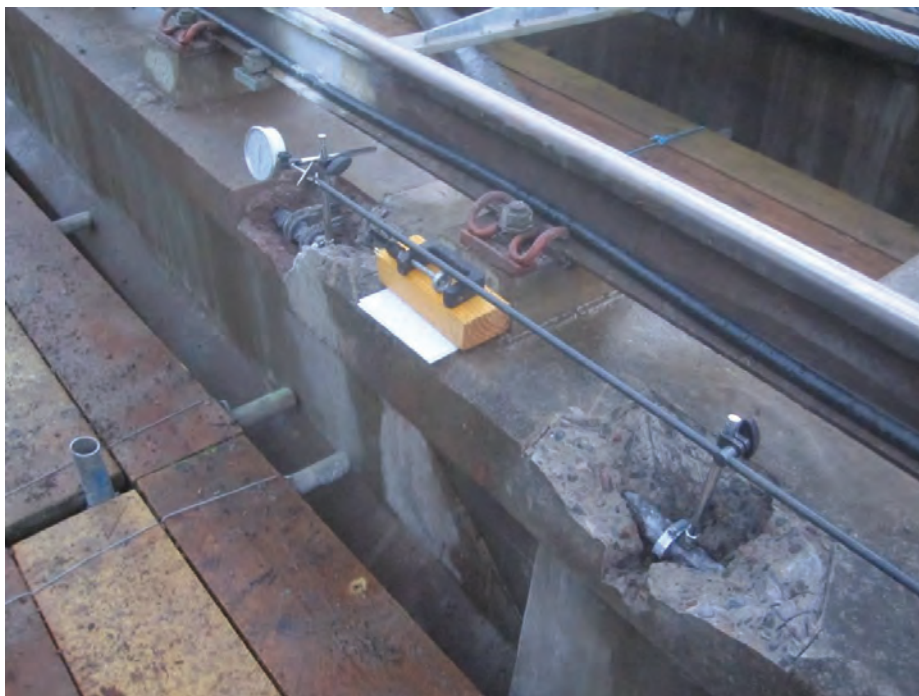
- 2 Reinforcement deformation across a gauge length of approximately half the in-situ joint length (see Figure 2). The dial gauge connection points were clamped directly onto reinforcement exposed by hydro demolition of the cover concrete. These tests were conducted at piers 22 and 56. At pier 22, the gauge length spanned across a grouted coupler connection. At pier 56, the gauge length spanned across a threaded coupler connection but not a grouted coupler.

Figure 2 Type 2: General setup for reinforcement deformation tests

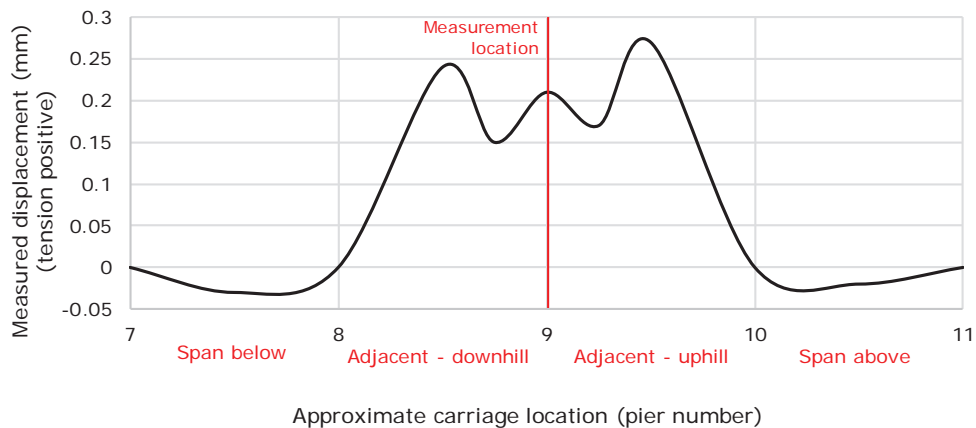
The videos of the dial gauge readings were processed to determine the displacements, as well as the approximate position of the rail carriage at the time the maximum displacements occurred. Figure 3 shows the relationship between displacement and carriage location for Test No. 1 (see Table 1). The results are generally indicative of what would be expected to occur in a continuous beam, with compressive displacements occurring when the carriage is one span away and tensile displacements occurring when the carriage is on adjacent spans.

Figure 3 Displacement versus carriage position for Test No. 1 (typical of all tests)

Pairs of tests conducted on both the uphill and downhill interface of the same in-situ joint (Test Nos. 5 & 6, 7 & 8, and 9 & 10) allow for the total displacement due to interface cracking on both ends of the joint to be assessed. The maximum tensile displacements for the relevant in-situ joints are listed in Table 4. It is noted that the downhill and uphill interface tests were not ran concurrently, so the "total" displacements are taken as the sum of the maximum displacements measured in two separate tests. However, this is expected to cause little error as the response is elastic and similar maximum tensile displacements are obtained regardless which adjacent span the carriage is on (see Figure 3).
