DECEMBER 2018  
HIGHLANDS AND ISLANDS ENTERPRISE

# CAIRNGORM FUNICULAR RAILWAY

## VIADUCT APPRAISAL REPORT

Rp01

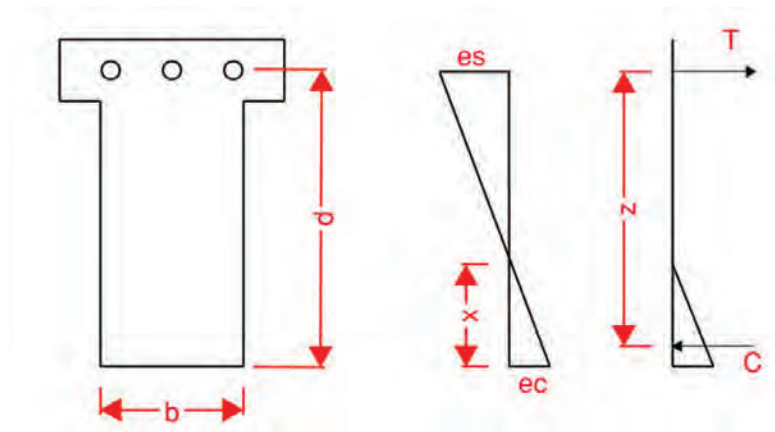
Theoretical tensile strains in the top flange reinforcement (3 No. T32 bars in all cases) due to the hogging moments were assessed using a sectional analysis of the in-situ joint cross-section (Figure 4). A triangular concrete stress block and a constant section width of 340 mm was assumed. In all cases, maximum concrete stresses were approximately 5 MPa or below, indicating that the triangular stress block assumption was appropriate.

Figure 4 Basis of reinforcement strain calculations
